Turtle Mountain Field Laboratory, Alberta (NTS 82G): 2014 Data and Activity Summary

AER/AGS Open File Report 2015-10

D.E.Wood, D.K. Chao and T.C. Shipman

February 2016

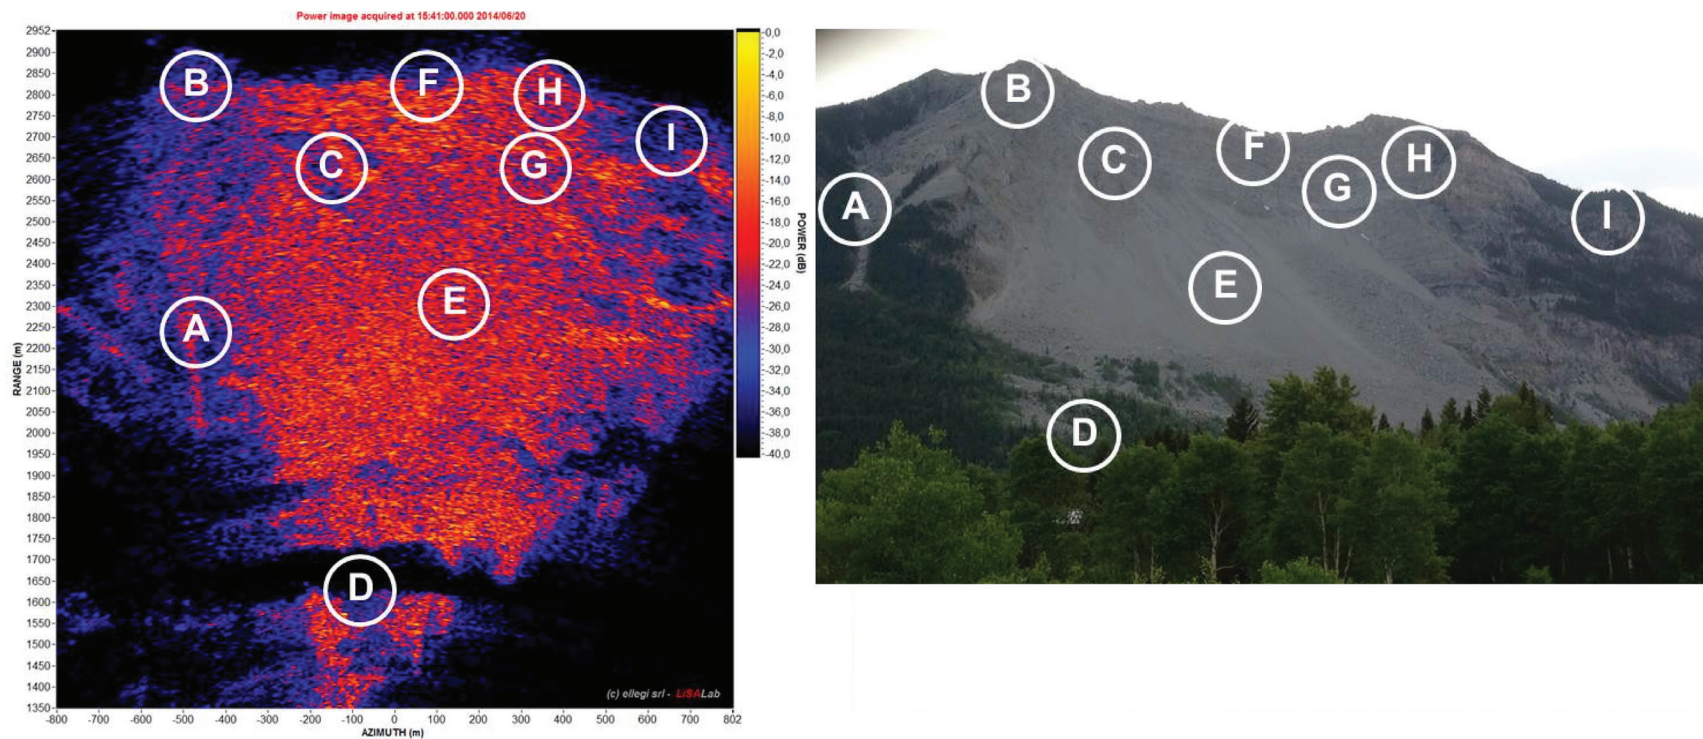
Figure 8. First image produced by the LiSAR mobile system over the 24-hour testing period June 19–20, 2014.

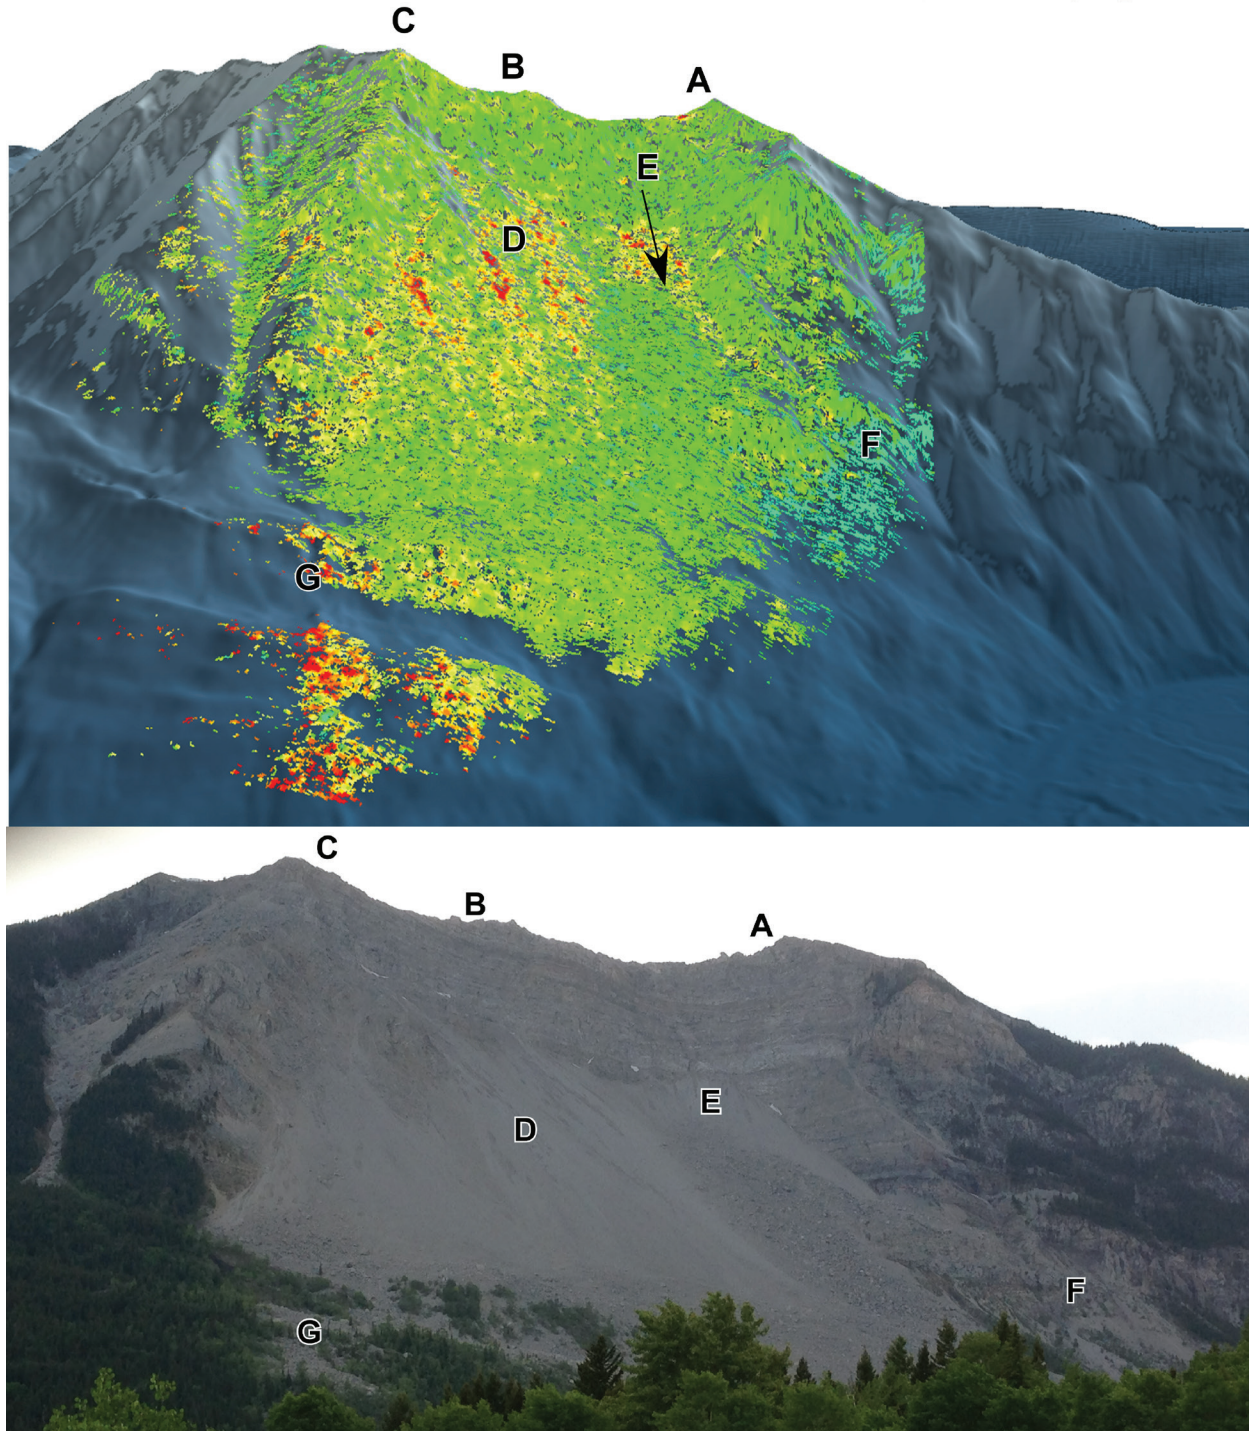
Figure 12. 3D displacement map (top) measured from June 20 through September 20, 2014, and view of the eastern face of Turtle Mountain (bottom). Letters A to G denote locations of regions described in Table 1.

The analyses completed by Ellegi concluded that no generalized block movement was recorded during the first quarter of monitoring from June 20 through September 20, 2014 (Figures 15–20). During the second quarter of monitoring, the points of interest (P_1–12) will continue to be monitored and will be compared to the first quarterly results. Additional points of interest may be added to further quarterly analyses if additional areas of displacement or localized rock falls are identified. Results from the second quarter will be reported in next annual report.

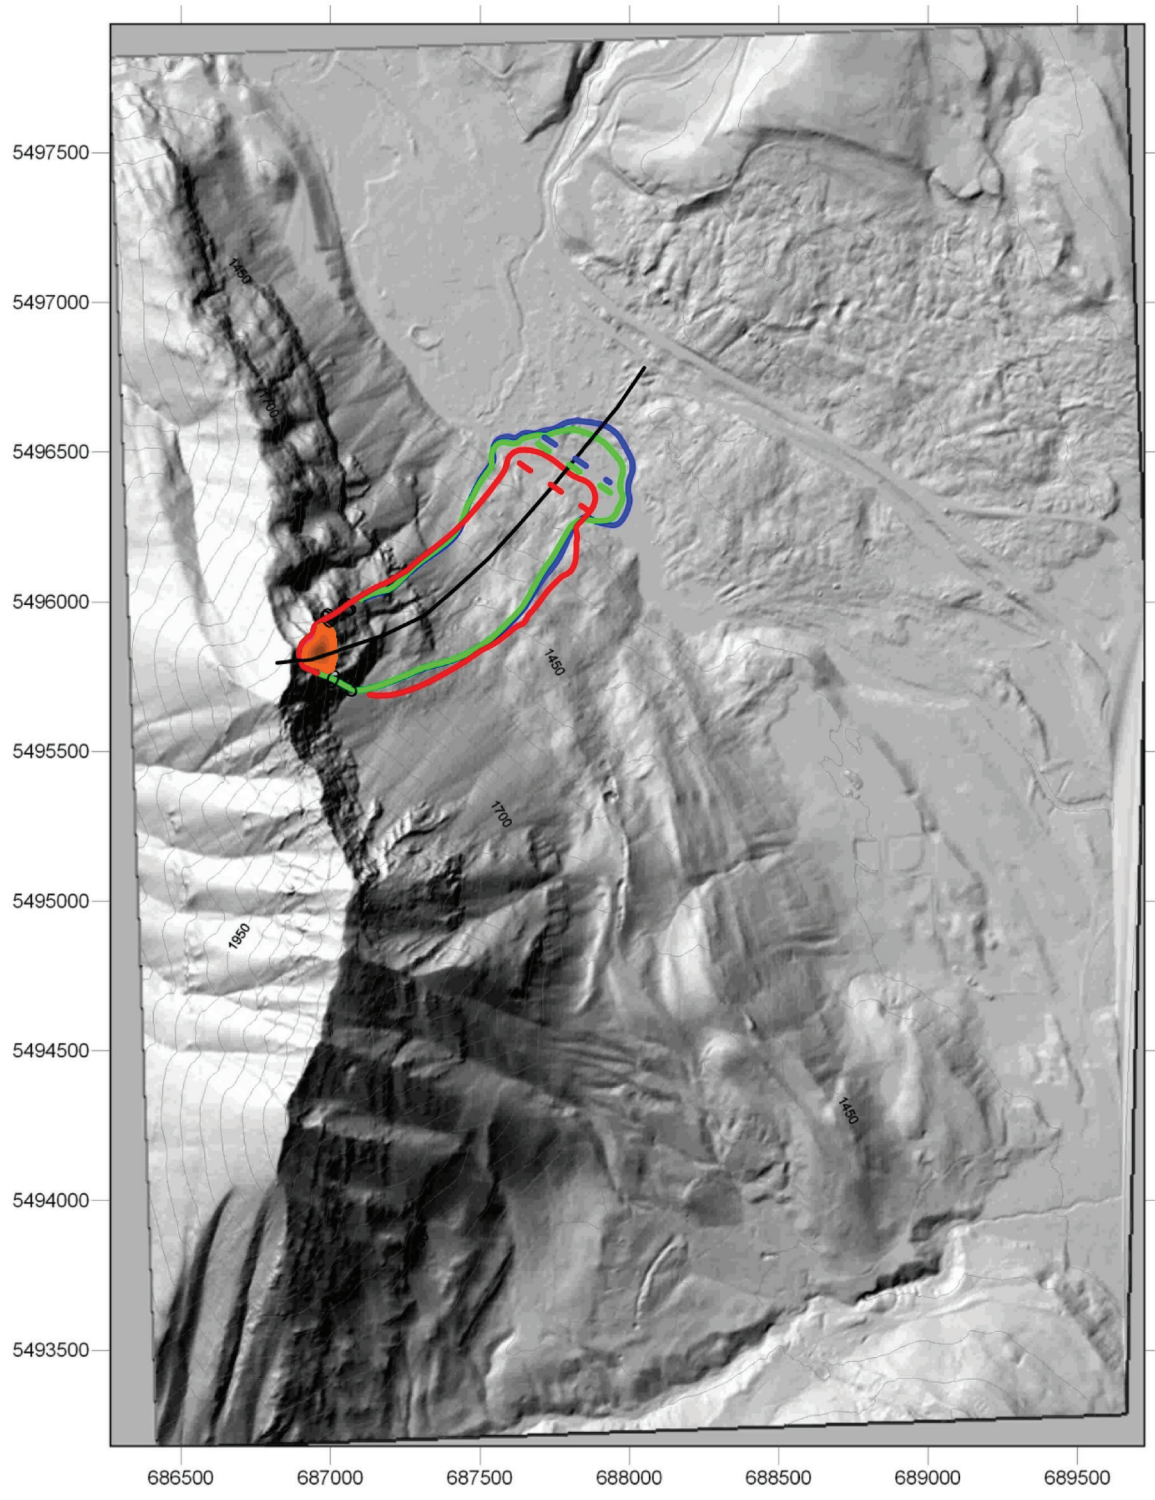
Figure 21. Runout-modelling results for “shallow” rock failure at North Peak (modified from Hungr, 2014, Figure 6; Appendix 1). Solid lines depict outline of runout based on 3D model analyses and dashed lines depict outline of runout based on 2D analyses. Orange area delineates area of failure.

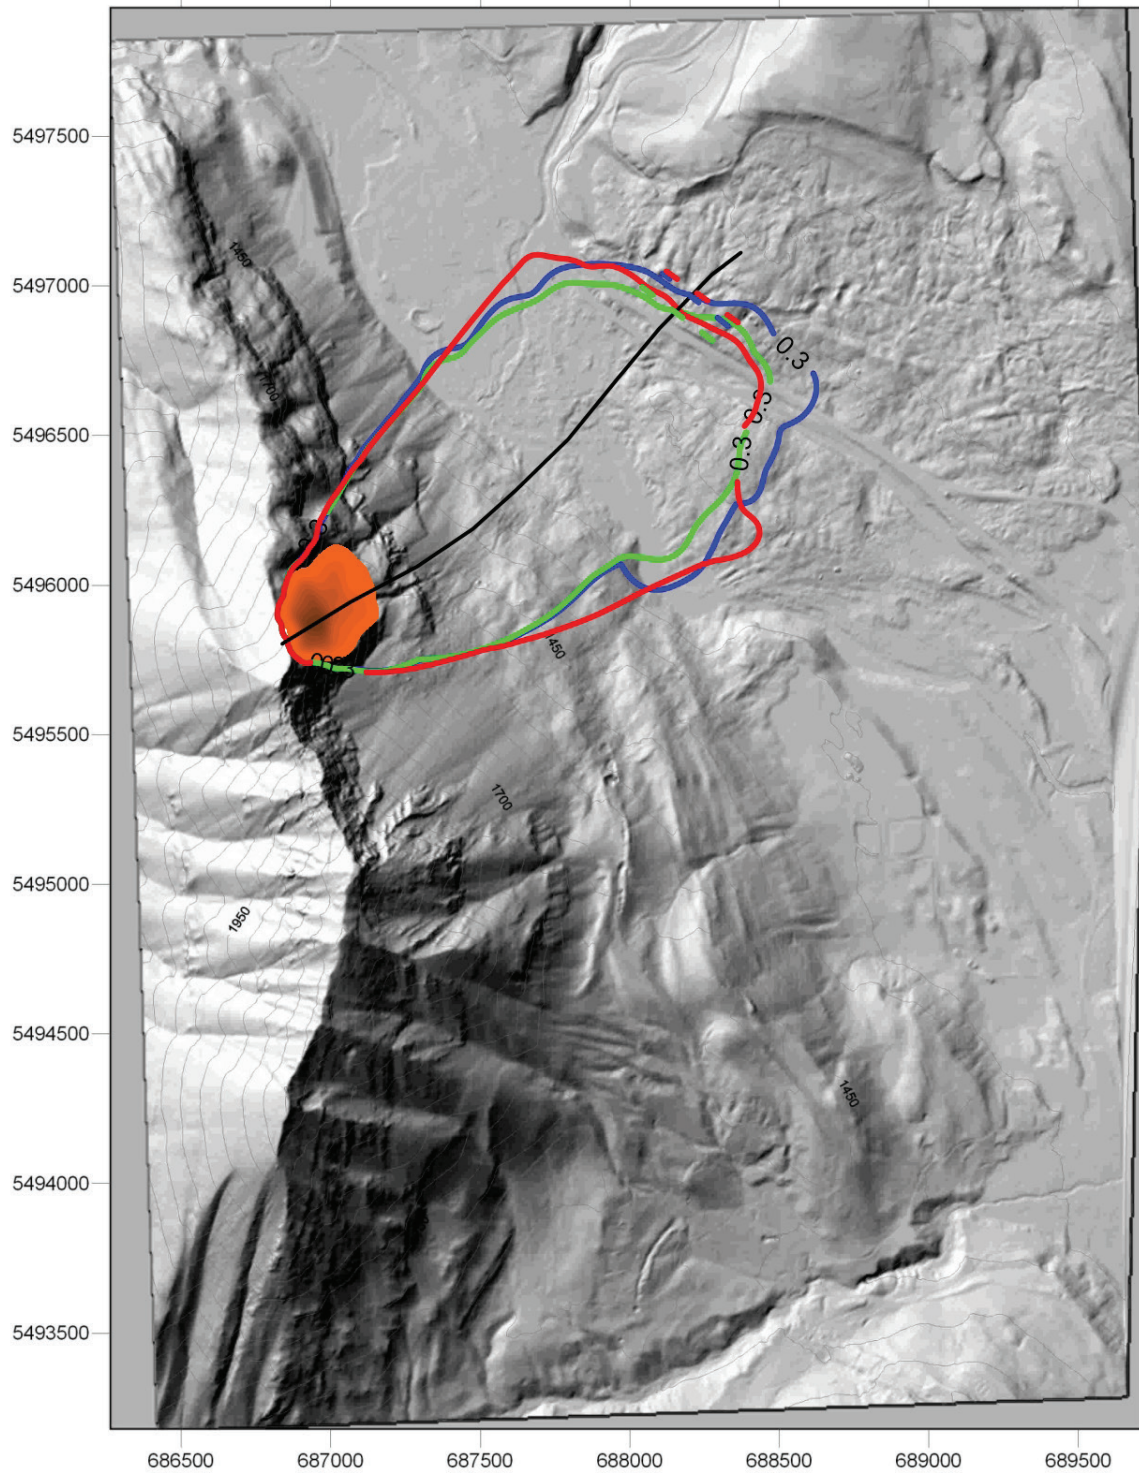
Figure 22. Runout-modelling results for “deep” rock failure at North Peak. Solid lines depict outline of runout based on 3D model analyses and dashed lines depict outline of runout based on 2D analyses. Orange area delineates area of failure (Hungr, 2014, Figure 7; Appendix 1).

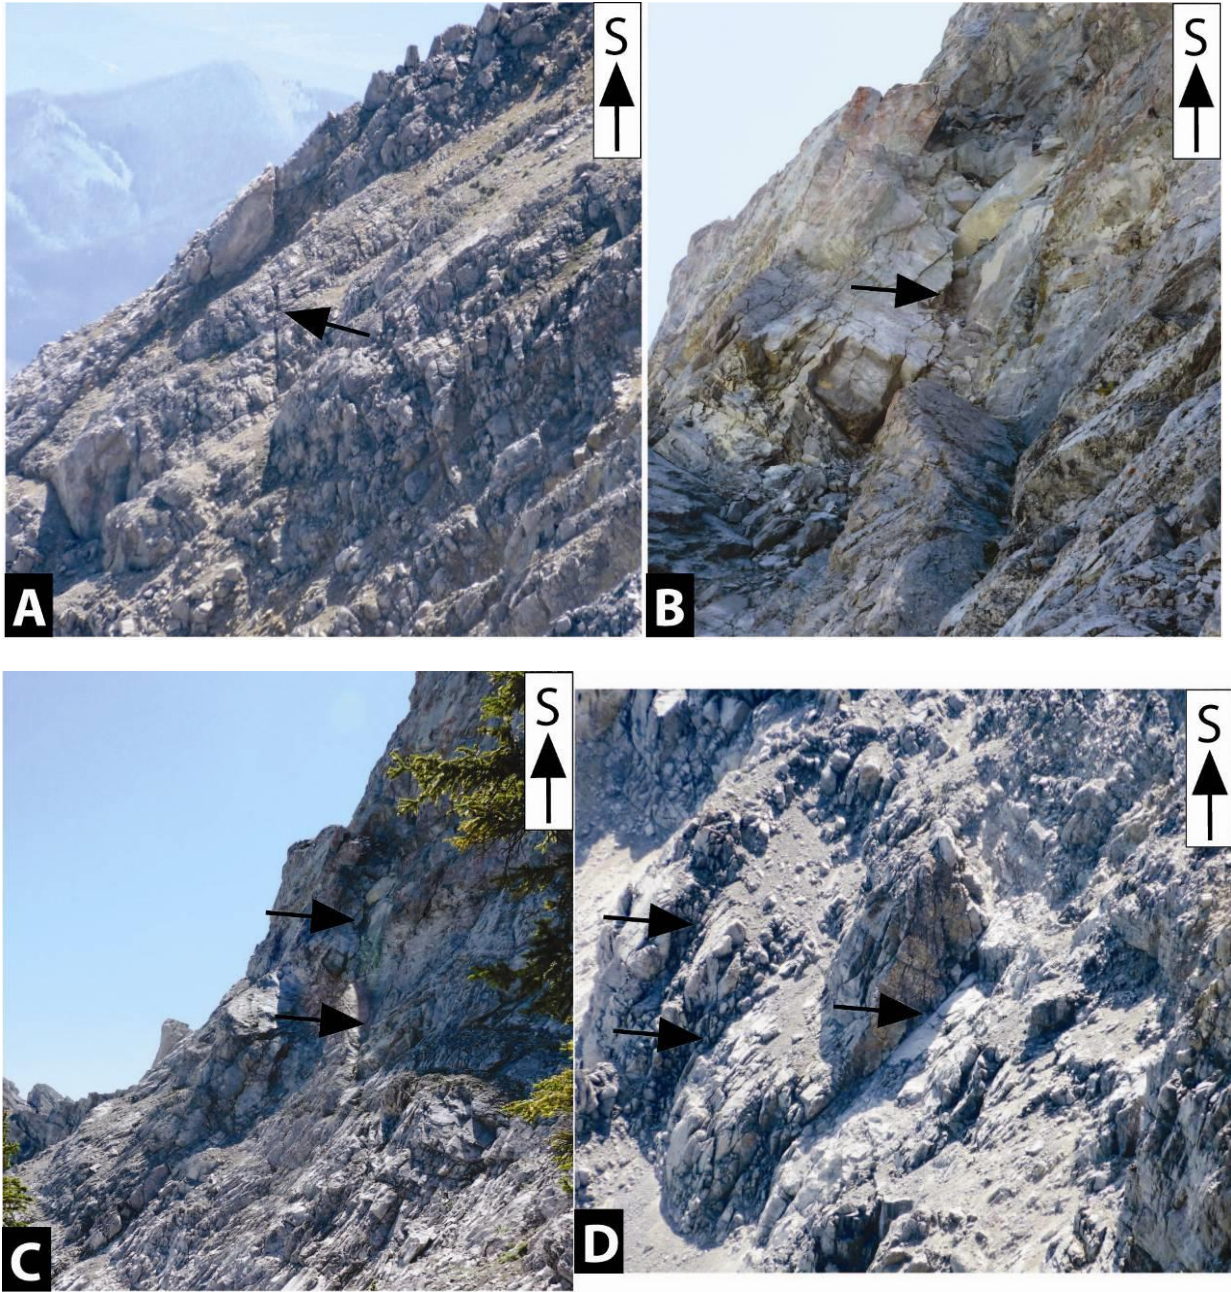
Figure 4: Field examples of persistent fractures "crack J3". A) Southern prolongation of a fracture. B) and C) Persistent fracture located at the top of the spur. D) Persistent fractures southward of the spur in the cliff of the Frank Slide scar.

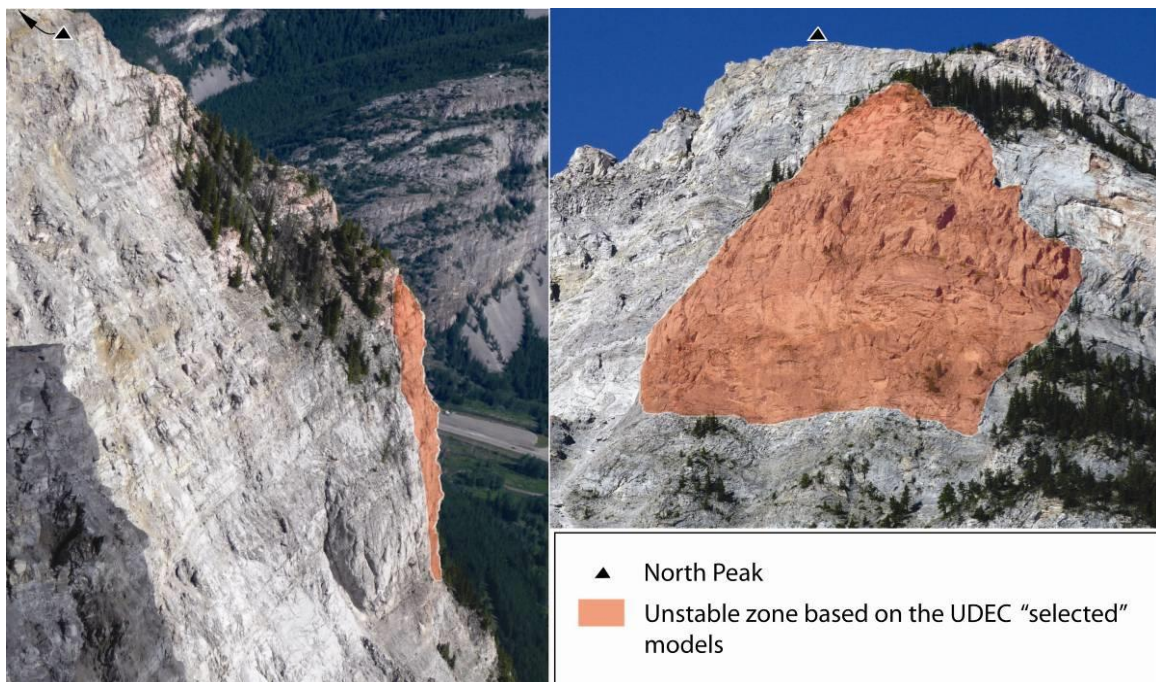
Figure 9: Outline of the present day unstable zone deduced from UDEC modelling. Only the superficial portion of the cliff is involved.

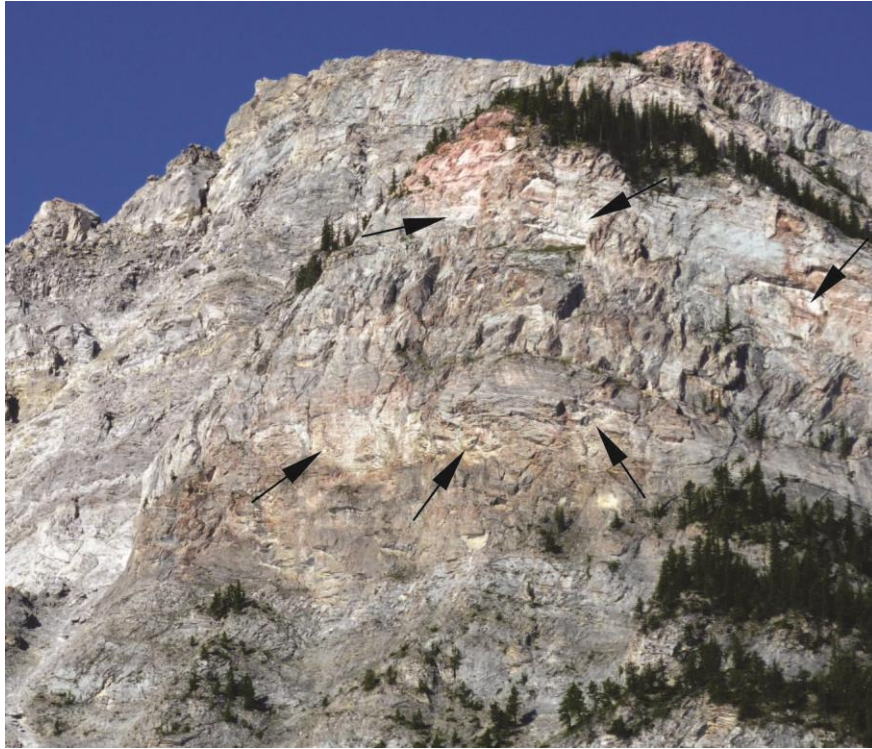
Figure 12: View towards the West of the main cliff showing fresh outcrops suggesting evidences of recent shallow block fall.
