Turtle Mountain Field Laboratory Monitoring and Research Summary Report, 2005

F. Moreno and C. Froese

Alberta Energy and Utilities Board

Alberta Geological Survey

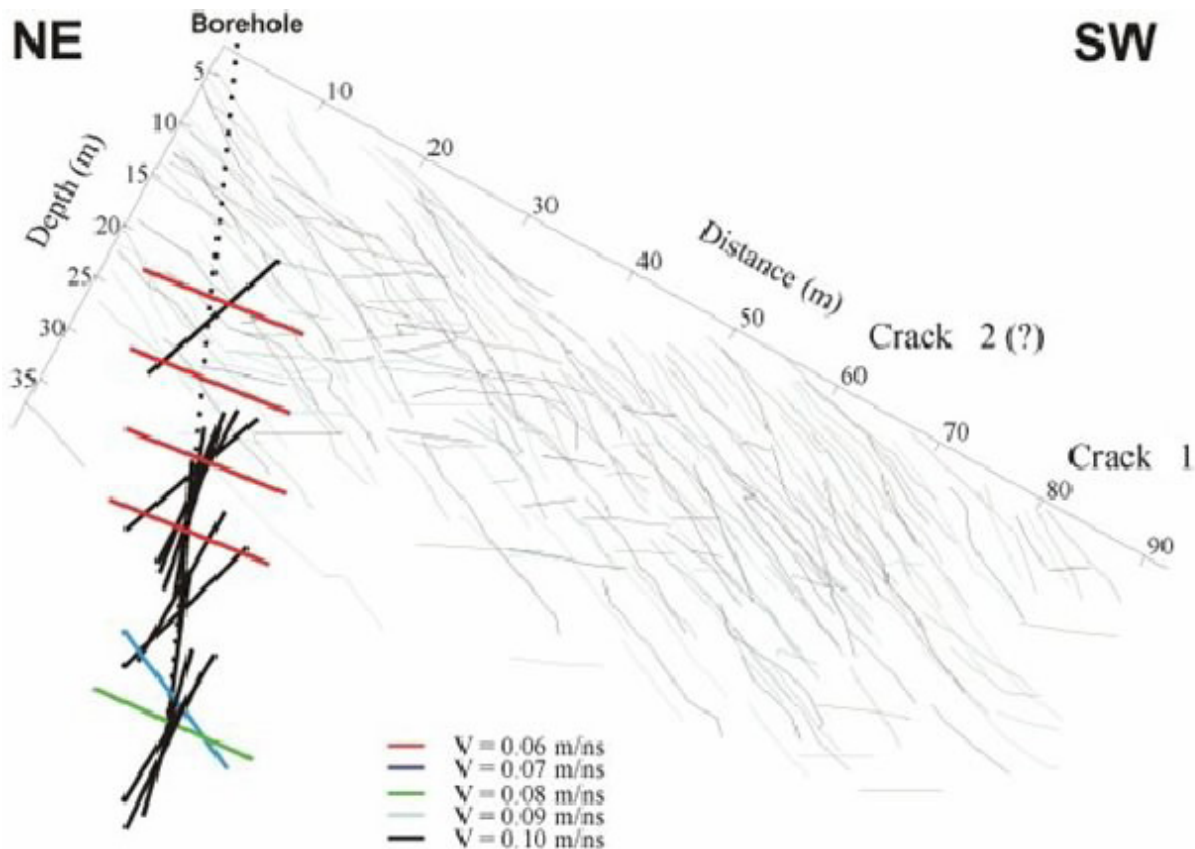
Figure 6. Profile from ground-penetrating radar (GPR) survey of South Peak of Turtle Mountain, with results of borehole televiewer analysis (*modified from Spratt and Lamb, 2005*).

In addition to the studies of the surface features, two recent studies have also attempted to characterize the subsurface conditions. During the summer of 2004, a 62 m deep test hole was drilled (Bidwell et al., 2005) and an optical televiewer used to photograph and map the bedrock conditions in the annulus (Spratt and Lamb, 2005). During the same time period, researchers from the University of Alberta (Theune et al., in press) utilized ground-penetrating radar (GPR) in an attempt to map the structure within South Peak, including a traverse running through the test hole. These combined studies mapped the apparent dips of bedding and all major fractures within 40 m of the surface. Although the GPR was able to pick up bedding trends parallel to the surface, fracture sets that were found to be dipping perpendicular to the surface from testhole observation were not observed in the GPR image. Figure 6 provides the combined results of the two surveys.

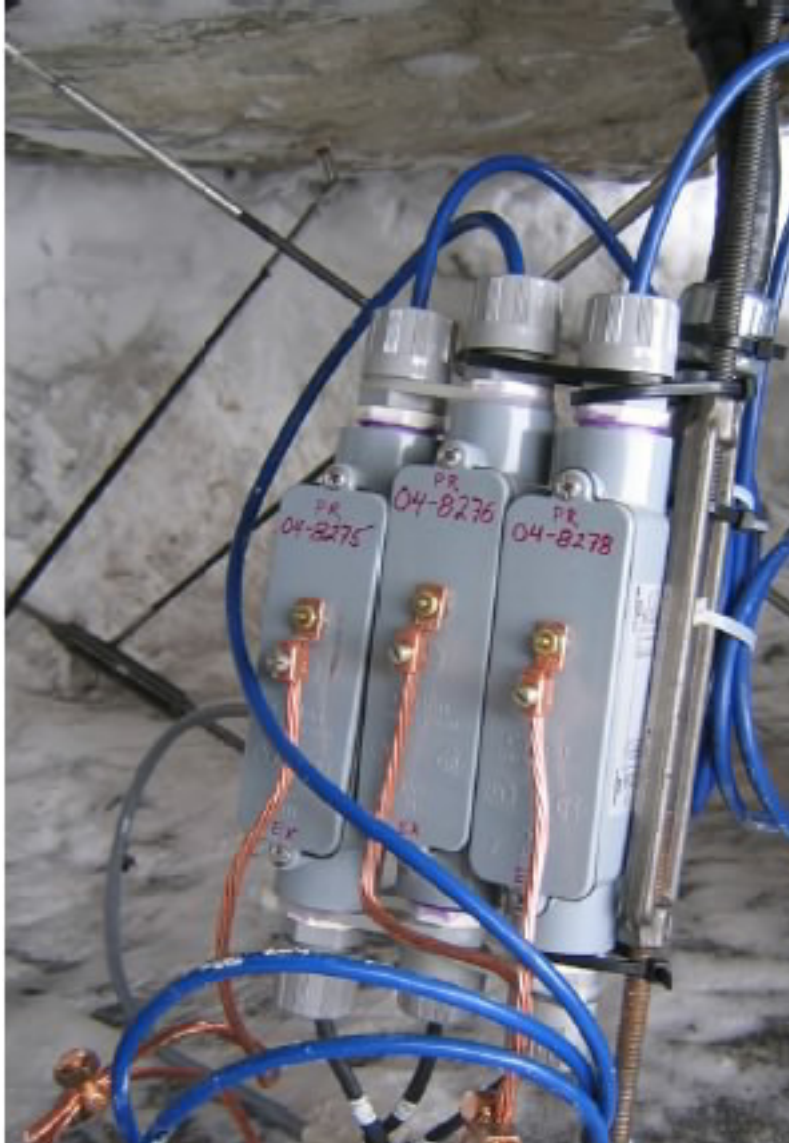
Figure 11. Electrical surge suppressors installed at crackmeter array H on South Peak of Turtle Mountain for protection of instruments from the effects of lightning. Grounding is accomplished by means of the small rock bolt at the lower right.

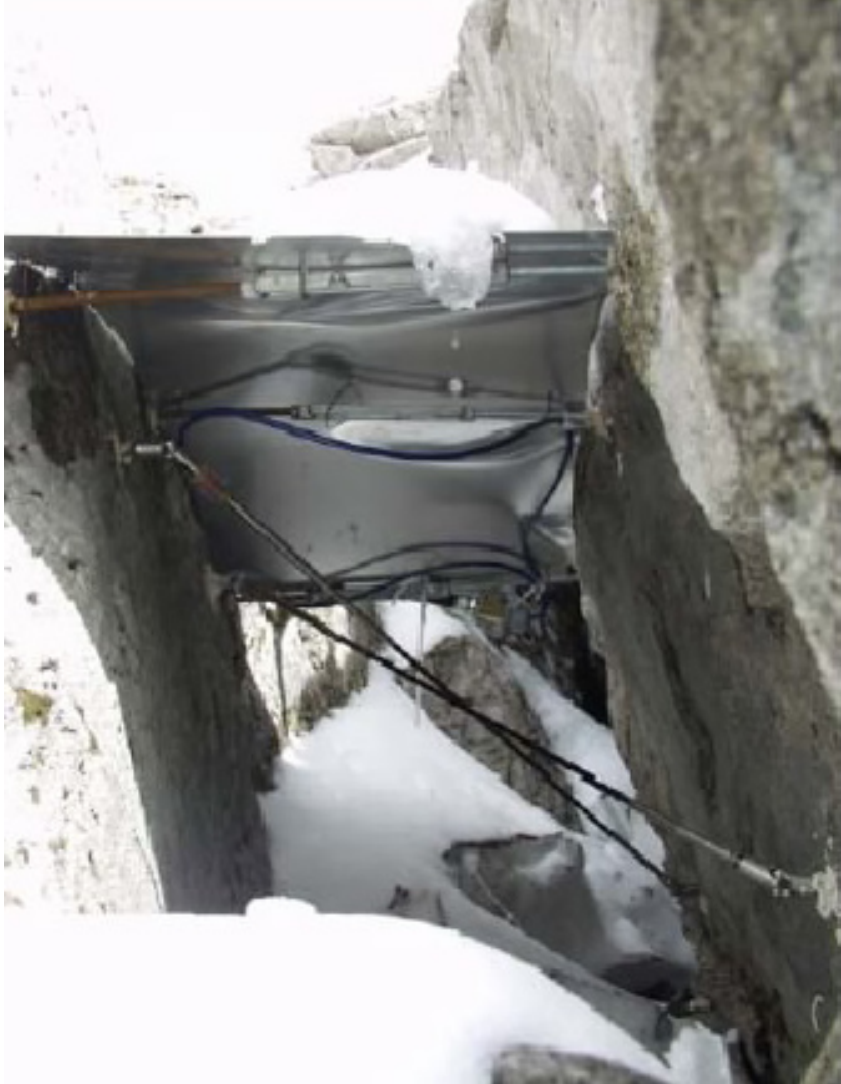
Figure 12. Protective aluminum snow roof installed over a crackmeter array on South Peak of Turtle Mountain to protect it from snow.

The crackmeters are Geokon model 4420 vibrating-wire strain gauges with a maximum range of 25 mm (or 50 mm in cluster D) and sensitivity of 10 μm . Each crackmeter incorporates a thermistor to obtain instrument temperature readings for thermal corrections to the data. All crackmeters were installed so that they were initially positioned in approximately the middle of their sensing range, to allow measurement of both crack closure and opening. The crackmeter anchors were epoxied into 12.5 mm diameter holes drilled into the walls of the fissure. A sheet metal roof was installed over each crackmeter array to provide protection from snow and falling rocks (Figure 12). Despite these protective roofs, several instruments were affected by drifting snow and ice build-up in late 2004.

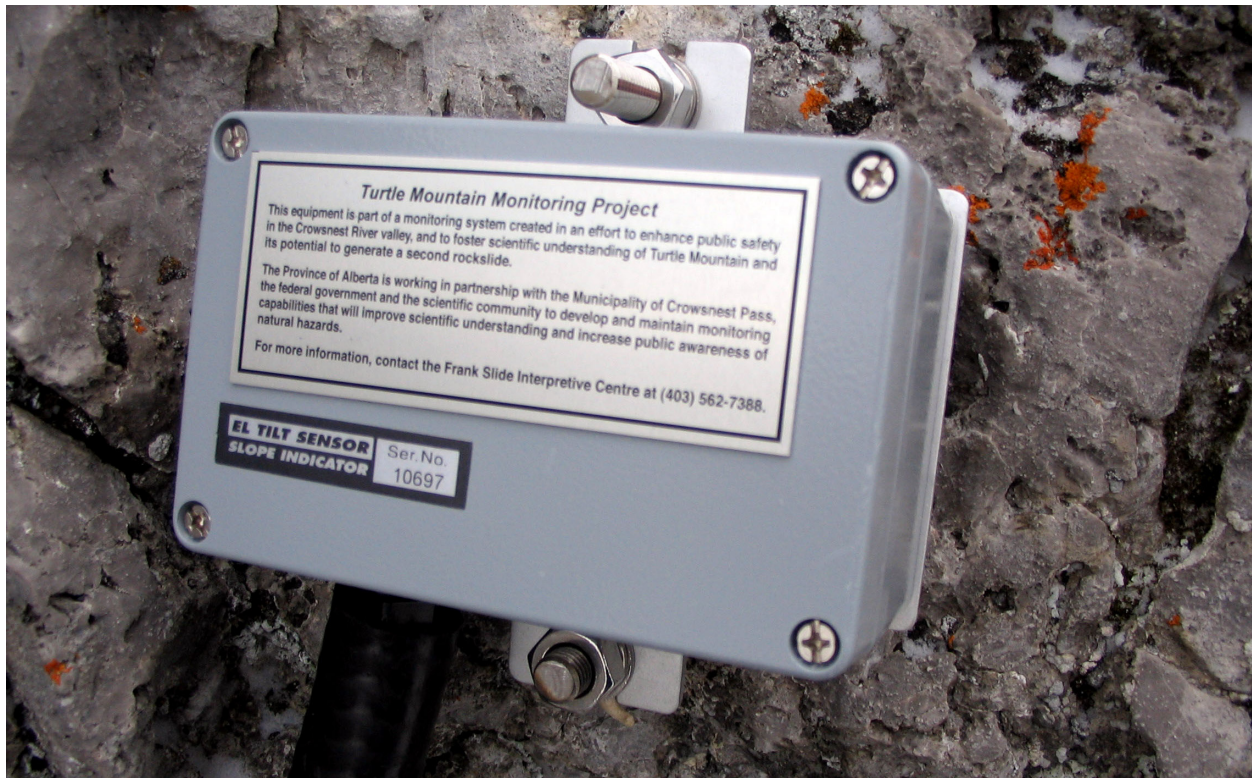
Figure 14. Electrolevel (EL) tiltmeter installed on South Peak of Turtle Mountain. Counter-clockwise rotation of the sensor represents positive tilt.

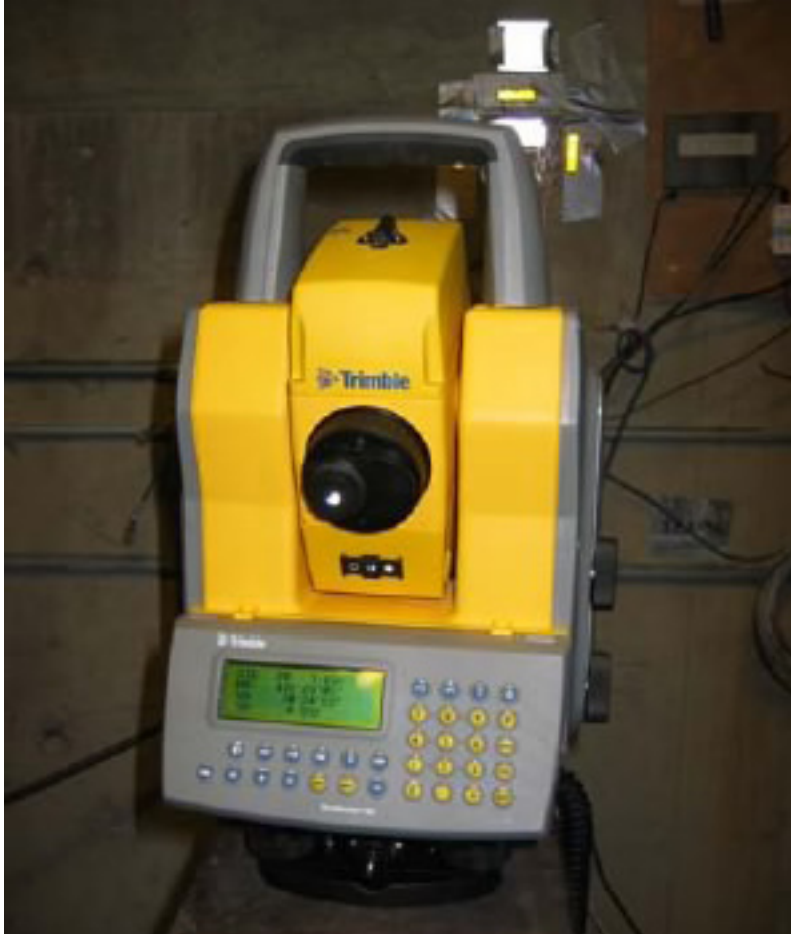
Figure 15. Trimble theodolite installed in the attic of the FSIC, viewing Turtle Mountain through a hole cut through the concrete wall of the building.

To complement the crackmeters, an automated laser-ranging survey system was deployed during late 2004. A computer-automated Trimble 5605 laser-ranging theodolite (Figure 15) was mounted in a protected area in the attic at the FSIC to sight prisms positioned on South Peak and Third Peak. A metal plinth for the theodolite was mounted permanently to the floor of the attic, and a viewing port was drilled

in the concrete wall of the building. To reduce interference by airflow, a plastic enclosure was set up around the instrument and the viewing port, and shock-absorptive pads were placed beneath the plinth to reduce vibrations from the FSIC air-conditioning system. Ten prisms were mounted at strategic points on Turtle Mountain. Four of these (Psm-1, Psm-2, Psm-3 and Psm-4) were mounted on reinforced concrete pedestals constructed during the summer of 2004. The other six prisms (Psm-7, Psm-8, Psm-9, Psm-10, Psm-11 and Psm-12) were mounted on the east face of Turtle Mountain by Vertical Systems International Inc. using ropes and climbing gear. The locations of the prisms are shown in Figure 16.

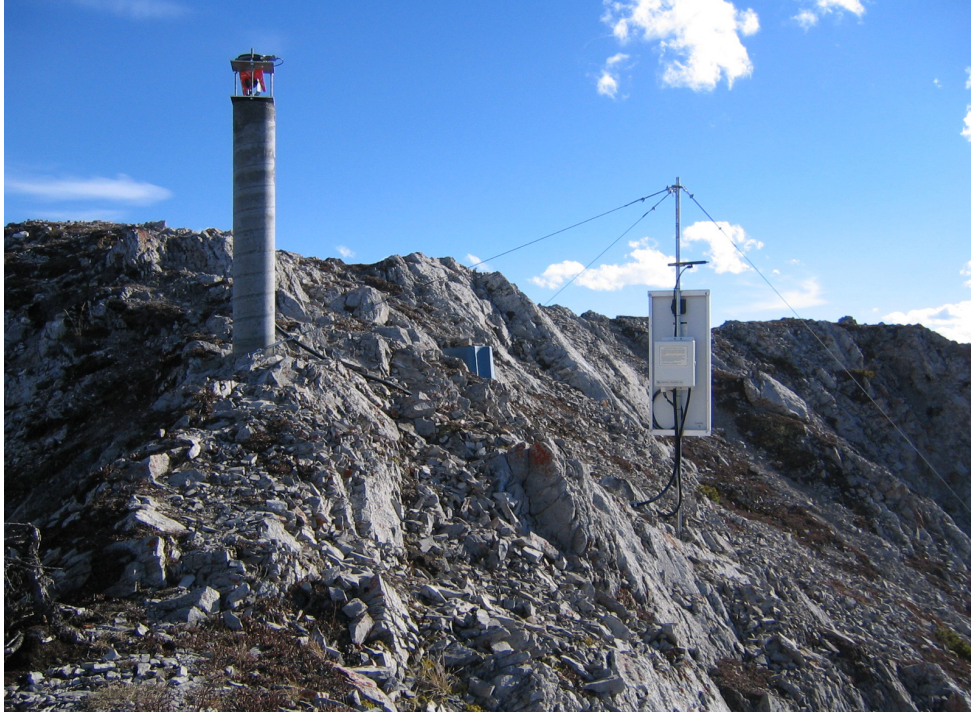
Figure 17. Combination theodolite prism and GPS antenna mounted on a concrete pillar near South Peak of Turtle Mountain. The prism is shown with an orange targeting guide; the oblate spheroid on top of the assembly is a GPS antenna.

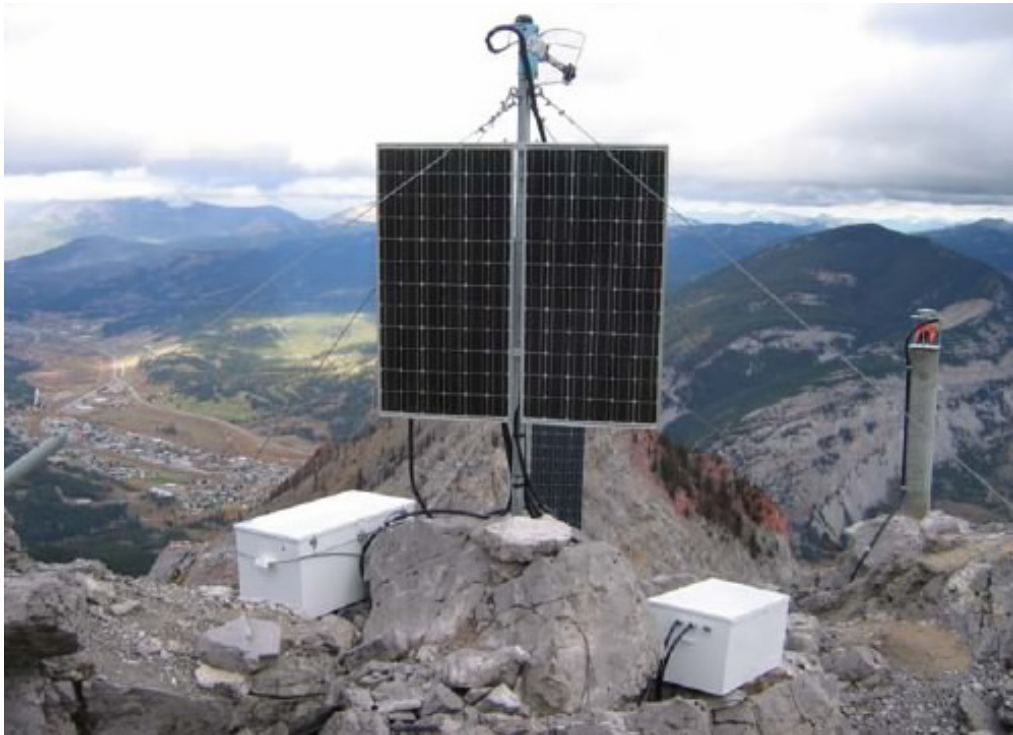
Figure 19. Surface microseismic station installed on South Peak of Turtle Mountain. This station has dual solar panels and battery boxes to accommodate the subsurface microseismic system installed in a borehole drilled nearby.

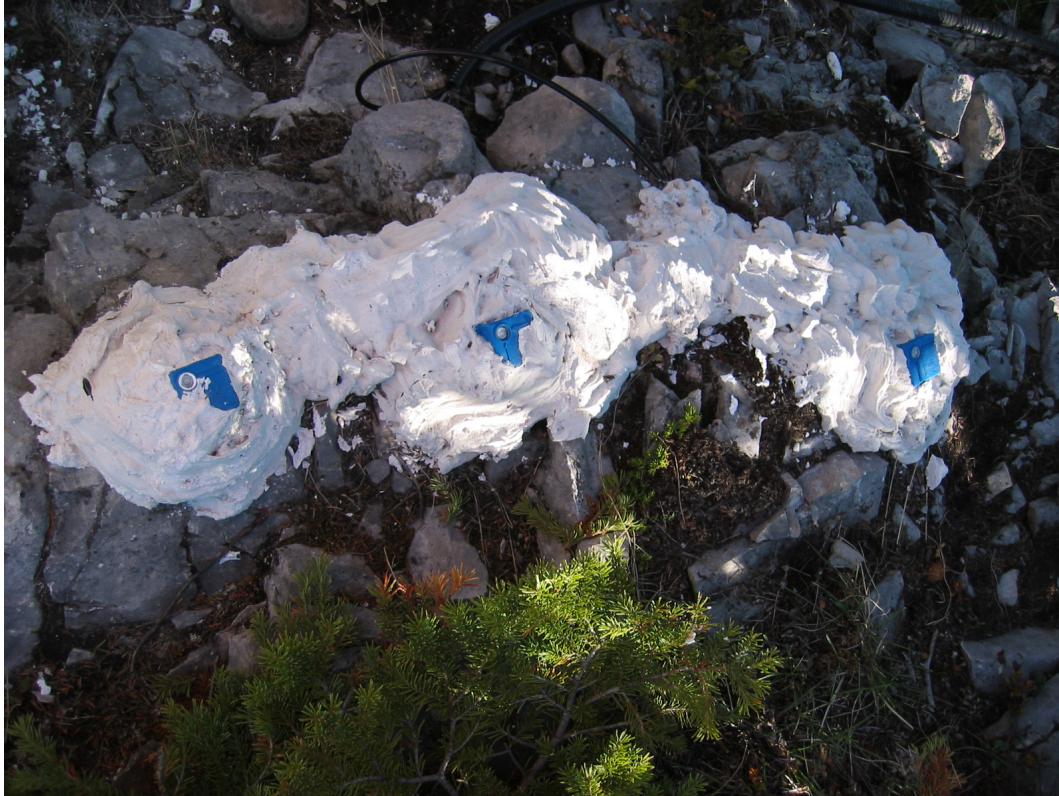
Figure 20. Geophones installed in outcrop on Turtle Mountain.

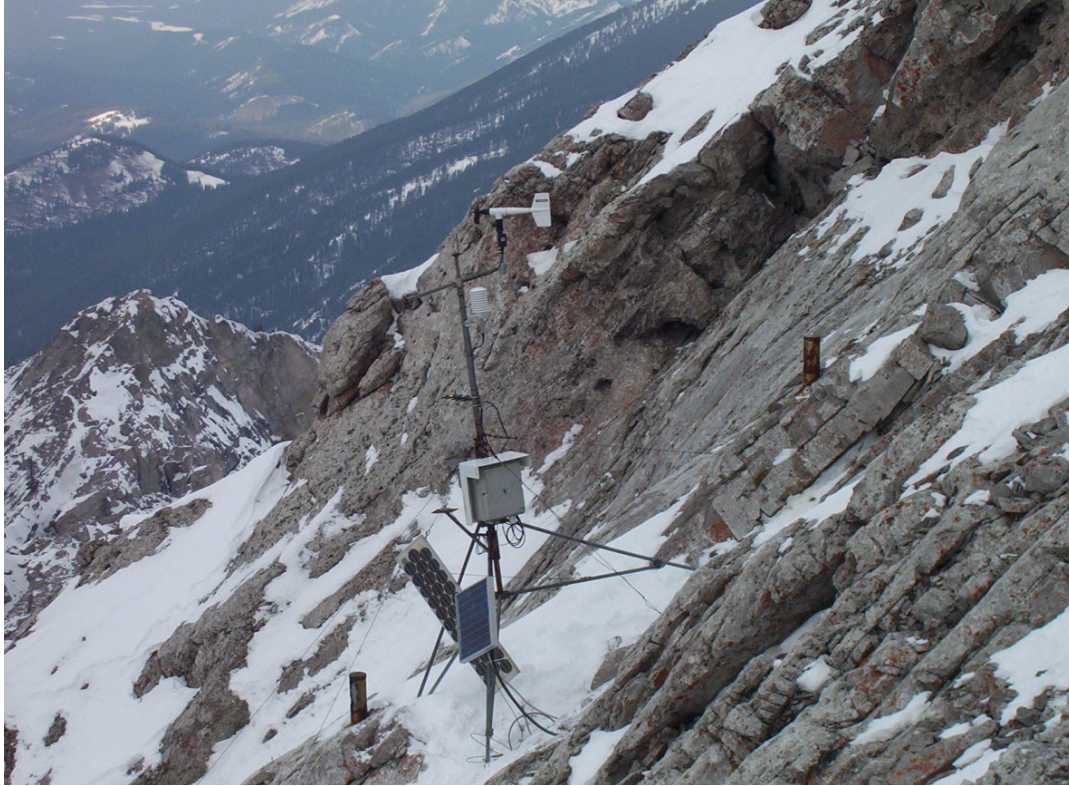
Figure 21. Weather station installed on the west side of Turtle Mountain.

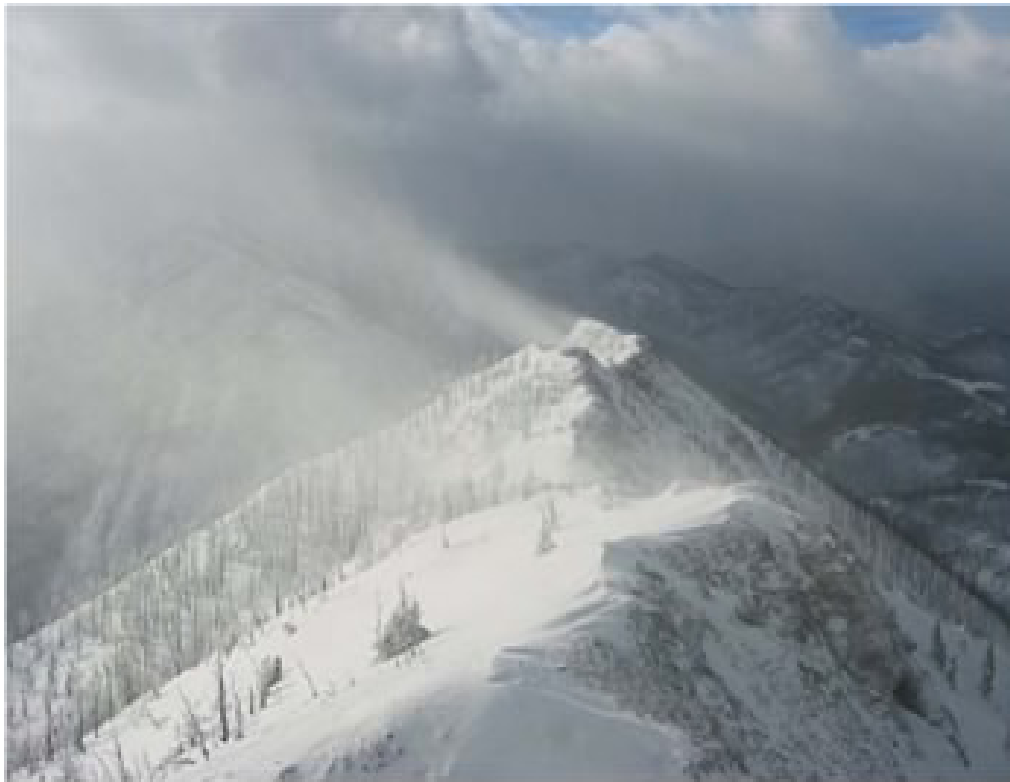
Figure 22. Winter weather conditions with drifting on the east side of Turtle Mountain.

It should be noted that any measurement of precipitation at the location of the present weather station may not be representative of actual precipitation falling on Turtle Mountain. Because the station is situated on a very exposed westward-facing slope and there is usually significant westerly wind at the site, little precipitation (rain or snow) accumulates here. As a result of wind effects, snow accumulates in much greater abundance directly east (leeward) of the ridge line — 2–3 m thick drifts have been observed during the winter (Figure 22).

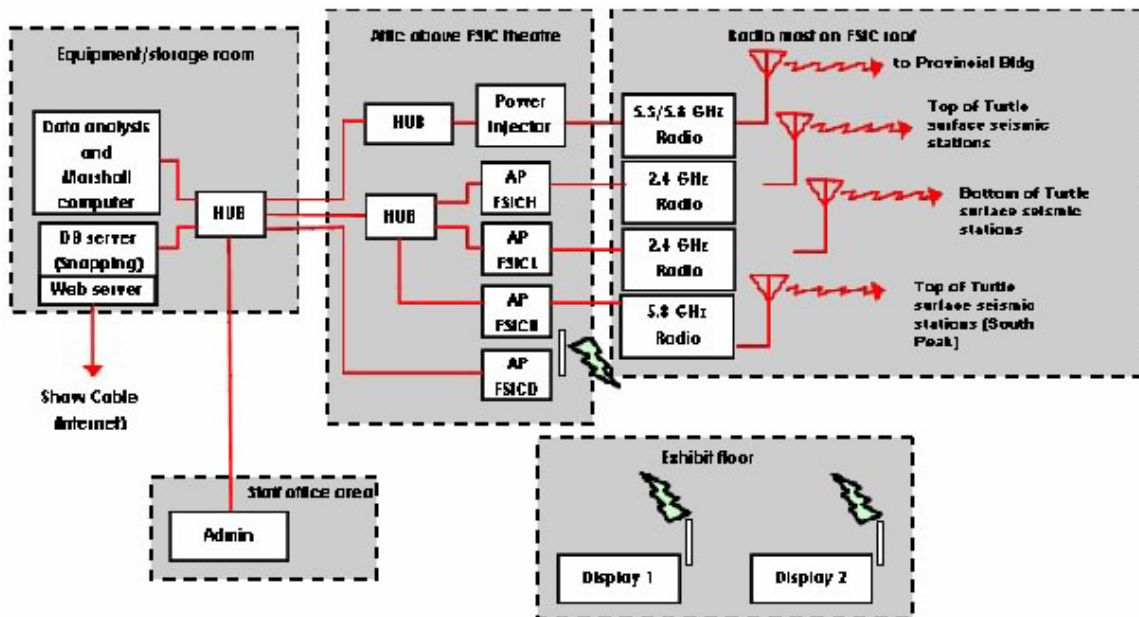
Figure 23. Schematic diagram of wireless and wired Ethernet data network at the Frank Slide Interpretive Centre (modified from Gennix Technology Corporation, 2004).

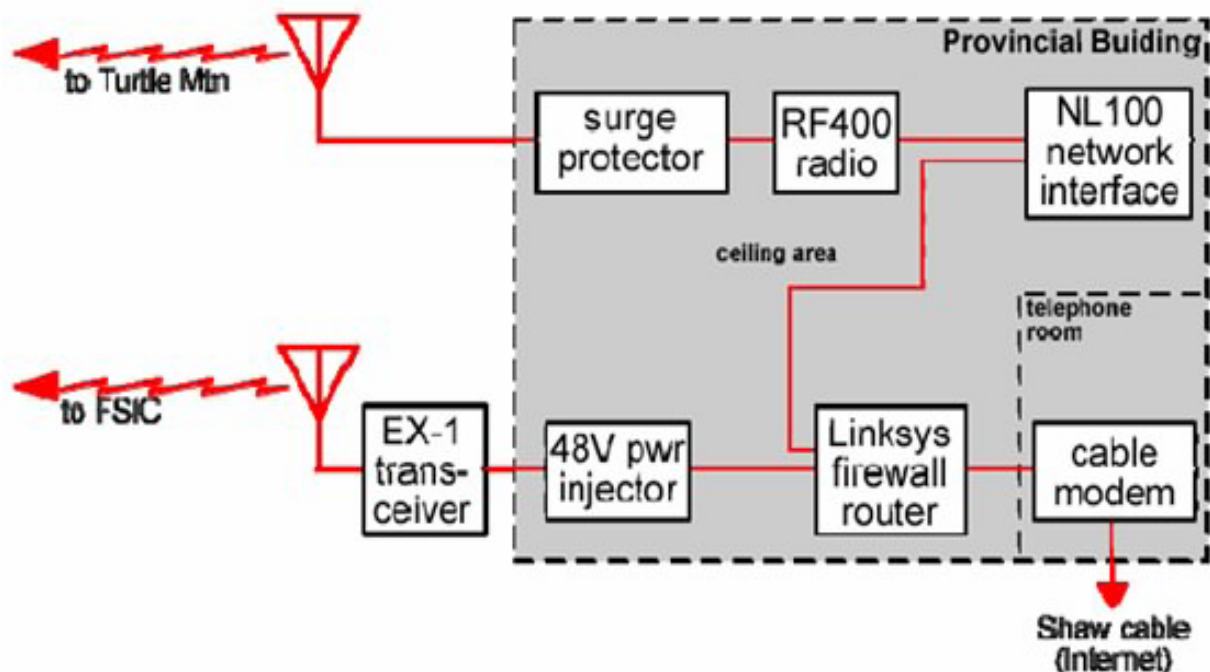
Figure 25. Schematic diagram of telemetry equipment installed at the Crowsnest Pass Provincial Building (Danaus Corporation, 2004).

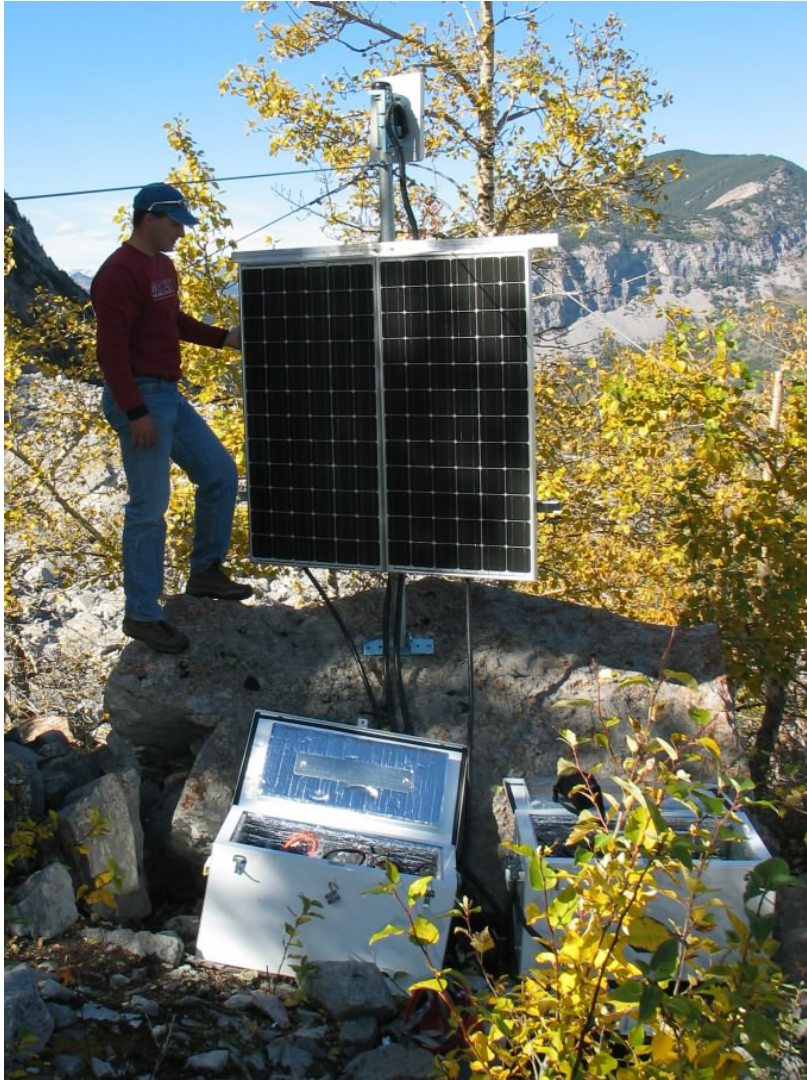
Figure 29. Solar power system on Turtle Mountain: Upgraded system at Pit station now provides double the generating and storage capacity.

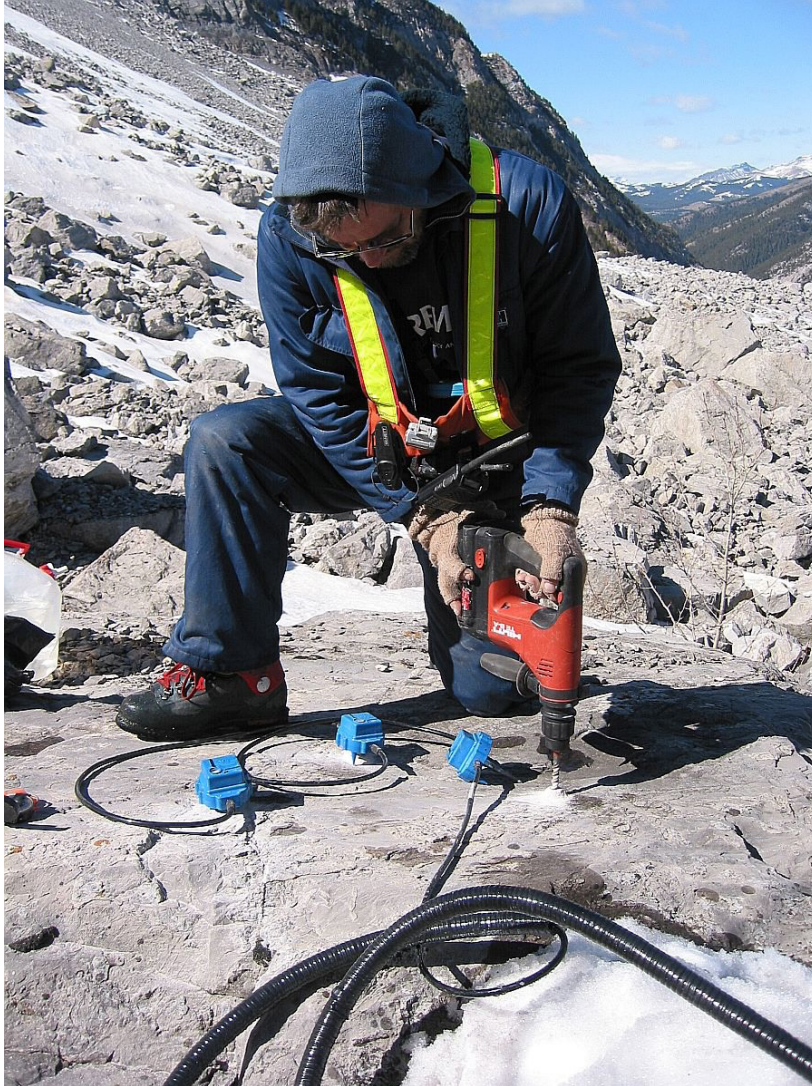
Figure 30. Installation of three-component geophones on Turtle Mountain.

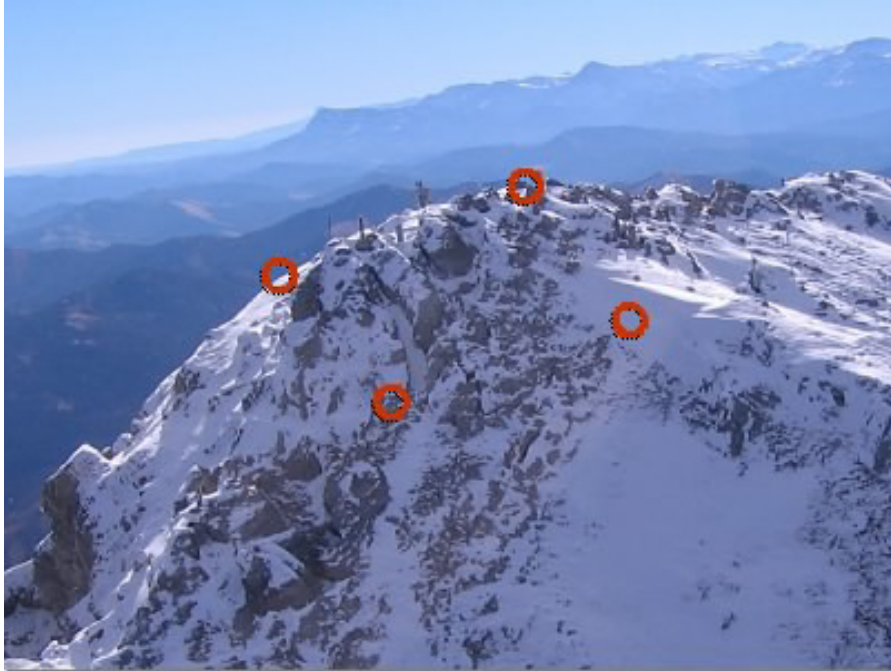
Figure 31. Location of the micro-array geophones South Peak, Turtle Mountain.

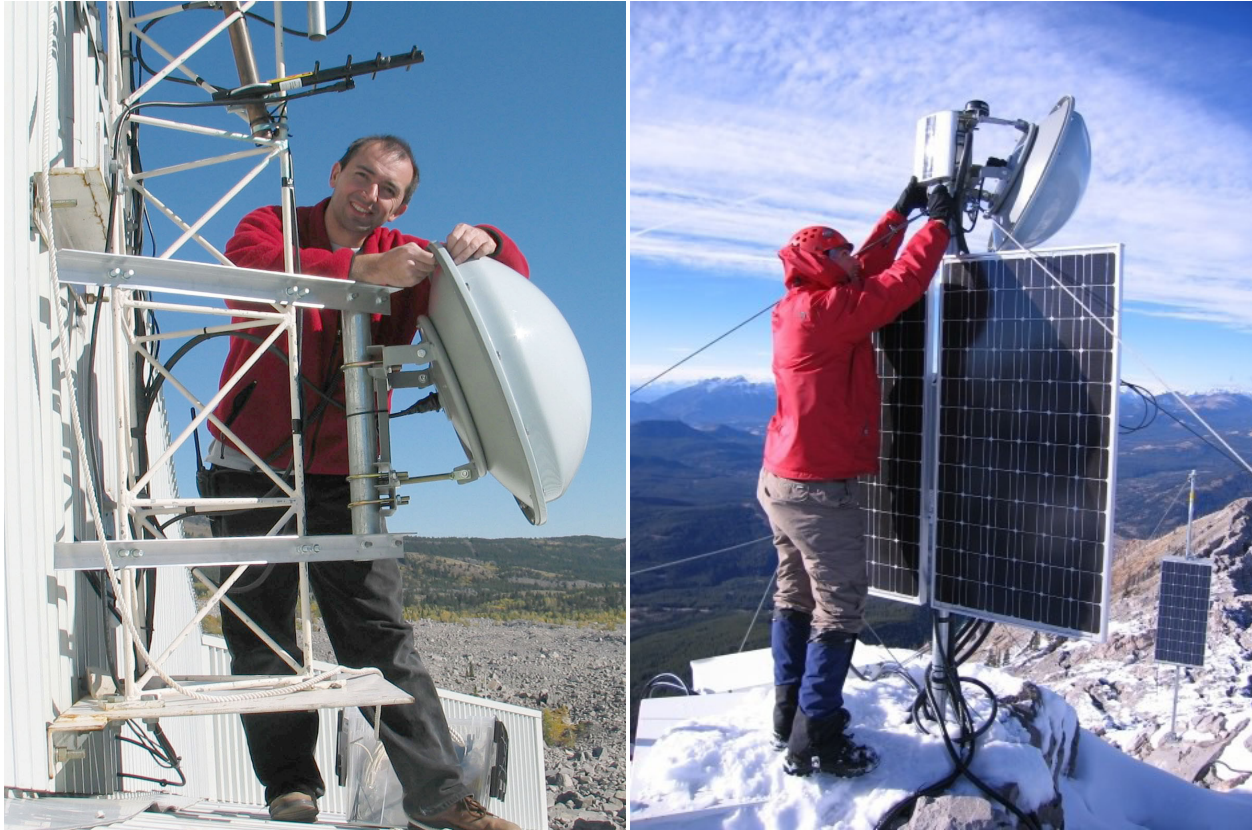
Figure 33. New antennas for the link between the Control Centre at the Frank Slide Interpretive Centre (left) and South Peak station (right), Turtle Mountain.

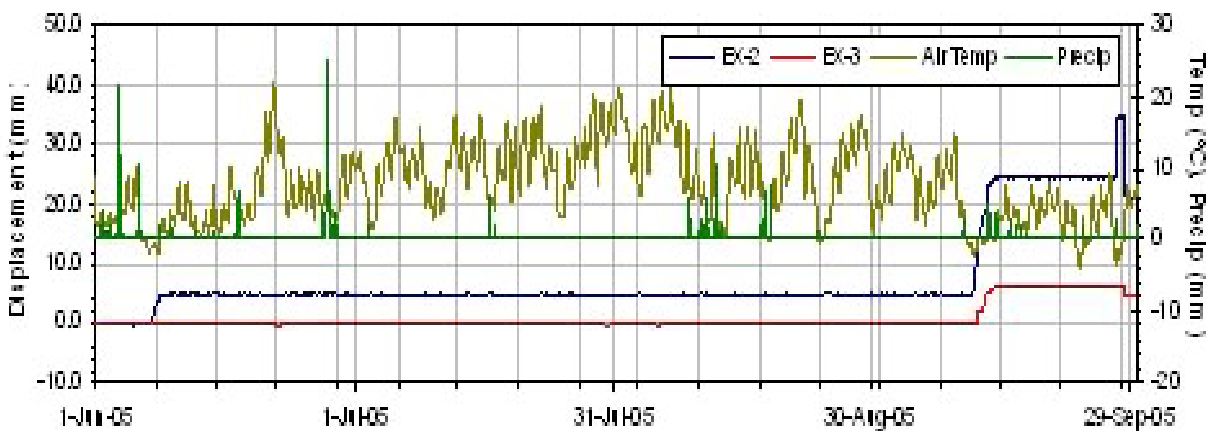
Figure 36. Effect of temperature and precipitation on displacements at Turtle Mountain.

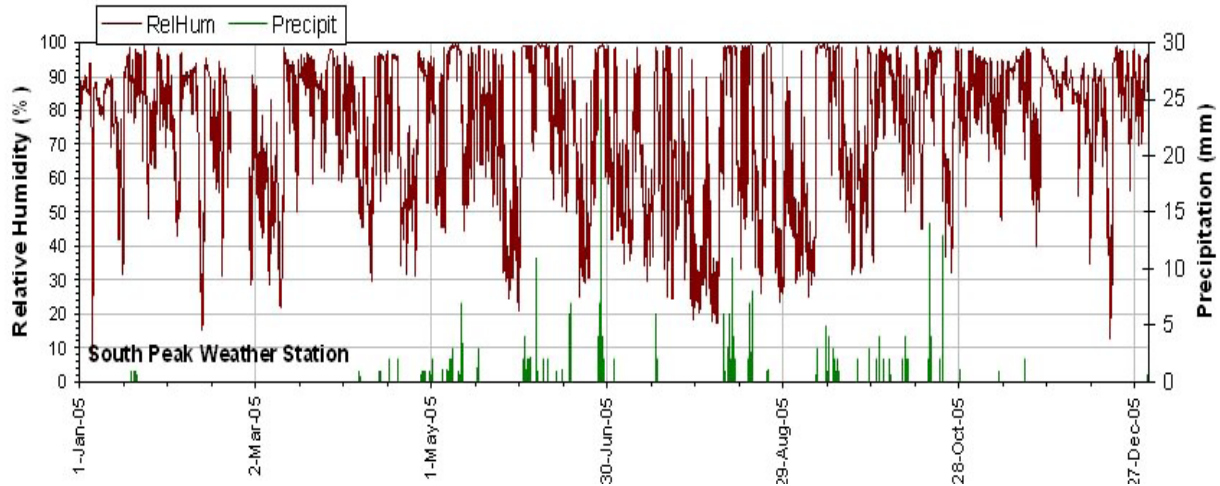
Figure 40. Variation of relative humidity and precipitation with time, 2005, South Peak station, Turtle Mountain.

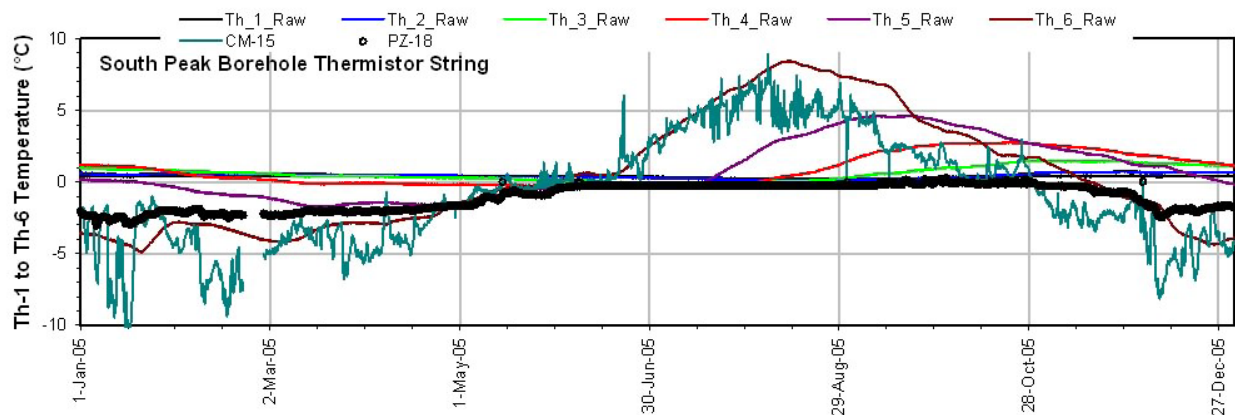
Figure 46. Variation of rock mass and crack temperature with time, 2005, South Peak borehole, Turtle Mountain.

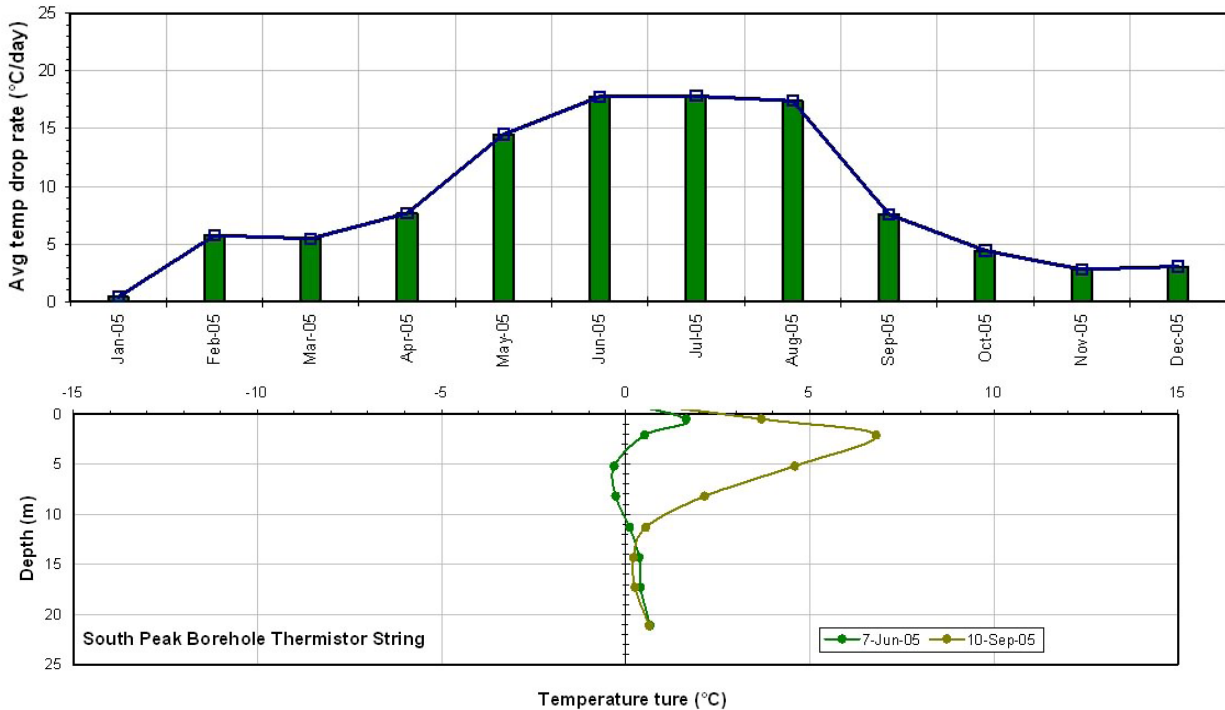
Figure 48. Daily average drop rate in temperature (a), and temperature distribution in the rock mass for two sudden temperature-drop events, 2005, South Peak borehole, Turtle Mountain.

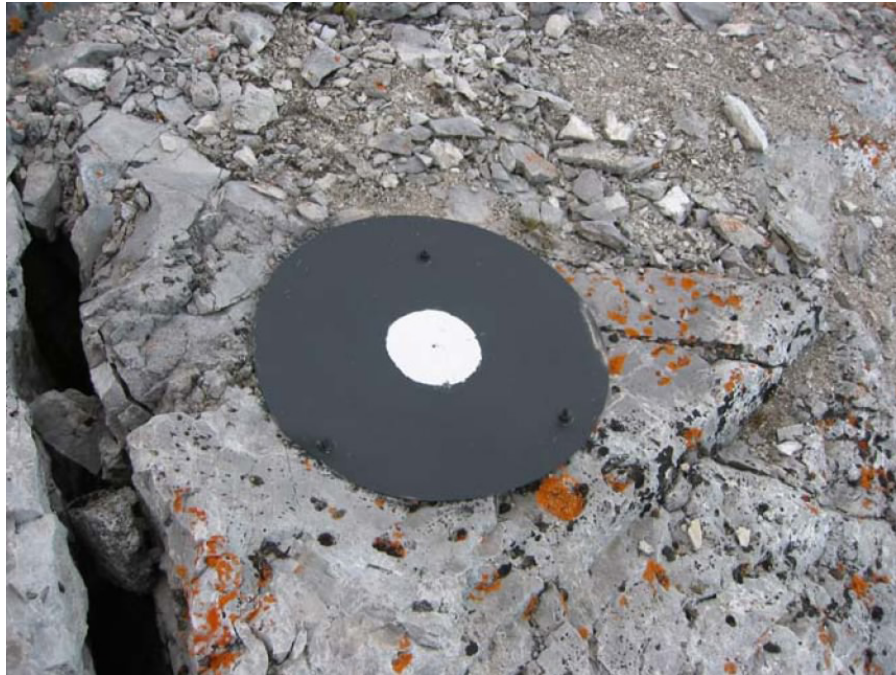
Figure 52. Photogrammetric target installed on Turtle Mountain in 1982 and repainted during the summer of 2005.

(photography flown during the summer of 1985), undertaken by Chapman (2006), highlighted differential movement trends for the various areas of South Peak rather than uniform movement of a single block. By the summer of 2005, targets had been bleached by sunlight and were completely white; they were therefore repainted prior to another photogrammetric flight. Figure 52 shows one of the repainted targets, each of which is approximately 0.5 m in diameter. The layout of the target network is shown in Figure 53.

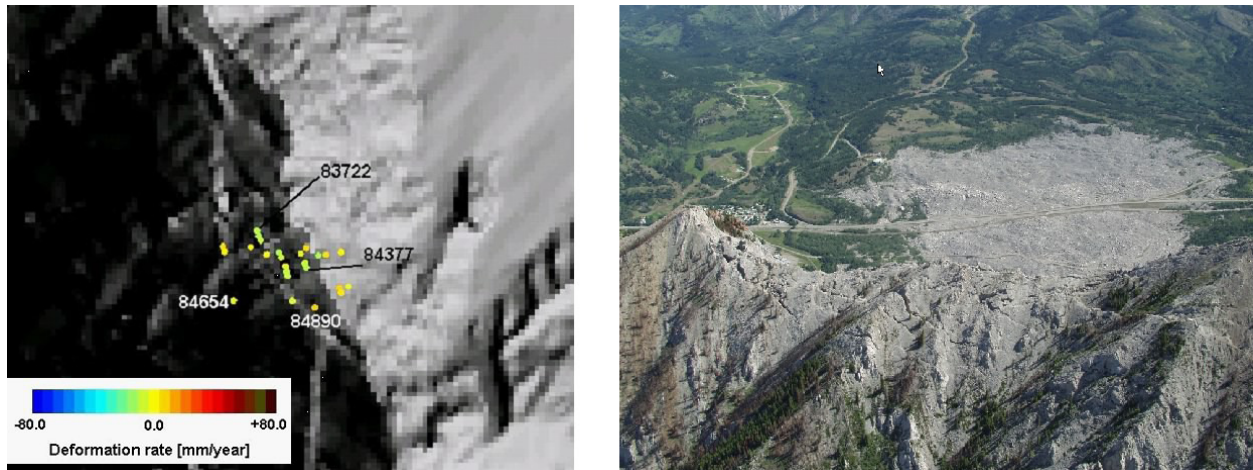
Figure 56. (left) Detected coherent target monitoring points for area 1 superimposed on digital elevation model). (right) Oblique airphoto of the headscarp of the 1903 slide (area 1), showing the fractured and blocky terrain (*modified from Vexcel Canada, 2005*).
