# Frank Slide and Turtle Mountain Early-Warning System Technical Tour Guidebook (NTS 82G)

F. Moreno<sup>1</sup>, M. Jaboyedoff<sup>2</sup>, A. Pedrazzini<sup>2</sup>,  
M. Charriere<sup>2</sup> and F. Humair<sup>2</sup>

<sup>1</sup>Energy Resources Conservation Board/  
Alberta Geological Survey

Moreno, F., Jaboyedoff, M., Pedrazzini, A., Charriere, M. and Humair F. (2011): Frank Slide and Turtle Mountain early-warning system technical tour guidebook (NTS 82G); Energy Resources Conservation Board, ERCB/AGS Information Series Report 139, 15 p.

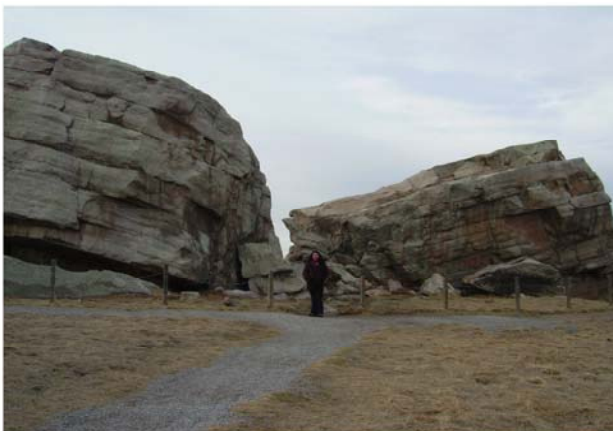
The name of the erratic was derived from the Blackfoot word for rock, 'okatok.' The Okotoks erratic is 9 m high, 41 m long and 18 m wide, and weighs 15 000 tonnes. The rock has been eroded into pieces but is still a large landmark on the flat prairie. If you look closely at the rock, you can see something vaguely familiar: a piece of quartzite that can be seen in outcrops in the Jasper area. It is a piece of the thick-bedded, micaceous, feldspathic quartzite of the Lower Cambrian Gog Group (Price et al., 1972). About 18 000 years ago, a rockslide caused a section of the Gog Group to crash onto the surface of a valley glacier in the present-day Athabasca River valley. The flowing glacier slowly carried this debris eastward to the plains, where the continental ice sheet deflected it southward.

The Big Rock (Okotoks erratic).

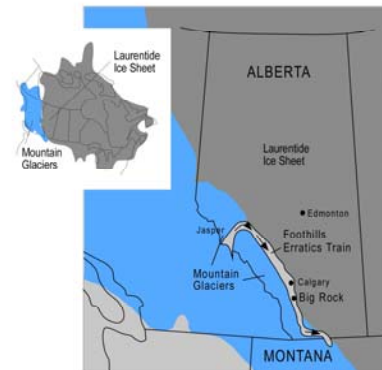
The Foothills erratics train is a group of rocks carried from the Rocky Mountain by glacial ice. This ice flowed southeastward along the edge of the Laurentide Ice Sheet and deposited the rocks in a narrow belt.

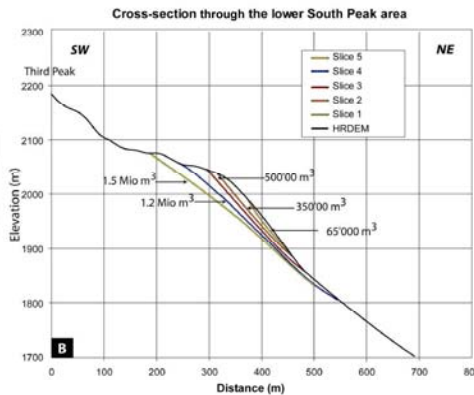
**A) Representation of the unstable zones detected in the lower South Peak area, and**

**B) their calculated volume (cross-sections oriented in direction of expected movements (from Pedrazzini et al., in press).**

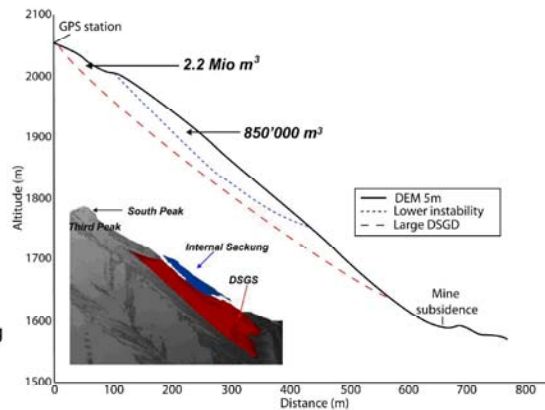
**Cross-section of the Third Peak instability oriented in the potential movement direction and showing the limits of potential unstable masses, calculated using the SLBL method (from Pedrazzini et al., in press).**

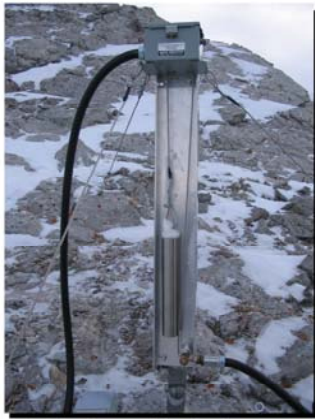
Typical head assembly of a wire extensometer, in which a weighted wire runs over a rotary potentiometer, calibrated to measure millimetres of displacement.

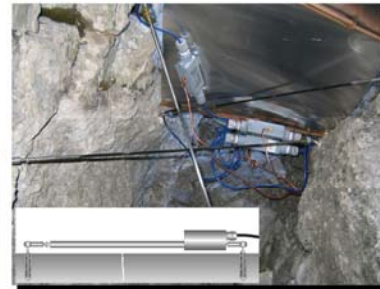
Typical configuration of crackmeters, with aluminum roof mounted to provide protection from snow overburden and falling rocks. Crackmeters were installed in sets of three in order to determine deformation vectors.

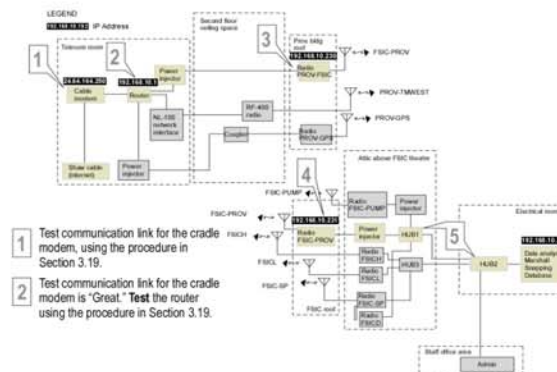
- 1 Test communication link for the cradle modem, using the procedure in Section 3.19.
- 2 Test communication link for the cradle modem is "Great." Test the router using the procedure in Section 3.19.
- 3
- 4
- 5

Typical troubleshooting protocol (Moreno and Froese, 2009b).

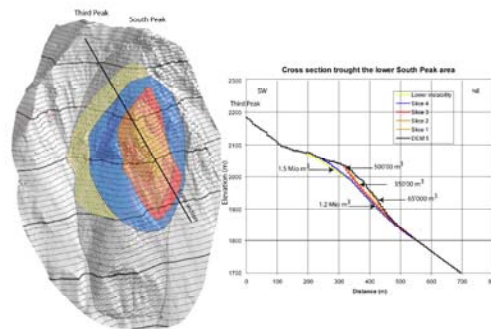
Areas of instability detected in the lower South Peak area (Pedrazzini and Jaboyedoff, 2008).

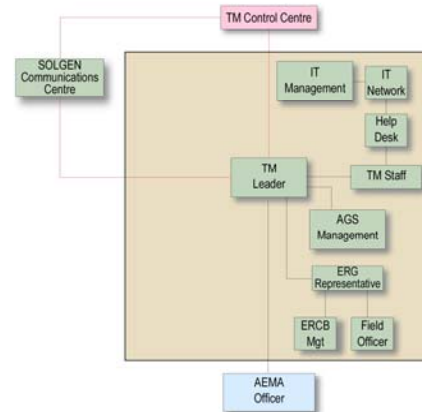
Internal communication flow (Moreno and Froese, 2009a).

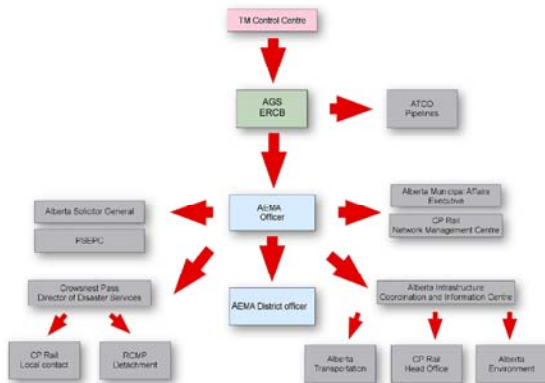
External communication flow (Moreno and Froese, 2009a).
