SUMMARY REPORT
CLEAR HILLS IRON SAMPLING PROGRAM

W. N. Hamilton

Alberta Research
May, 1974

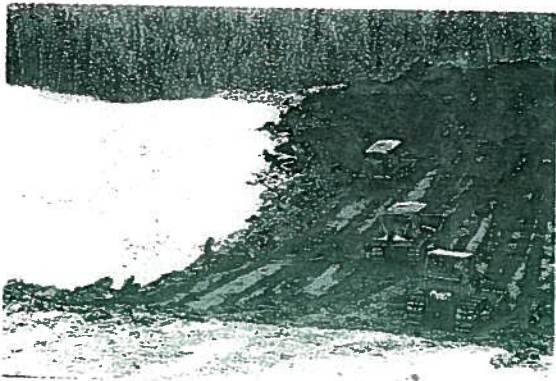
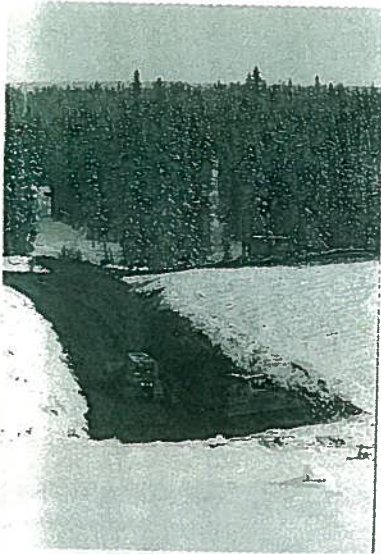
Plate 1. Clear Hills iron excavation program.

3. Excavation of overburden: a volume of more than 100,000 cubic yards was excavated from the pit area outlined in figure 2 using bulldozers (Plate 1A), exposing the iron bed along a strip 40 feet wide for a distance of 200 feet back from its outcrop on the edge of the creek valley. The walls of the excavation were sloped at about a 2.5:1 ratio for permanent stability. Overburden was disposed of in depressional areas

6. Equipment: four D8 Caterpillar bulldozers with ripping capability were used for the overburden excavation, two of these subsequently for the iron ore mining as well (Plate 1A,B); these proved to be the minimum requirement, and for certain stages of the program additional or heavier equipment could have been used advantageously (e.g., scrapers for the overburden stripping, a D9 for the iron ore trenching). A wide track D6 was used for snowplowing and road maintenance. The blasting equipment included a Gardiner-Denver compressor powering three hand-operated percussion drills simultaneously (Plate 1E); the explosive was Geogel 60%, a high velocity (20,000 fps) explosive that proved overpowerful for the rock conditions, causing more shattering and throwing out of the material than was desirable.
