Sand and Gravel Resources of the Rocky  
Mountain House (West Three Quarters of 83B)  
and  
Calgary (North-Central of 820 Map Areas, AB.

Open File Report 1987 - 3

D.W. Scafe  
P.C. Sham

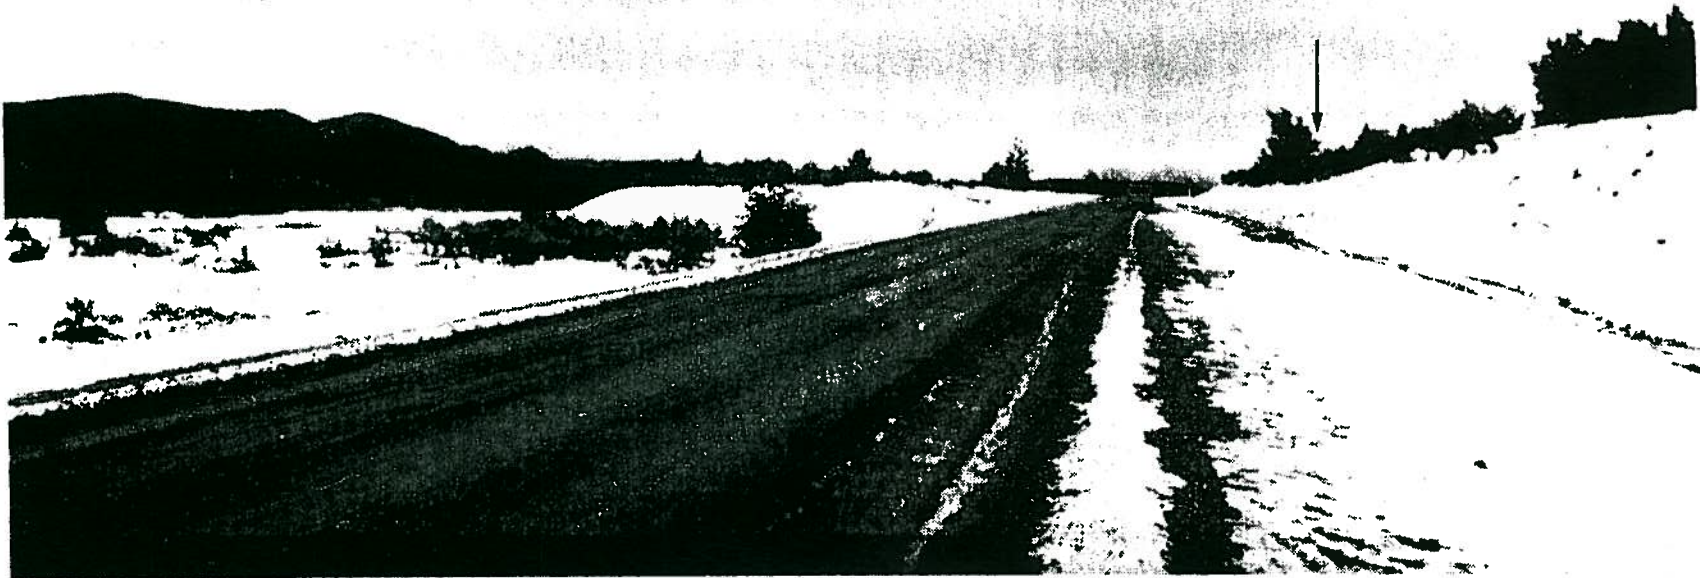
Plate 1. The topographic expression of Recent alluvial flood plain and terrace deposits of gravel present in the upper reaches of the Red Deer River valley (Deposit 81) southwest of Sundre is similar to that downstream in this and the other major rivers in the study area and can be used as a field aid during exploration for gravel. Above the highest break in slope (arrow) gravel deposits are absent in the upstream portions of the rivers and are widely scattered downstream.

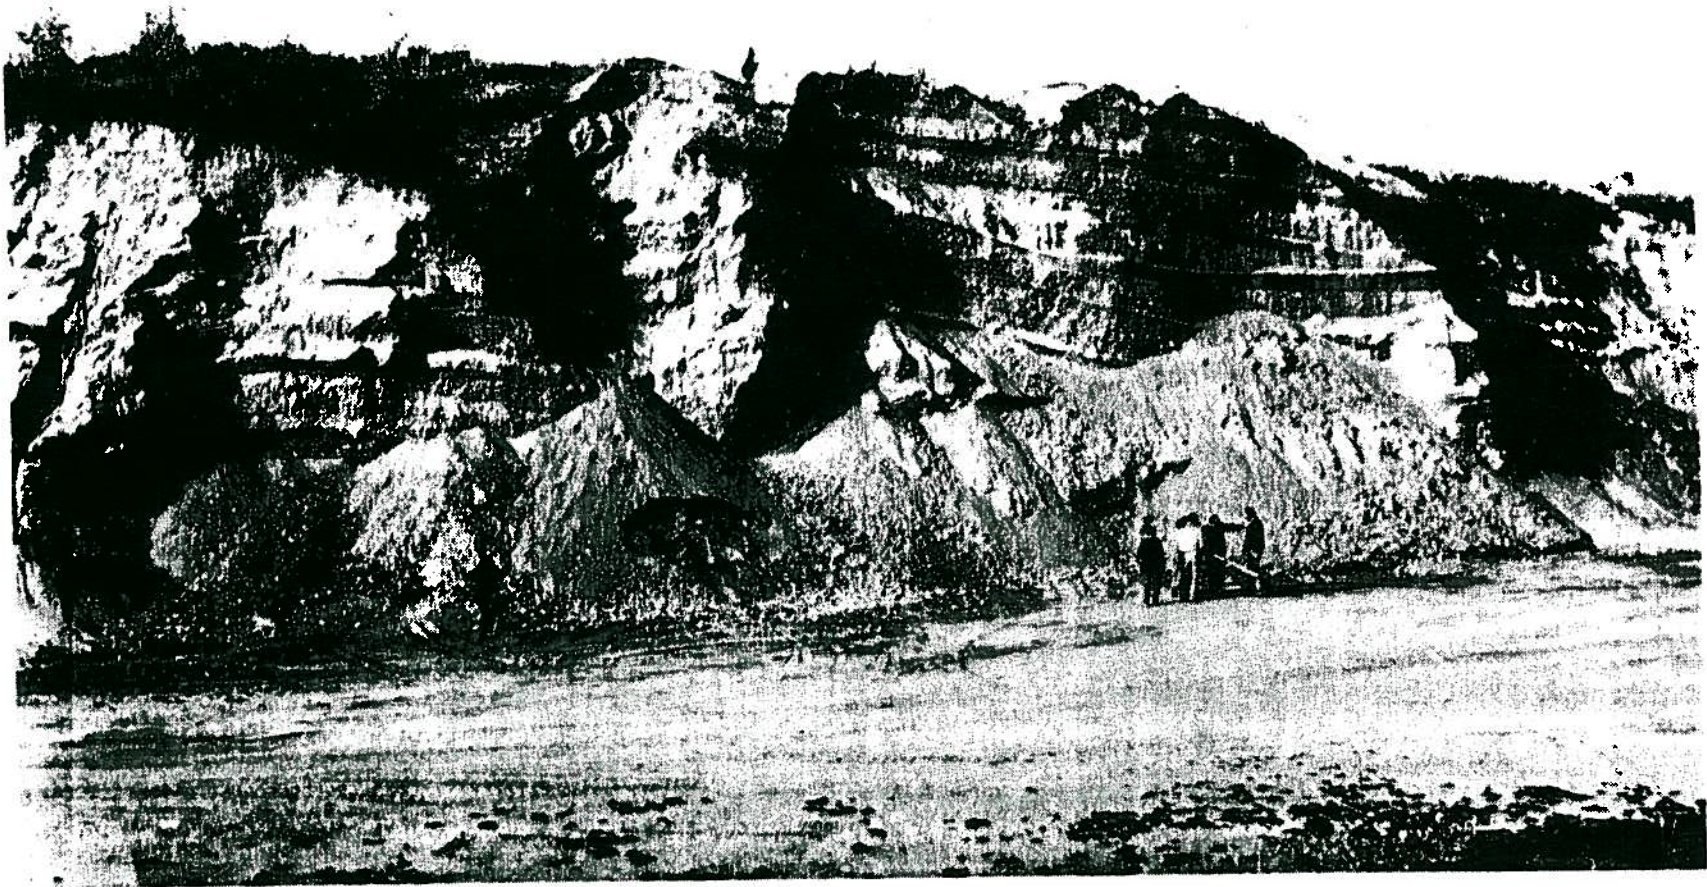
Plate 2. North of Leslieville, approximately 10 m of sand and gravel is exposed in an esker in Deposit 5.

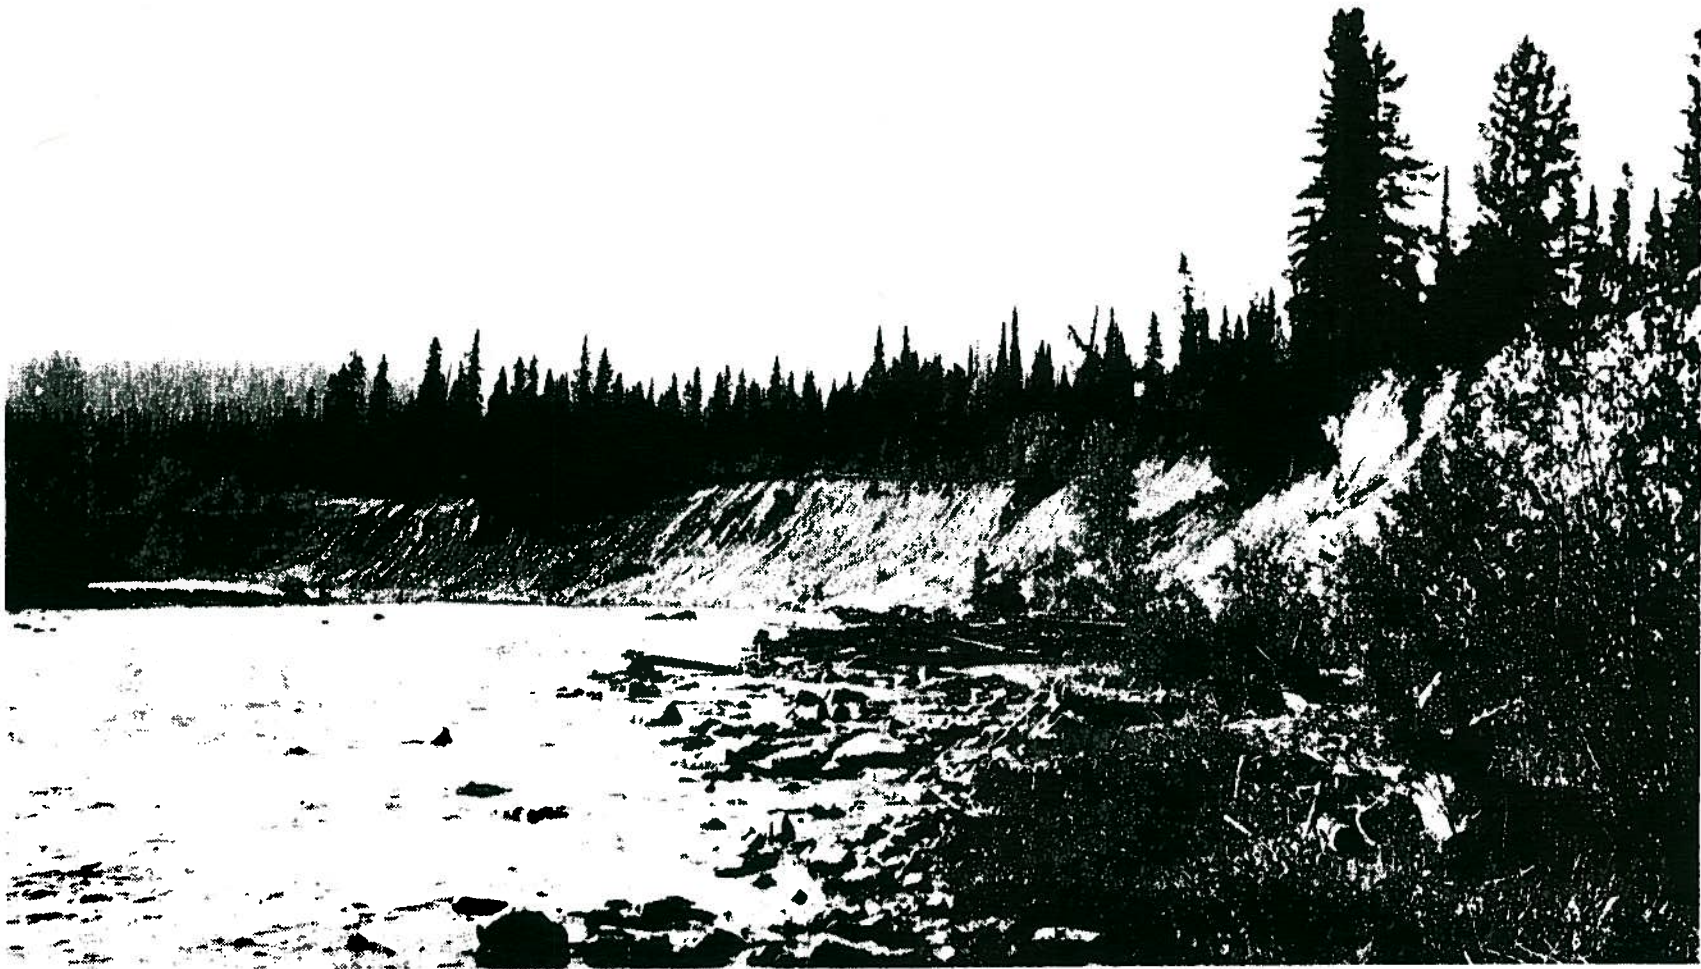
Plate 3. Approximately 12.5 m of gravel is exposed in a terrace in the Clearwater River valley (Deposit 47) near the bridge west of Seven Mile Flat. Most clasts are limestone.

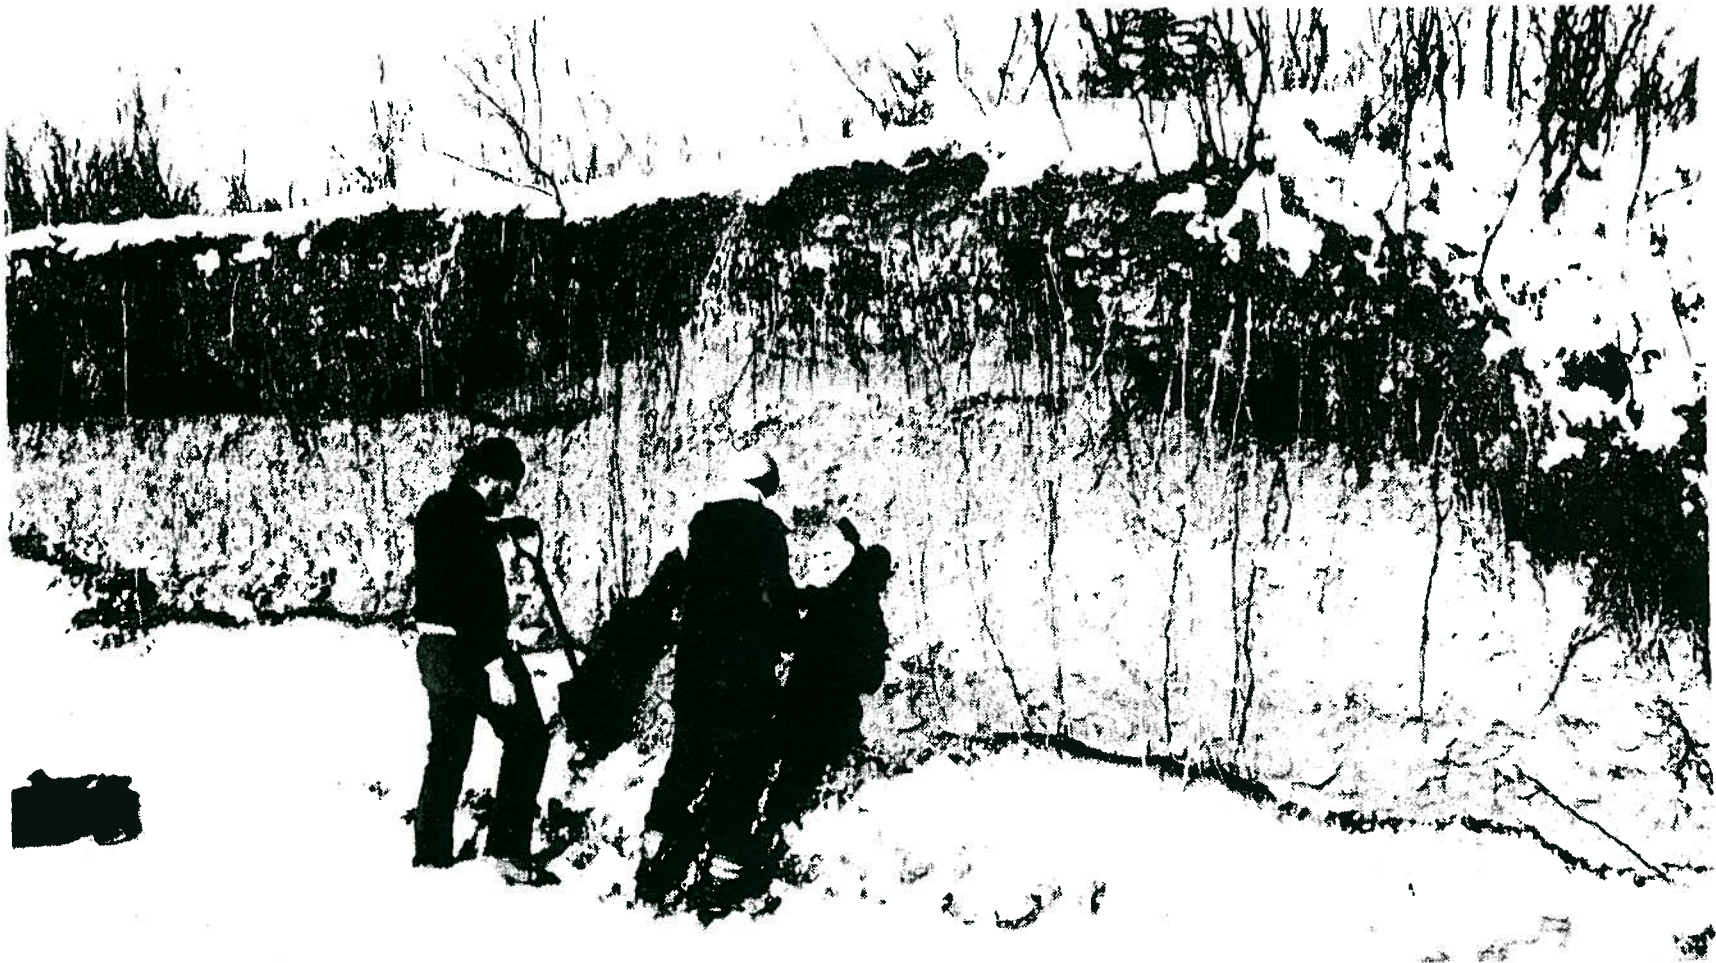
Plate 4. Gravel in bars, islands and banks of the Brazeau River (Deposit 35) varies from 0.5 to 2 m thick above river level beneath 0 to 1 m of silt and sand overburden. This material may be the major potential source of gravel in a large area with few deposits.
