SAND AND GRAVEL RESOURCES  
OF THE WANDERING RIVER AREA

MAP SHEETS  
PELICAN (EAST HALF 83P)  
WINEFRED LAKE (WEST HALF 73M AND 73M/7 AND /8  
BETWEEN THE NORTHERN BOUNDARY OF THE  
COLD LAKE AIR WEAPONS RANGE AND THE  
NORTHERN BOUNDARY OF THE MAP SHEETS)

D.W. Scafe  
W.A.D. Edwards  
D.R. Boisvert

1989

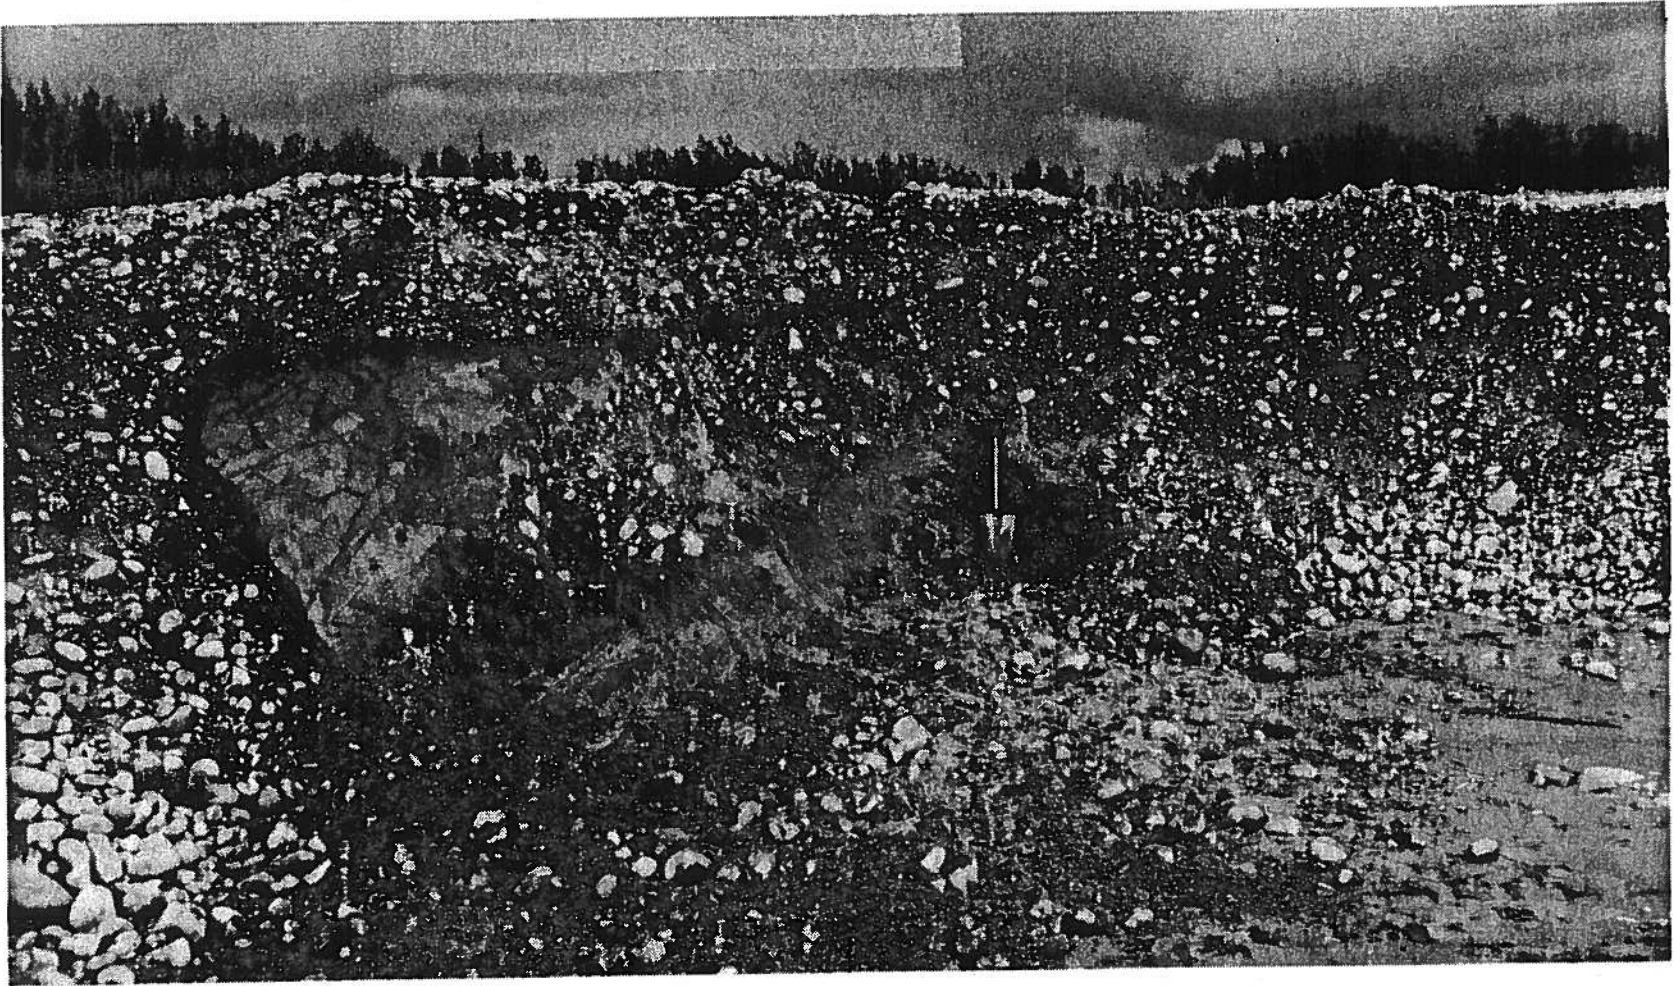
Plate 1. Glaciofluvial, dirty, poorly sorted, sandy gravel with abundant clasts from the Canadian Shield overlies, with sharp contact, preglacial, clean, fine to medium grained sand with scattered lenses of gravel and no clasts from the Canadian Shield in Deposit 34.

One prospect (34) in the study region may be of preglacial origin (Plate 1). If this is the case, then the gravel was derived from the mountains to the west as part of a preglacial river system which crossed the region. Preglacial deposits occur in many other parts of Alberta and can be excellent sources of high quality gravel. These deposits commonly are buried beneath till or glaciolacustrine clay and may be difficult to detect. Confirmation of this site as preglacial, through more detailed investigation, could justify a geophysical or test-hole drilling program to locate additional deposits of similar origin.

The preglacial origin for prospect 34 should be confirmed and a program developed to find other preglacial deposits.

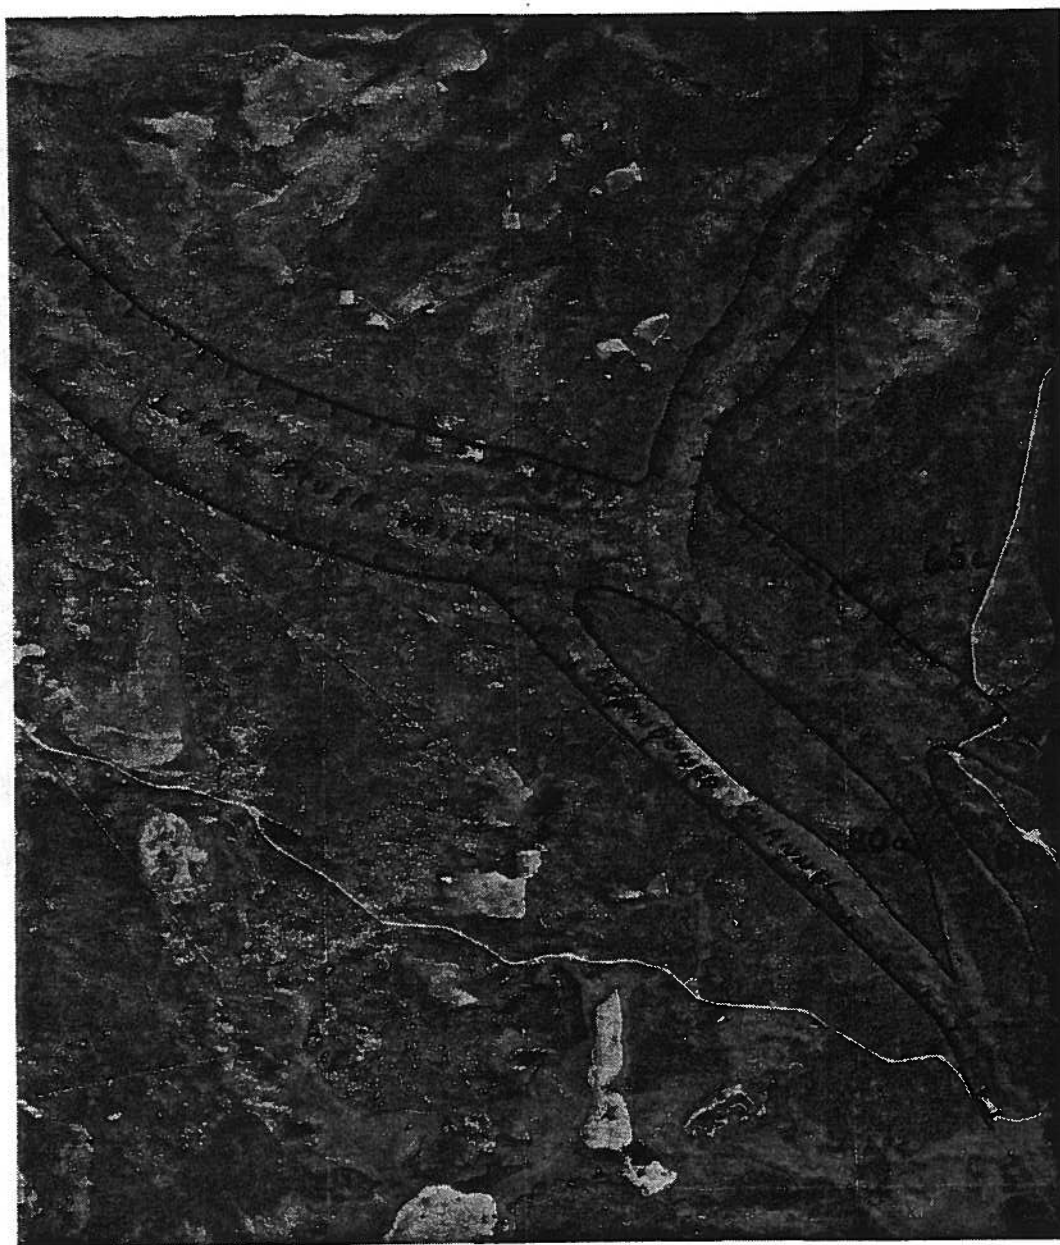
Plate 2. Meltwater channel prospects in the Logan River valley. Air photo AS 2790 204 shows the meltwater channel, abandoned channel and cutoff prospect (80), low terrace (81) and the glaciofluvial system (65) which joins the meltwater channel at a right angle.

The Logan River is a misfit river occupying what was probably an ice-marginal meltwater channel. The channel trends generally NNW-SSE (Plate 2). Granular materials are present along the valley as low level bars or terraces above the present stream (prospects 10, 20, 21, 73 and 81 on Figures 2 and 3) and as high level abandoned channels or cut-offs (prospects 80, 82, 86, and 87 on Figure 3). The cut-offs are believed to be early channels of the meltwater drainage system that were abandoned and left hanging as the main channel migrated and entrenched. Sand (20 on Figure 2), and sand with gravel prospects (10, 80, and 81 on Figures 2 and 3), were confirmed by field checks in both the low terraces and high cut-offs. It is assumed that other areas identified on air photos within the Logan River and House River valleys also contain granular material (prospects 21, 82, 86 and 87 on Figures 2 and 3). The House River valley intersects a NE-SW trending meltwater channel/esker system near the northern end of the meltwater channel (Plate 3). Prospects 10 and 20 on Figure 2 contain sand with pebbles. Esker prospects 18 and 19 have a high probability of containing sand with pebbles. Granular material carried by this ice-contact/esker system may have been one source of sediment for the Logan River and House River valley meltwater system. Time relationships

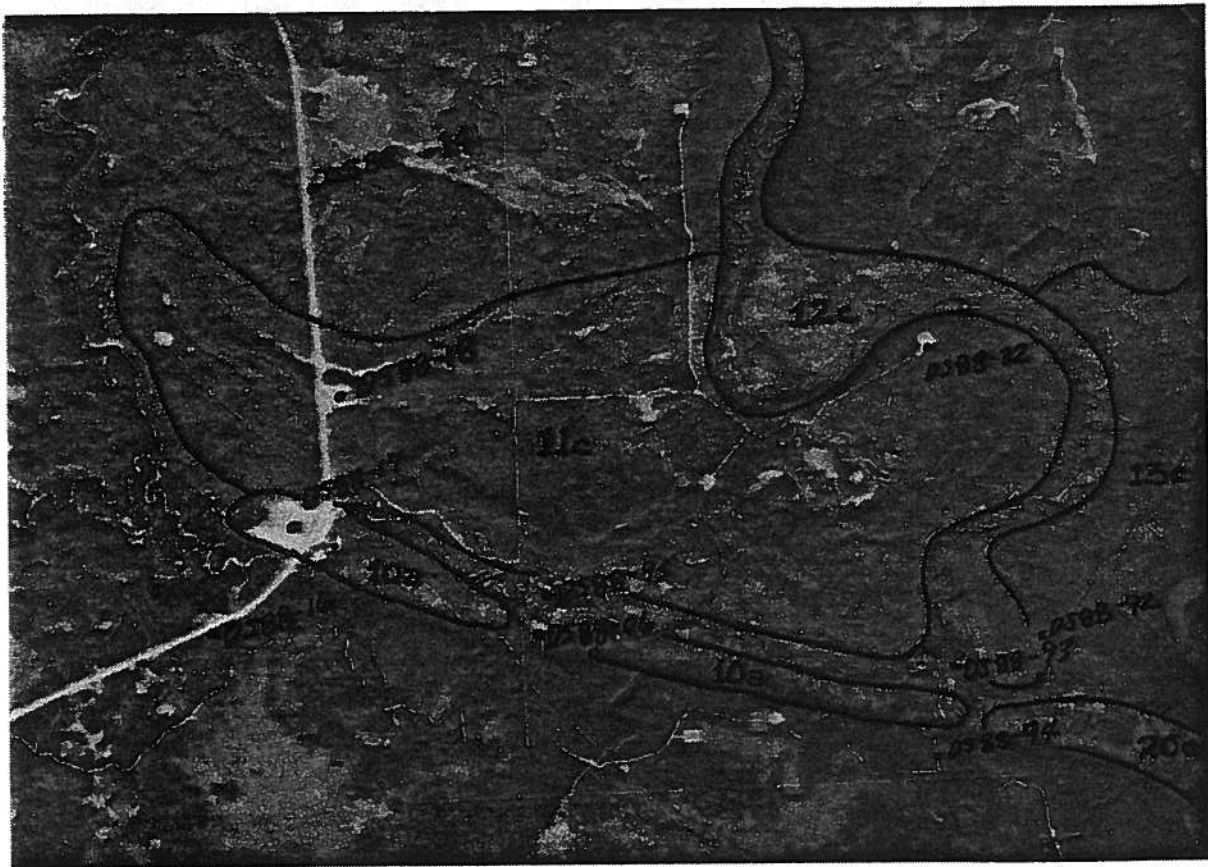
Plate 3. Gravel prospects near the crossing of the House River by Hwy 63. Air photo AS 2791 209 shows prospects 10 and 20 (meltwater channel terraces) and prospects 11, 12 and 13 of the intersecting glaciofluvial system.

have not been established for this hypothesis. Of the 17 prospects in the entire study area which contain some gravel, three (17%) are present in this system.

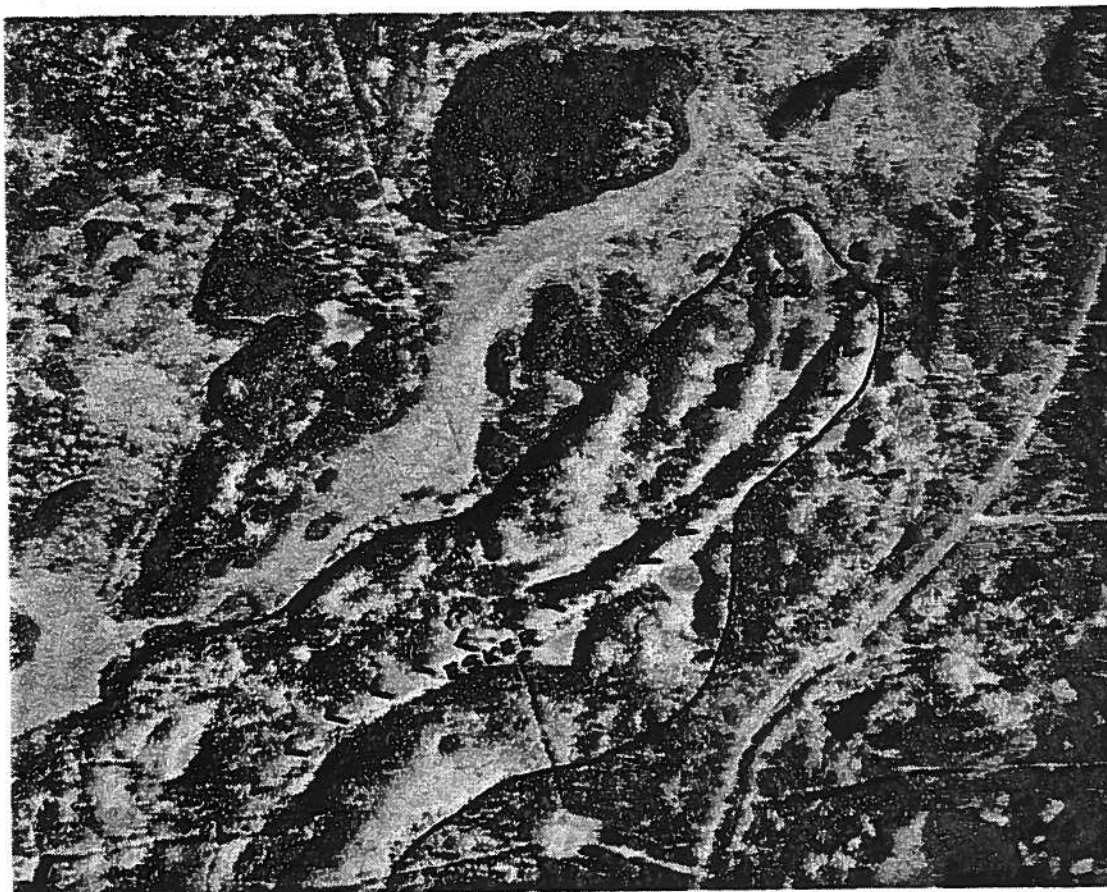
Plate 4. Esker ridge southwest of Goodwin Lake. Air photo AS 1762 092 shows an esker ridge that forms part of prospect 76.

The Goodwin Lake esker and ice-contact system (Plate 4) also trends NE-SW to E-W. It is represented by prospects adjacent to the lower half of the May River and from the Logan River along Goodwin Lake, Glover Lake and Edwards Lake. Four prospects along this system were confirmed to contain sand (68, 69, 71 and 77 on Figure 3). One prospect (61) contains some gravel. Three other areas on this trend have a high probability of also containing sand (62, 70 and 76 on Figure 3).

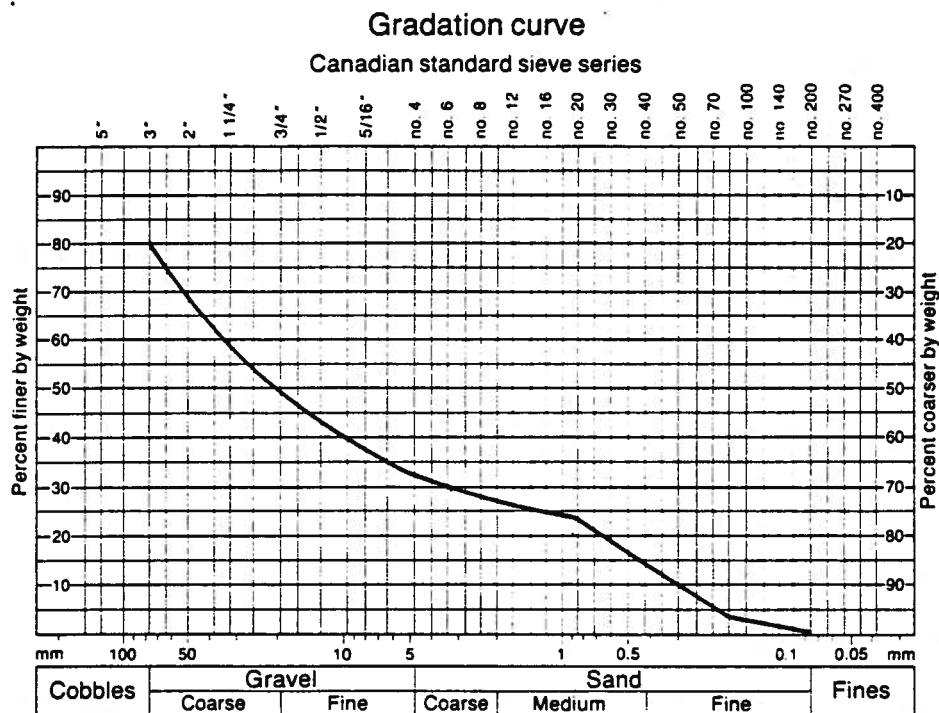
Pit Location: LSD10 Sec7 Tp79 R14 W4M

Dirty, fine to medium grained sand with clasts less than 15%. Coarse clasts are abundant and consist primarily of igneous rocks from the Canadian Shield, some hard sandstone, quartzite, ironstone and chert. Till overburden is 7m thick. It is unknown how far the material extends to the west.

Gradation:           20% cobbles           48% gravel  
                          31% sand                1% fines

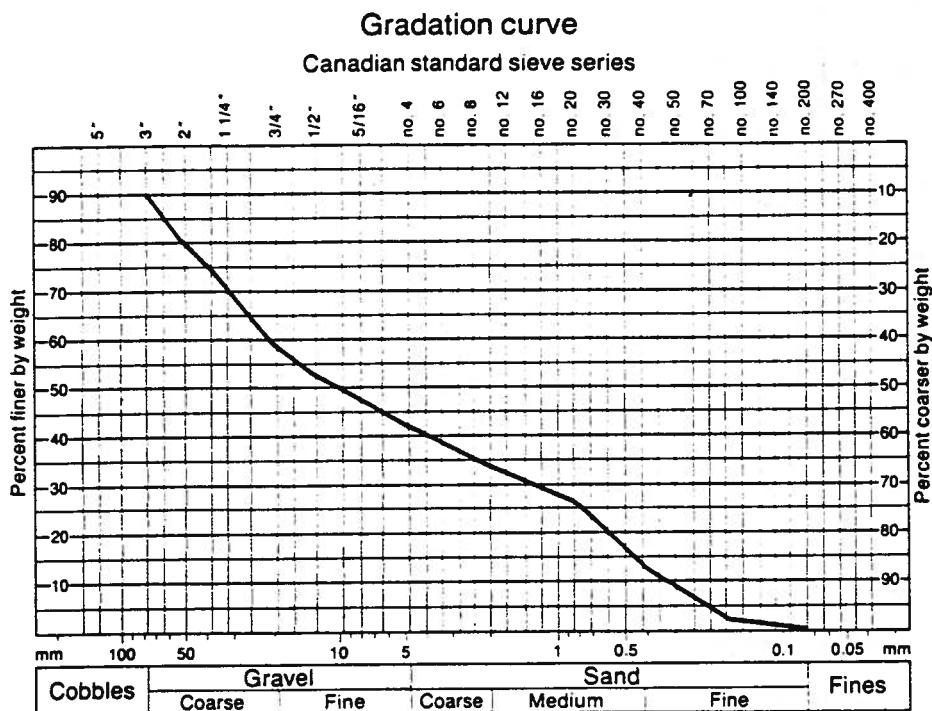
Site Location: LSD7 Sec7 Tp79 R14 W4M

New roadcut in dirty, iron stained, fine to coarse grained sand with approximately 8% clasts. Clasts are primarily angular to subangular igneous rocks from the Canadian Shield with hard sandstone, quartzite, ironstone and minor limestone. Till overburden varies from 15cm to 1m. This site is approximately 300m south of the pit described above and two new roadcuts between the two locations exhibit till in excess of 2m with no clasts in the ditch. The high ground to the west of this site could be drilled on speculation for aggregate.

Gradation:            10% cobbles            48% gravel  
                              41% sand                1% fines

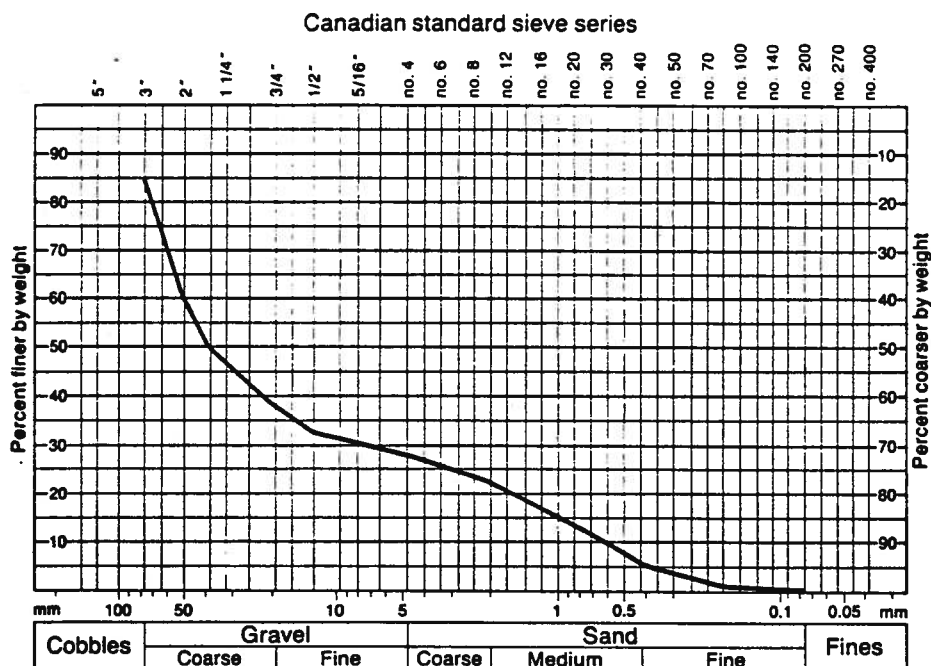
Gradation:	15% cobbles	57% gravel
	27% sand	1% fines

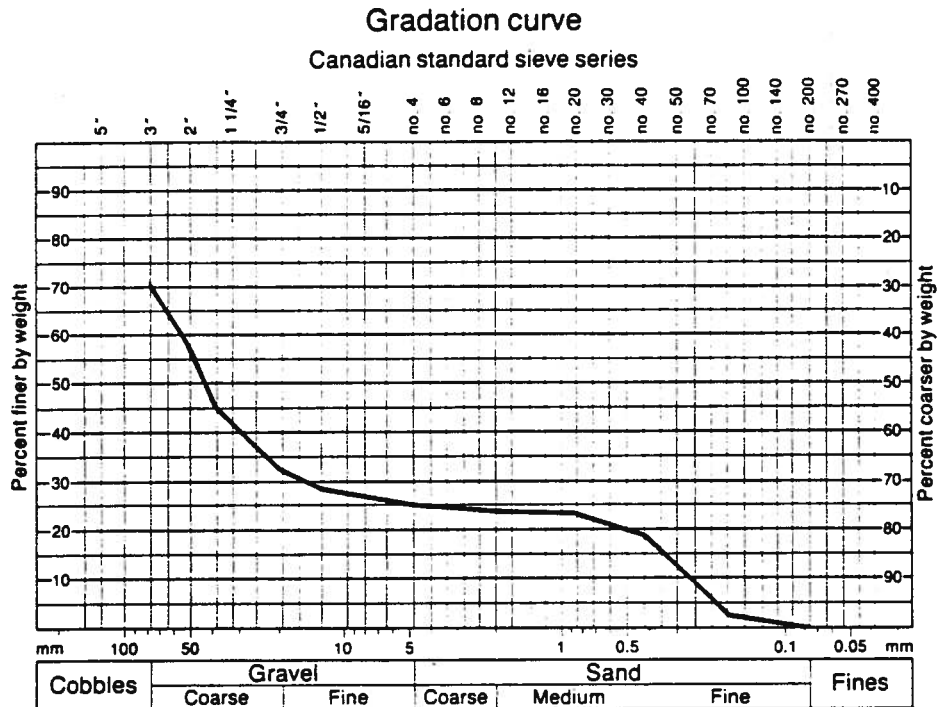
Underlying Tertiary age material from a gravelly lens:  
 Gradation:                   % cobbles                   45% gravel  
                                   45% sand                    % fines

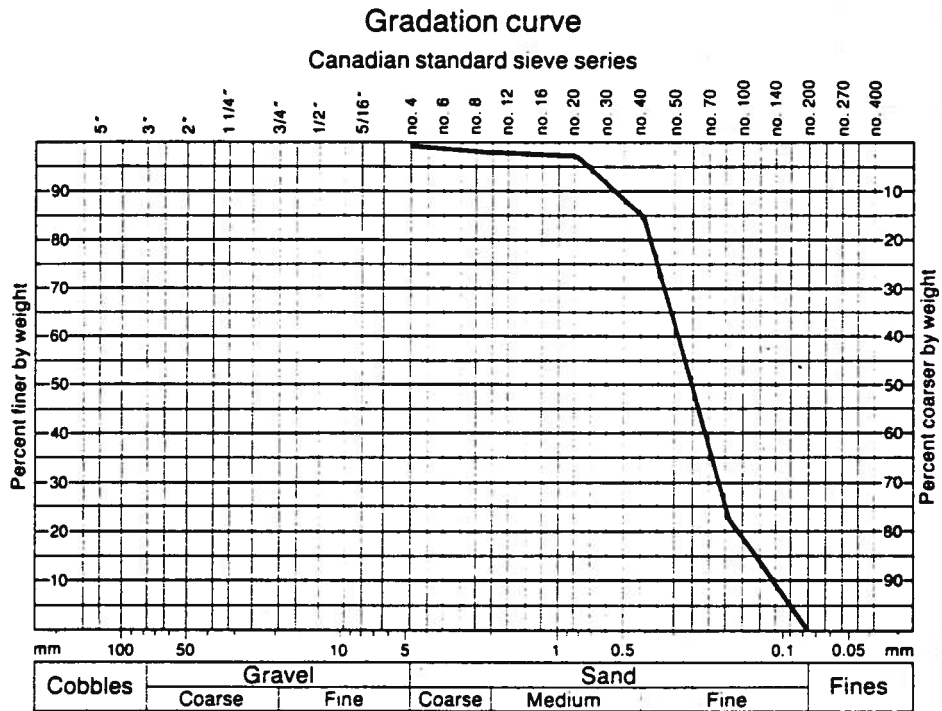
Roadcut with approximately 8.75m of till overburden over 3.5m of clean, fine to medium grained sand with a few coarse grained sand stringers. Organic fragments outline some shallow dipping cross bedding planes.

Gradation:                   % cobbles                   % gravel  
                                   100% sand                   % fines

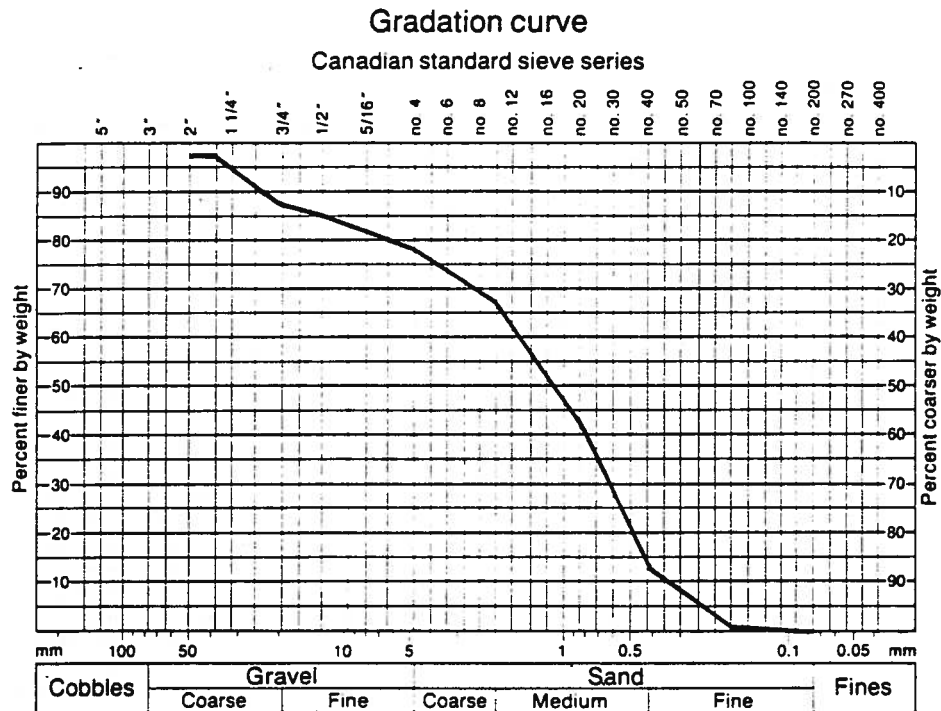
Site Location: LSD14 Sec34 Tp77 R15 W4M

Roadcut exposing 10.5m of clean, fine to coarse grained sand with a few stringers of clay and clasts to 25cm fewer than 5%. Till overburden is approximately 1m thick. Clasts are primarily igneous rocks from the Canadian Shield with hard sandstone, quartzite, ironstone and minor limestone.

Gradation:                   % cobbles                   19% gravel  
                                   78% sand                    % fines
