Turtle Mountain Field Laboratory: 2006 Data and Activity Summary

F. Moreno and C. Froese

Energy Resources Conservation Board
Alberta Geological Survey

May 2008

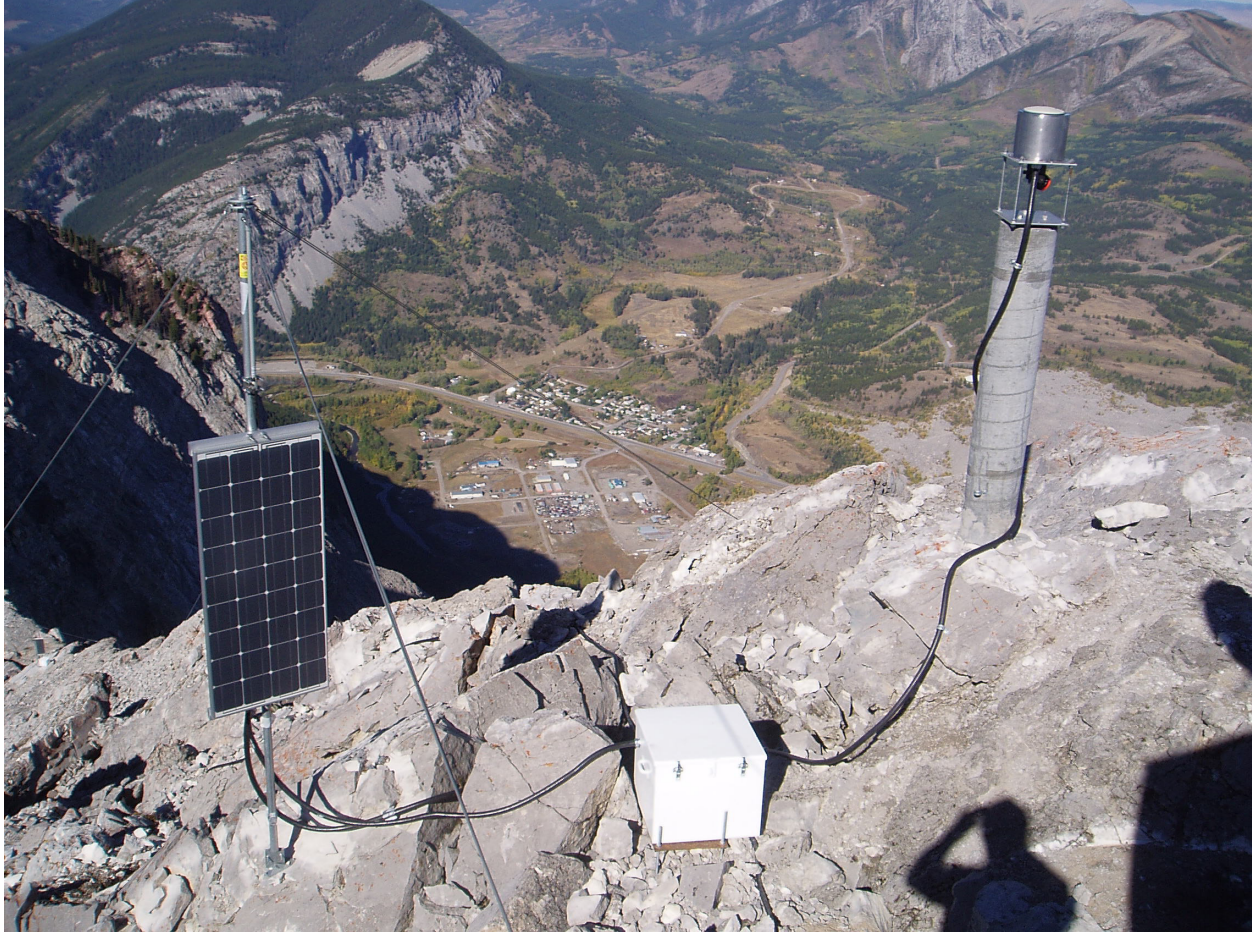
Figure 3. Typical dGPS installation showing concrete pillar with Novatel antenna (right), battery box (centre) and solar panel (left) (Photo: Glen Bjorgan, McElhanney).

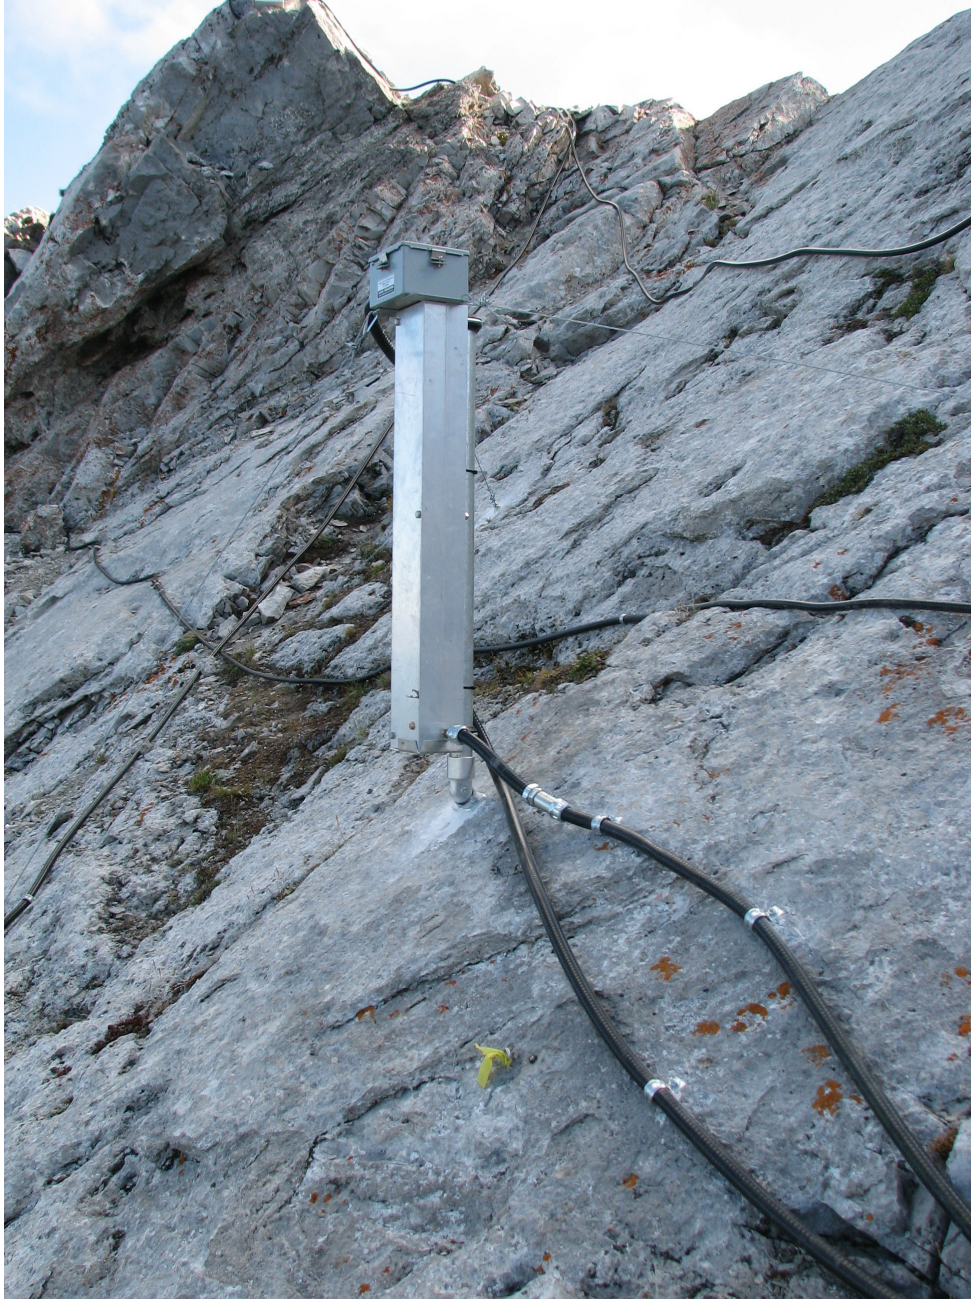
Figure 4. Head assembly for extensometer EX-5.

During the July field campaign, a fifth surface-wire extensometer was installed near the weather station. This installation is similar to those outlined for the existing extensometers (Moreno and Froese, 2006),

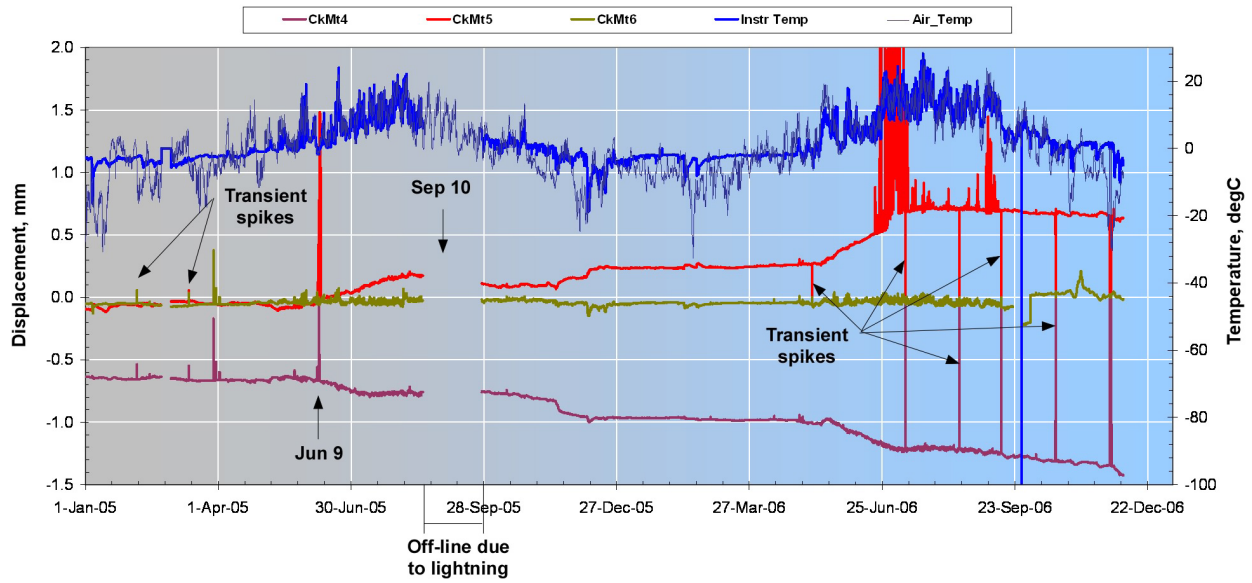
Figure 8. Plot of displacement versus time for crackmeter Set B, South Peak, Turtle Mountain.

While displacements were observed on many of the crackmeter sets, the most indicative record of slope displacement was obtained from a cluster of three crackmeters at Set B. These instruments provide a nearly continuous two-year record of slope displacement with minimal interruptions or effects from snow loading. Monitoring results from crackmeters Set B reveal a persistent annual displacement cycle, dominated by an active phase with displacements occurring in early autumn to late winter, and a relatively inactive phase with limited to no displacements during the spring to late summer period (Figure 8). Incremental displacements of approximately 0.4 mm have been measured during each displacement cycle (the total width of the cracks range between 1.0 to 1.5 m at the crackmeter locations). Crack-width changes correlated to daily temperature fluctuations can also be observed (~ 0.02 mm); however, no permanent displacement has been recorded after every cycle. Electrical noise, believed to be induced by lightning strikes, has caused apparent changes up to 1.5 mm (as illustrated in Figure 8).

A seasonal pattern can be observed on measured surface displacements and strongly correlates to annual temperature variations (Figure 8). Careful scrutiny of crackmeter Set B records indicates distinctive variations in the displacement rate during the warming and cooling seasons. An increase in displacement can be seen during periods of prolonged warm air temperatures, typically during summer to autumn. This is followed by cessation of the displacements during the winter phase. During the winter phase, there can be two acting mechanisms: 1) thermal contraction due to rock cooling, and 2) a permanent slip on discontinuities, created from stress introduced by thermal contraction of the rock mass. These displacements are in opposite directions, resulting in an overall displacement having insignificant values (almost zero). Unfortunately, due to reliability and accuracy issues, these displacement patterns cannot be confirmed by any of the other primary surface instruments.

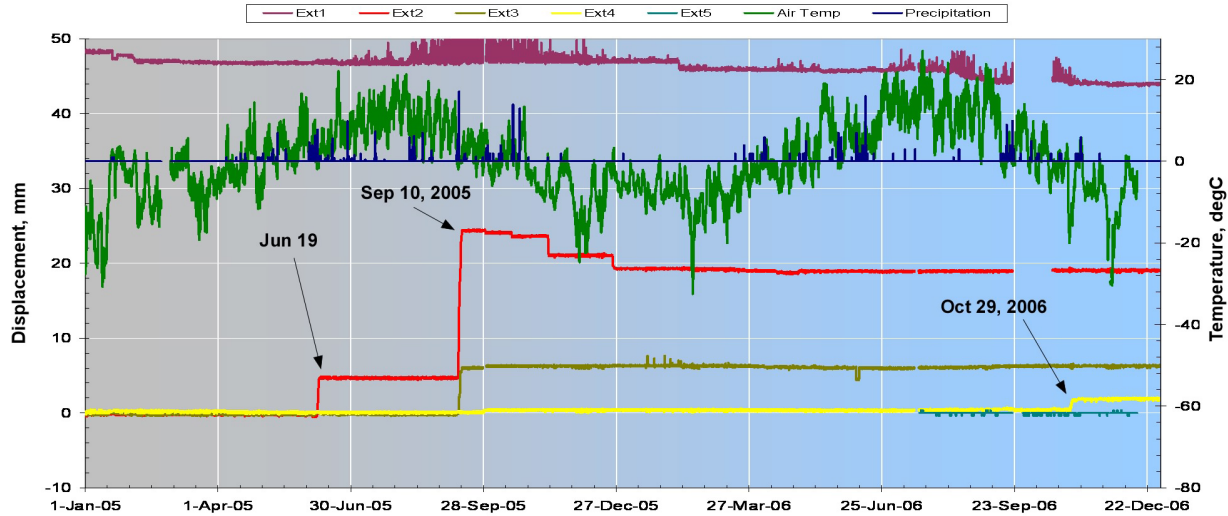
Figure 10. Plot of displacement versus time for extensometers.

Each of the five extensometers shows very stable responses during the reporting period. No daily or seasonal changes can be seen in the displacement data. Extensometer EX-2 and EX-3 continue to be extended at 19 mm and 6.17 mm, respectively. These displacements were recorded during two periods of heavy precipitation in early June and early September 2005 and are discussed in greater detail in Moreno and Froese (2006, 2007). A gradual displacement of 1.3 mm occurred at extensometer EX-4 in November 2006, believed to be a result of a dramatic drop of air temperature between October 29 and 30.

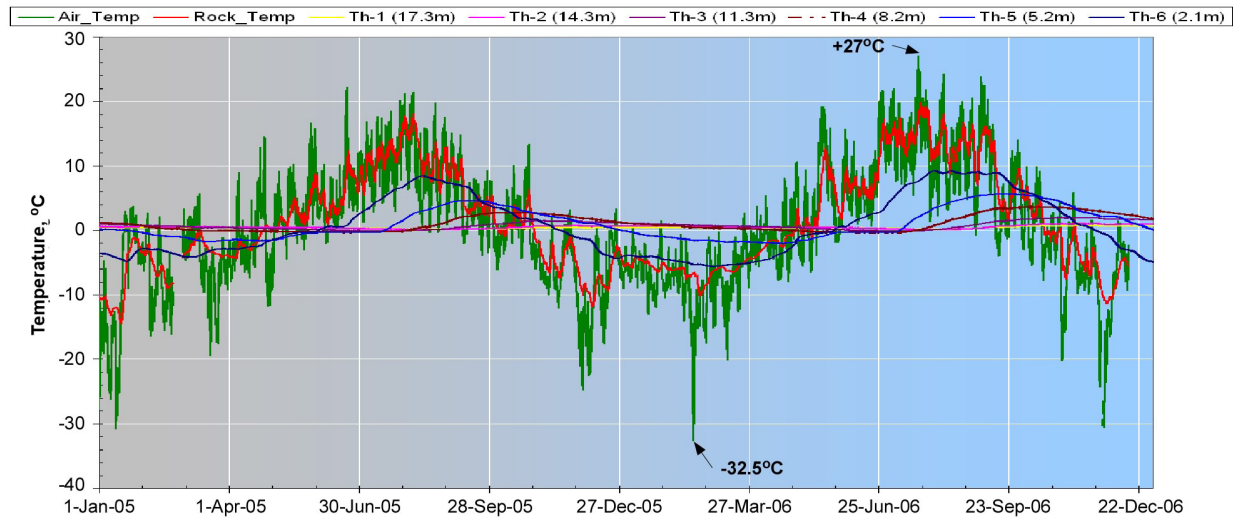
Figure 12. Air temperature and rock temperature variations with depth at the borehole for 2006.

Average temperatures at the top of South Peak in 2006 were warmer than in 2005. Records ranged from 6.4°C in January (-10°C in 2005) to +13.9°C in July (+10°C in 2005), with significant variations throughout the year. An extreme maximum of +27°C and an extreme minimum of -32.5°C were recorded on July 22 and February 16, 2006, respectively (Figure 12). Freezing conditions typically prevail from early November through March; although, where blanketed by snow, the ground surface usually remained above freezing throughout the winter. Significant daily temperature variations were also common. Three examples of variations can be seen on the temperature records of January 16, October 30 and November 28. Rock temperature shows the same general trend as air temperature, but is more subdued (lower maximum and minimum readings), with a time lag of about 12 hours relative to significant changes in air temperature. Seasonal temperature fluctuations penetrate only about 15 m into the slope (Th-2) and are negligible below that depth, with significant temperature variations measured to a depth of 8.2 m (Th-4). On the other hand, daily temperature variations are measurable only about 4 m into the slope (Figure 12).

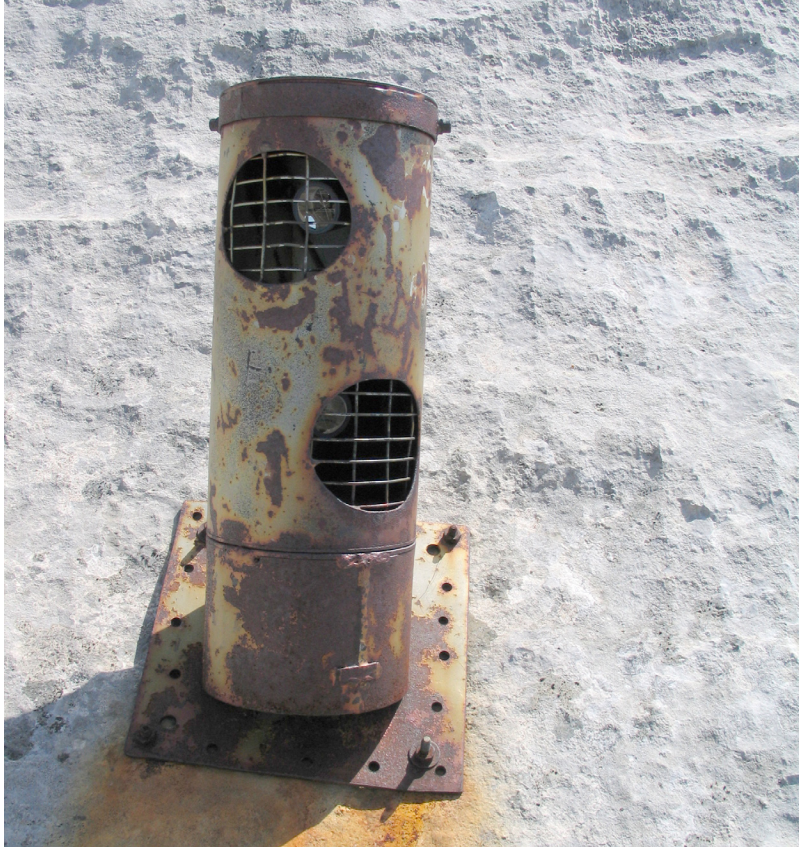
Figure 14. EDM target installed on Turtle Mountain in 1982.

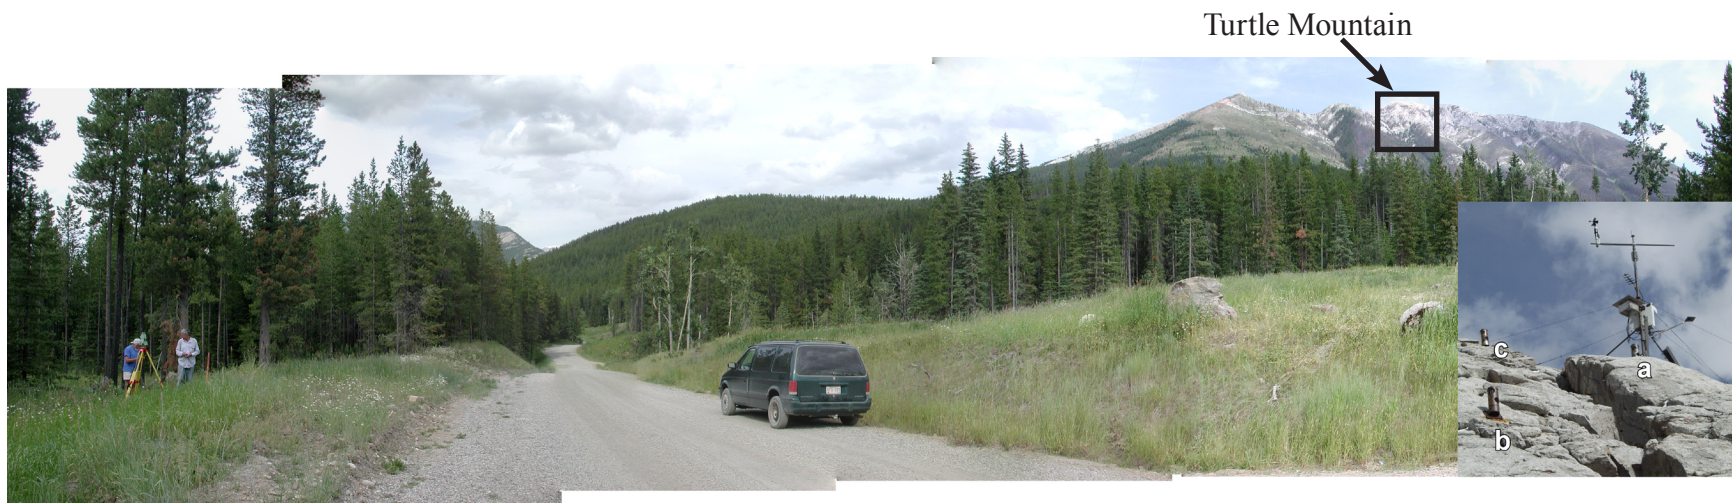
Figure 16. Monitoring Station C2 and target network layout (a, b, and c – box insert).

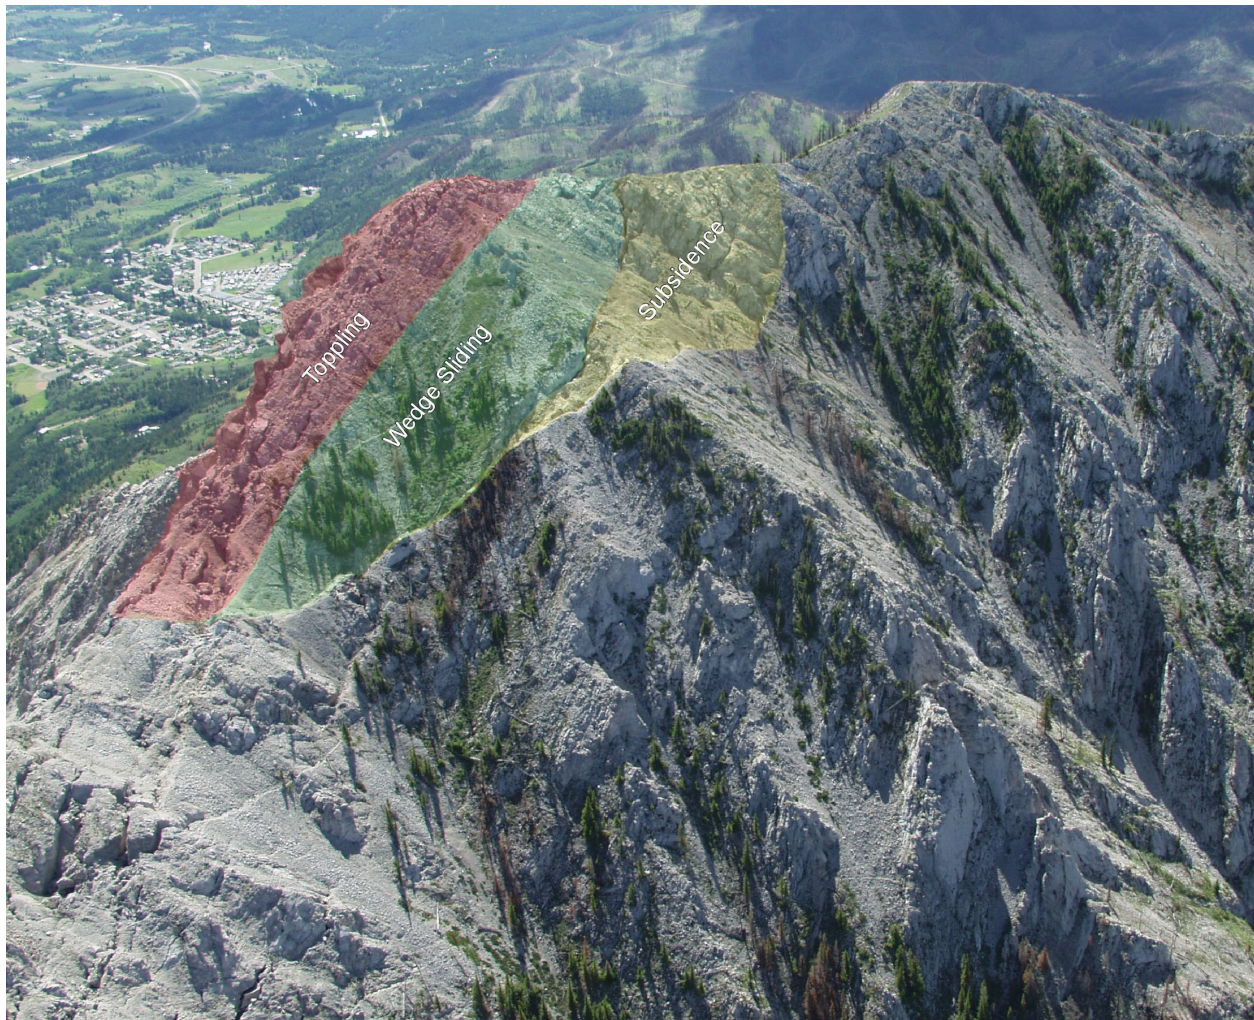
Figure 20. Southeast facing oblique view of South Peak showing simplified zoning of postulated deformation zones.

A separate, but complementary, work undertaken on Turtle Mountain using the recently acquired LiDAR proposes an updated interpretation of the failure mechanism for the South Peak of Turtle Mountain (Moreno et al., in press.). The revised interpretation divides the South Peak into three main modes of failure: 1) toppling off the east side of South Peak, 2) wedge failure below along the western limb of the Turtle Mountain anticline, incorporating South Peak, and 3) subsidence of heavily fractured rock into the graben at the back of the wedge (Figure 20). The significance of these studies is a reassessing of the interpretation of the historical monitoring results from the 1930s to present. As these studies have been focussed on the peak itself, they provide deformation data for the toppling and wedge failure mechanisms, but do not provide data for the larger lower slope planar failure. Initial estimates indicate that the volume of the toppling and wedge failures are likely in the order of 0.5 million m³ and that the lower slope planar failure has a likely volume in the order of 5.5 million m³ and is controlled by two major fracture sets dipping NE (J2) and ESE (J3), with sliding along bedding planes along the east limb of the Turtle Mountain Anticline. As this work was initiated in late 2006, an update will be provided in the 2007 summary and published in Moreno et al. (in press).
