Turtle Mountain Field Laboratory: 2007 Data and Activity Summary

F. Moreno and C.R. Froese

Energy Resources Conservation Board
Alberta Geological Survey

Moreno, F. and Froese, C.R. (2008): Turtle Mountain field laboratory: 2007 data and activity summary; Energy Resources Conservation Board, ERCB/AGS Open File Report 2008-07, 40 p.

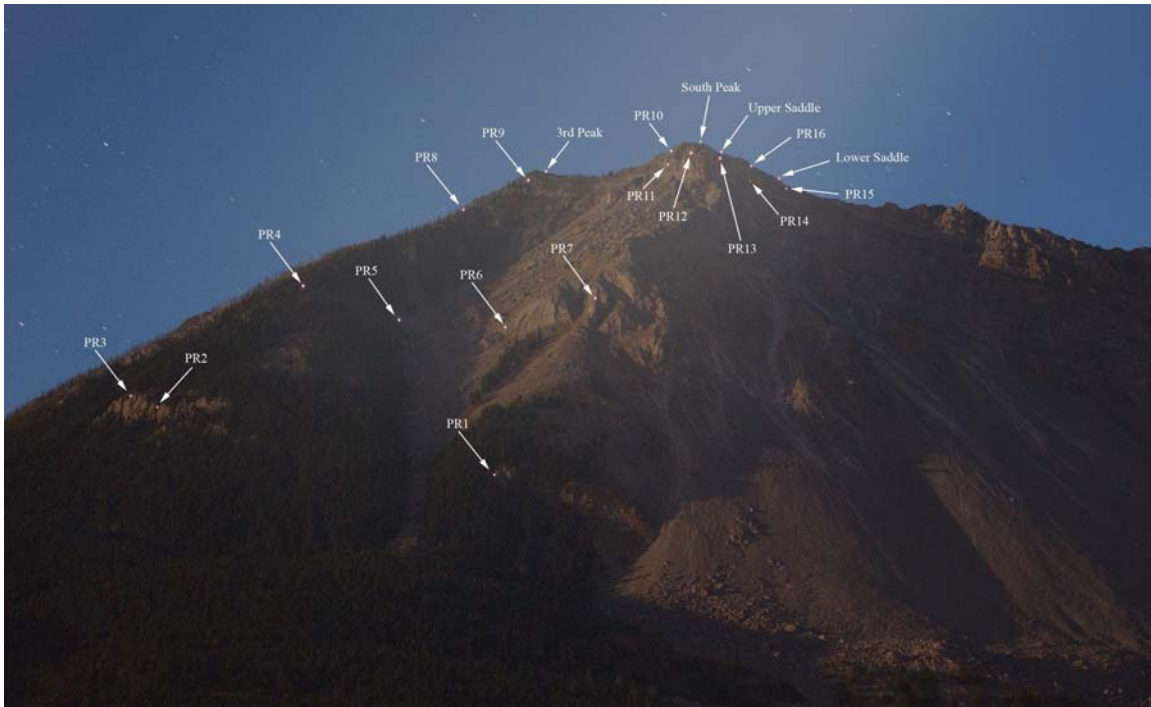
Figure 3. Location of the prisms on Turtle Mountain, as viewed from the pumphouse. Prisms PR1–PR16 were installed in 2007, while the remaining prisms (Third Peak, South Peak, and Upper and Lower Saddle) were installed in conjunction with GPS pillars in 2005. This photo was taken at night on July 28, 2007 using a large spotlight to illuminate the prism locations. Photo: G. Bjorgan, McElhanney Consulting Services Ltd.

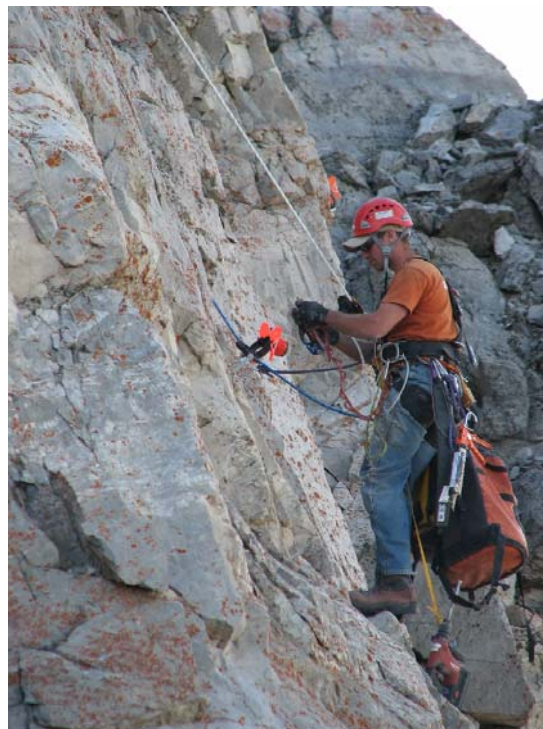
Figure 4. Installation of one of the sixteen prisms on the eastern face of Turtle Mountain during July 2007.

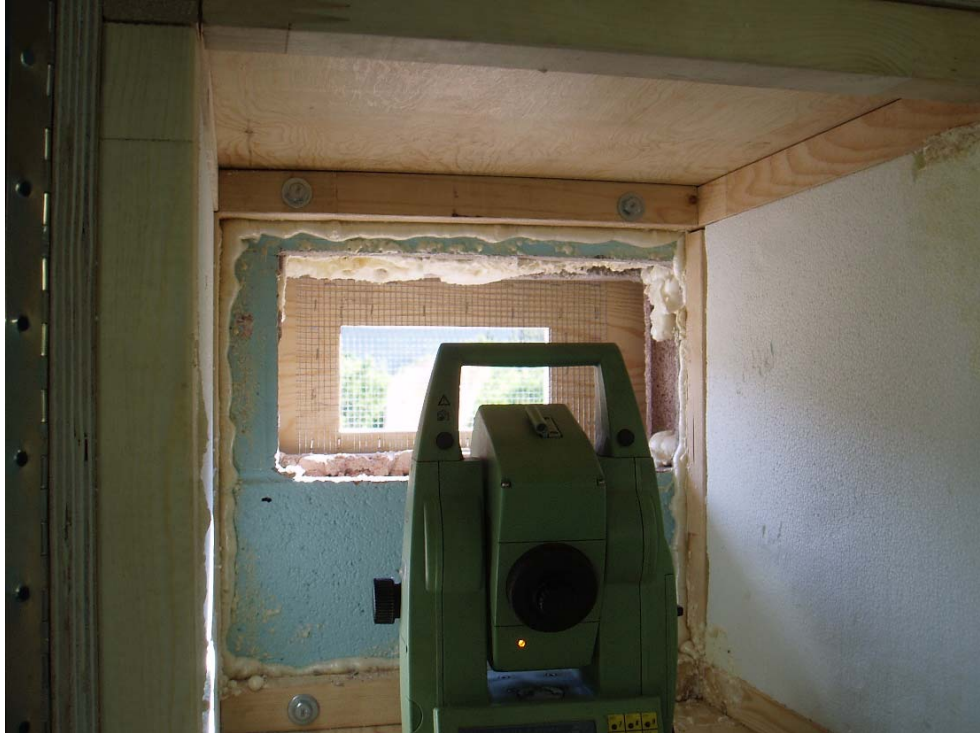
Figure 5. The Leica ‘total station’ installation in the municipal pumphouse at Bellevue, near the base of Turtle Mountain. The total station is in an insulated box and located approximately 3 km from the prisms on the eastern face of Turtle Mountain. Photo: G. Bjorgan, McElhanney Consulting Services Ltd.).

The total station is located at the municipal pumphouse in Bellevue on a reinforced concrete pillar that was built for the project. A viewing port was constructed through the brick wall of the building and a protective wooden structure built and insulated to keep outside air from affecting any of the equipment in the pumphouse (Figure 5). The total station can measure distance with an accuracy of about ± 3 mm between the pumphouse and the prisms (an absolute distance of almost 3 km). However, given the large change in elevation between the pumphouse and the summit of Turtle Mountain, atmospheric refraction can introduce large errors in measuring absolute distance. To fully correct for refraction effects, distance measurements from the total station to the four ridge prisms are constantly taken by their co-located GPS. These readings are used to calibrate the distance between the ridge and the total station, and these calibrated distances are then used to correct the distances to the other prisms. Since each prism must be visible to the instrument in order to gather readings, readings cannot be obtained when the prisms are obscured (fog, snow, ice on the prisms). The prisms are covered by snow and ice during much of the winter, so the reliability of readings, if obtained, is low.

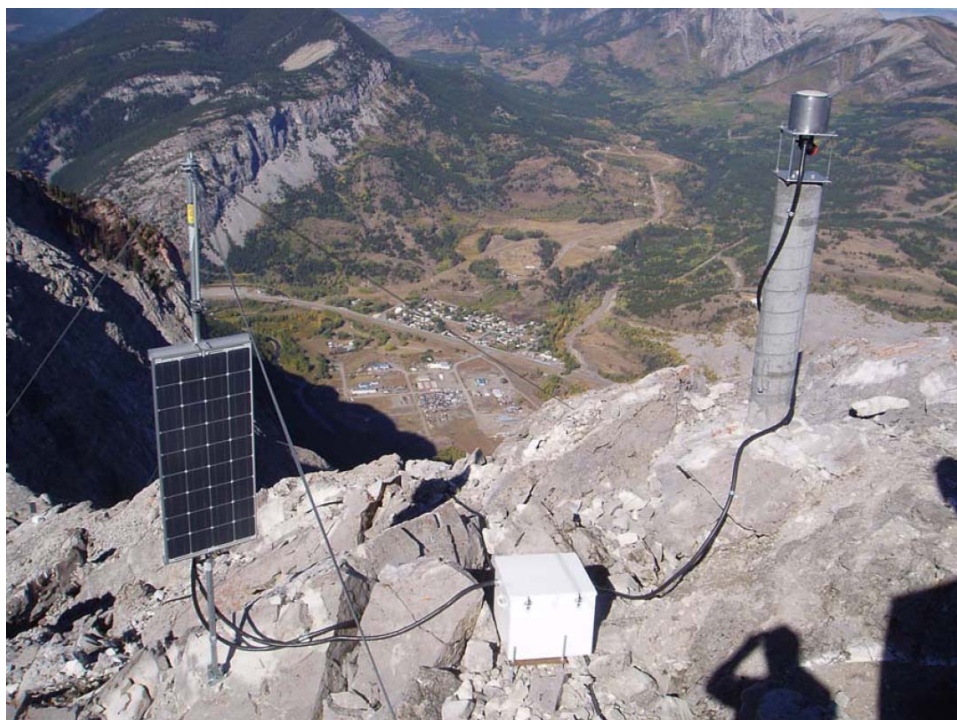
Figure 6. Typical differential GPS installation on Turtle Mountain, showing concrete pillar with Novatel antenna (right), battery box (centre) and solar panel (left). Enclosure hidden behind solar panel. Photo: G. Bjorgan, McElhanney Consulting Services Ltd.

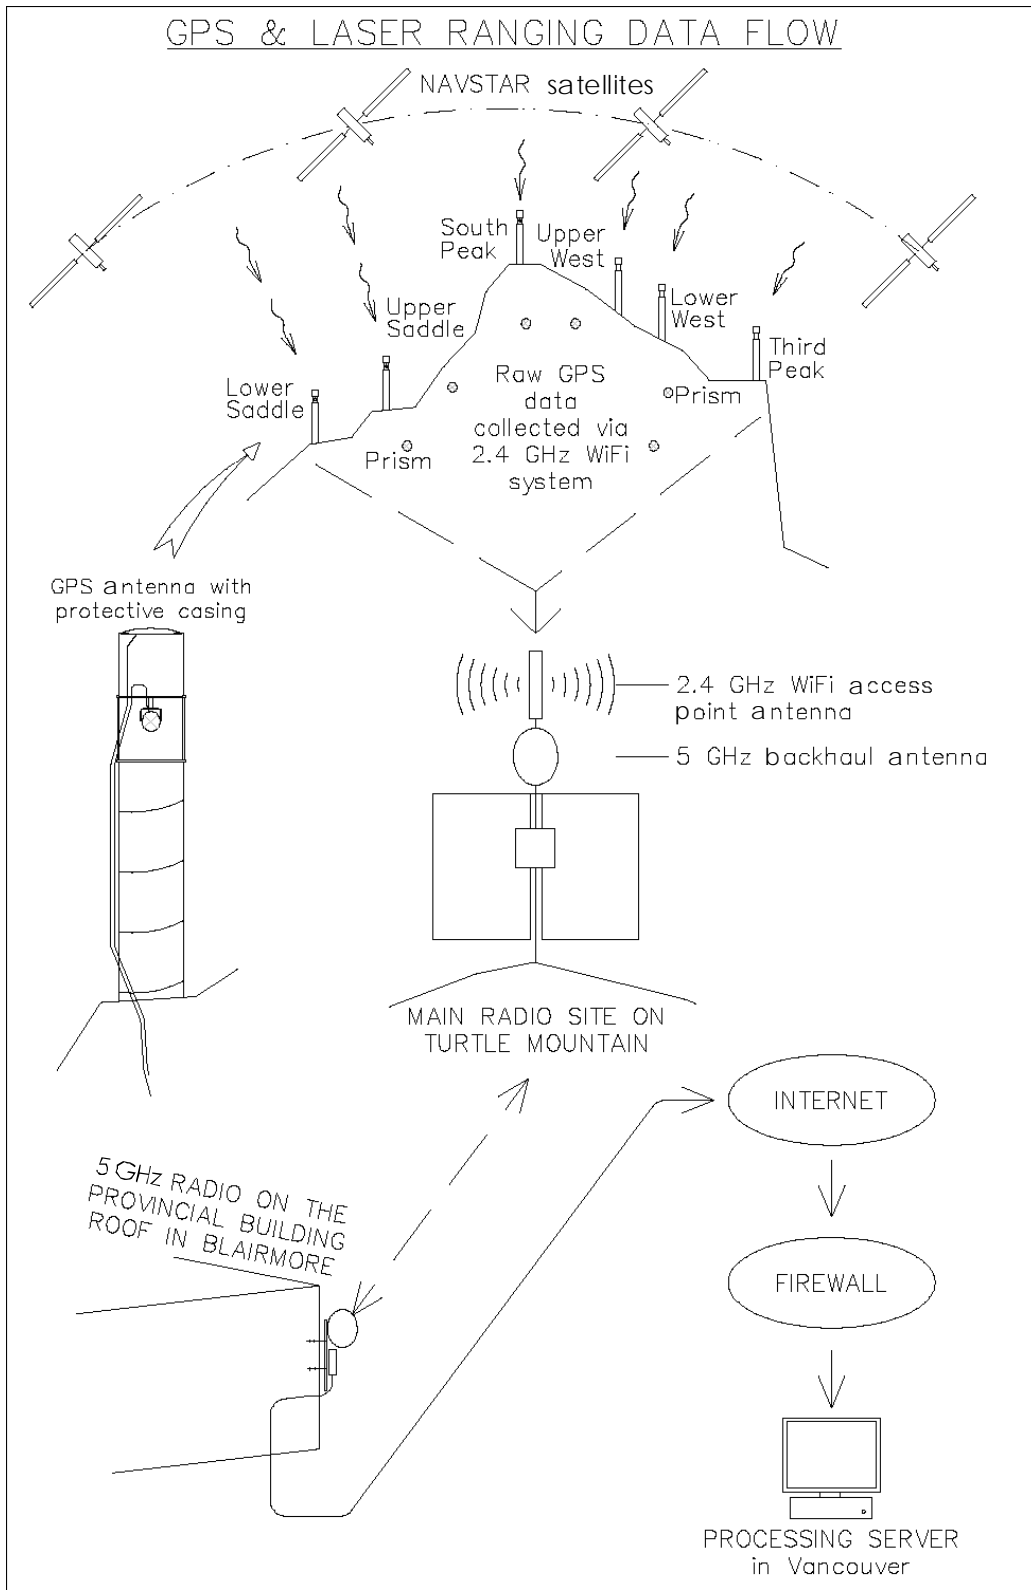
Figure 7. Schematic diagram of data flow for the combined dGPS-EDM system on Turtle Mountain (from McElhanney Consulting Services Ltd., 2007; Combined GPS and EDM monitoring on Turtle Mountain, Alberta, Bjorgan and Froese, work in progress, 2008).

Both types of processed solutions are then filtered and archived on the processing computer. Raw data processing, filtering and archiving will be migrated to the computer server located at the FSIC in the summer of 2008; the results of this will be reported in the 2008 annual summary. A schematic diagram of the data flow for the GPS and EDM systems is shown in Figure 7.

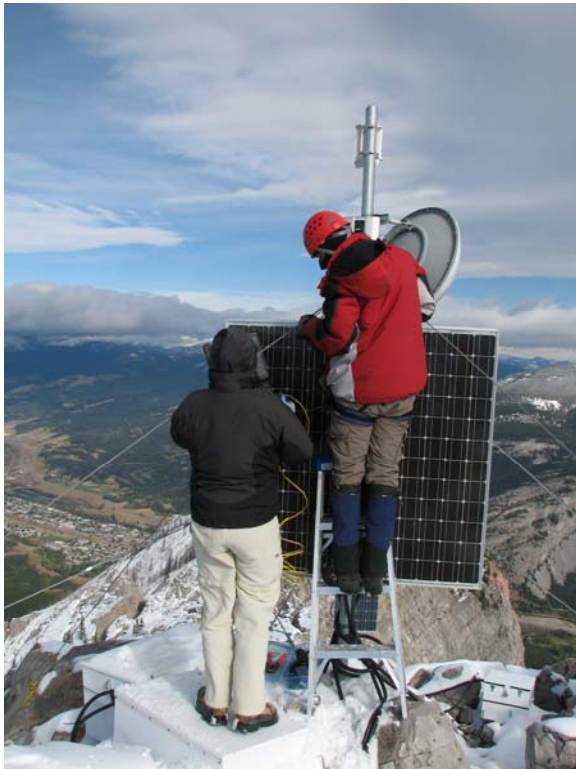
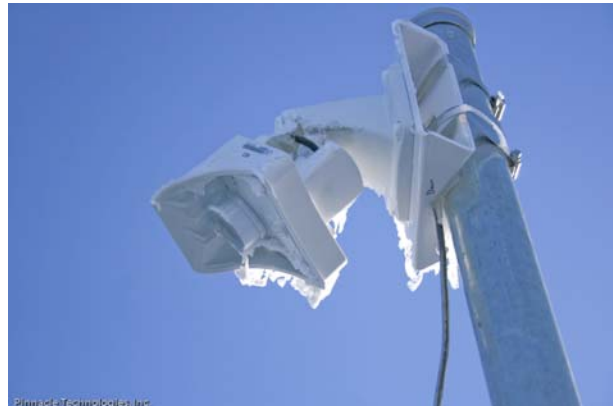
Figure 8. Web camera installation on the South Peak of Turtle Mountain, showing radio antenna, battery boxes and solar panels (left), and close-up of camera, pole mount and mast extension (right). Photo: H. Bland, Pinnacle Technologies (formerly Alto Instruments Ltd.).

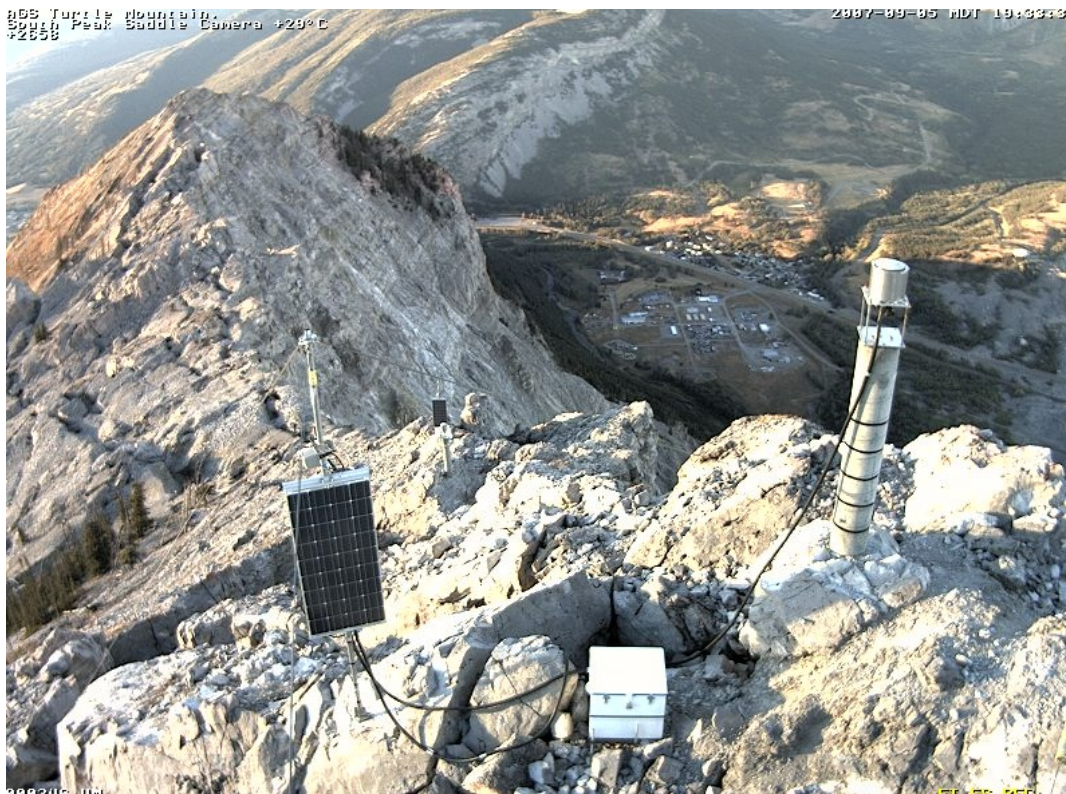
Figure 9. Image from the web camera on the South Peak of Turtle Mountain. Photo: H. Bland, Pinnacle Technologies (Alto Instruments Ltd.).

Two web cameras were installed at Turtle Mountain by H. Bland of Pinnacle Technologies (formerly Alto Instruments Ltd.) to provide visual confirmation and help with interpretation of any displacement detected by the primary monitoring system. One was located at the top of the mountain (South Peak), looking down to the northeast across the head of the 1903 slide, and the other at the bottom of the mountain (Bellevue pumphouse), looking up at the eastern face of Turtle Mountain. The South Peak camera was installed at a former seismic monitoring station at South Peak. Seismic monitoring at this station ceased in 2006 after severe lightning destroyed the monitoring equipment and data radio. During installation, the damaged radio was replaced, a mast extension added to accommodate the camera mount and additional guy wires installed to prevent the mast from twisting under severe winds. Installation also included the re-use of existing equipment enclosures, solar panels, solar controllers and associated batteries (Figure 8). The camera is attached to the mast extension and connected through a single cable to the network radio, which transmits the image data to the computer server at the Frank Slide Interpretive Centre (Figure 9).

The two cameras have been configured to archive images to the computer server at the FSIC every 5 minutes. In addition, they transmit an image to the server every 10 minutes for use on a web page. This frequency can be adjusted remotely to a few seconds, should conditions warrant more frequent image acquisition. The cameras deposit their image files (in JPEG format) into a time-ordered hierarchy of directories (YYYY/MM/DD). A scheduled task runs on the computer server to build daily movie files based on the collection of JPG images. Both the images and the movie files are available via the web-server software (Apache) running on the Turtle Mountain server (http://www.ags.gov.ab.ca/geohazards/turtle_mountain/turtlecam/turtle_webcam.html).

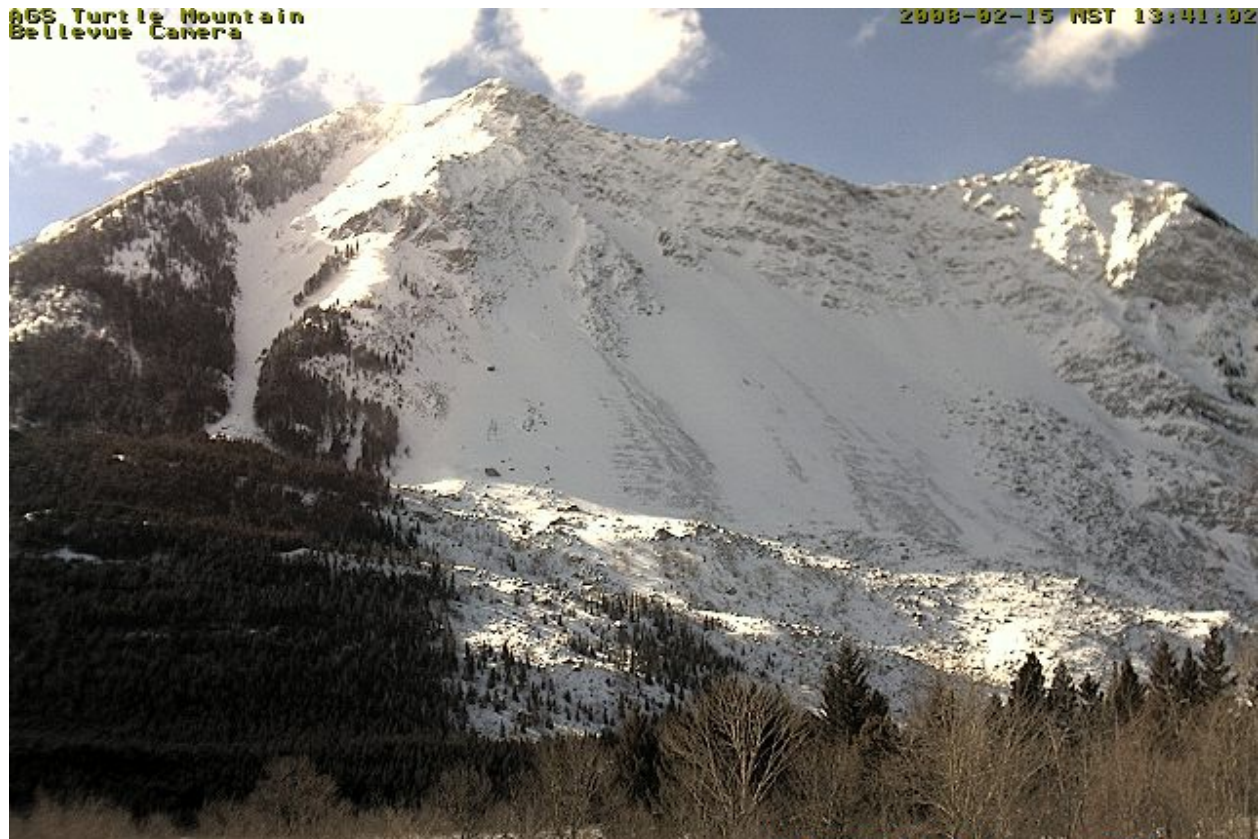
Figure 10. Image from the web camera at the Bellevue pumphouse, near the base of Turtle Mountain.

The view captured by the Bellevue pumphouse camera includes the eastern face of South and Third peaks, the Frank Slide scar, North Peak and lower portions of the mountain (Figure 10).

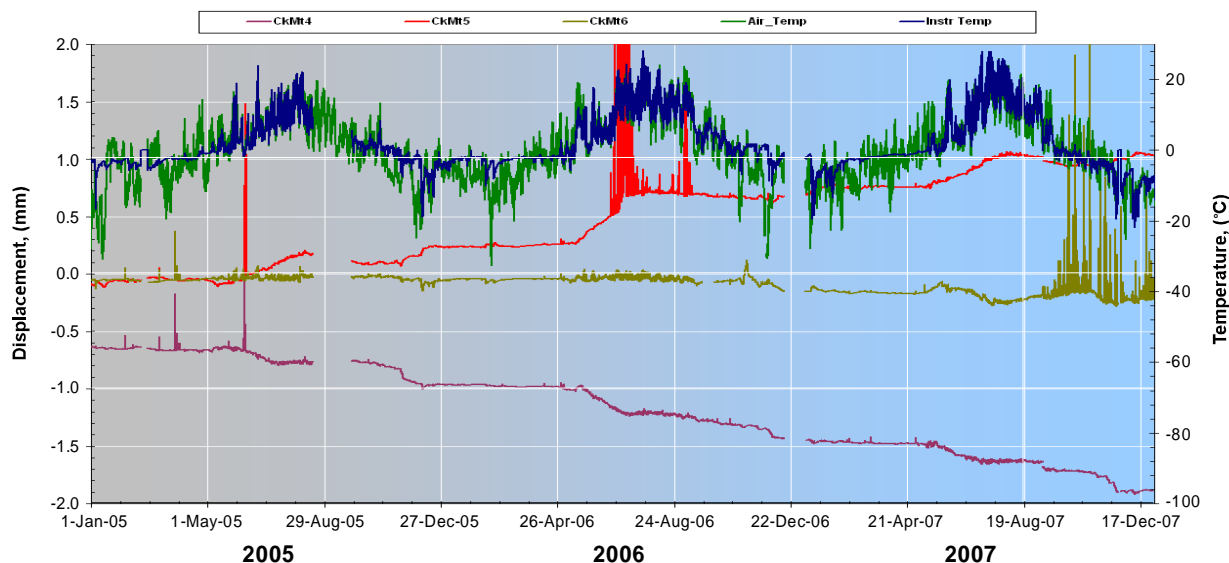
Figure 11. Plot of displacement versus time for crackmeter Set B, South Peak, Turtle Mountain.

Crackmeters were installed to monitor continuously the direction and magnitude of surface-fracture opening. Details of installation have been described by Moreno and Froese (2006). Although displacements were observed on many of the crackmeter sets, the most indicative record of slope displacement has been obtained from the cluster of three crackmeters in Set B. These instruments provide the time series of crack opening and temperature over a period of three years (Figure 11). Monitoring results show an annual displacement cycle, which correlates with temperature cycles, that are dominated by an active phase, with displacements occurring in early autumn to late winter, and a relatively inactive phase, with limited to no displacements in spring to late summer. Magnitudes of displacement rate of 0.4 mm/year have been recorded. Likewise, the measured data show displacement fluctuations, related to daily air-temperature cycles, with crack-width changes on the order of 0.02 mm.

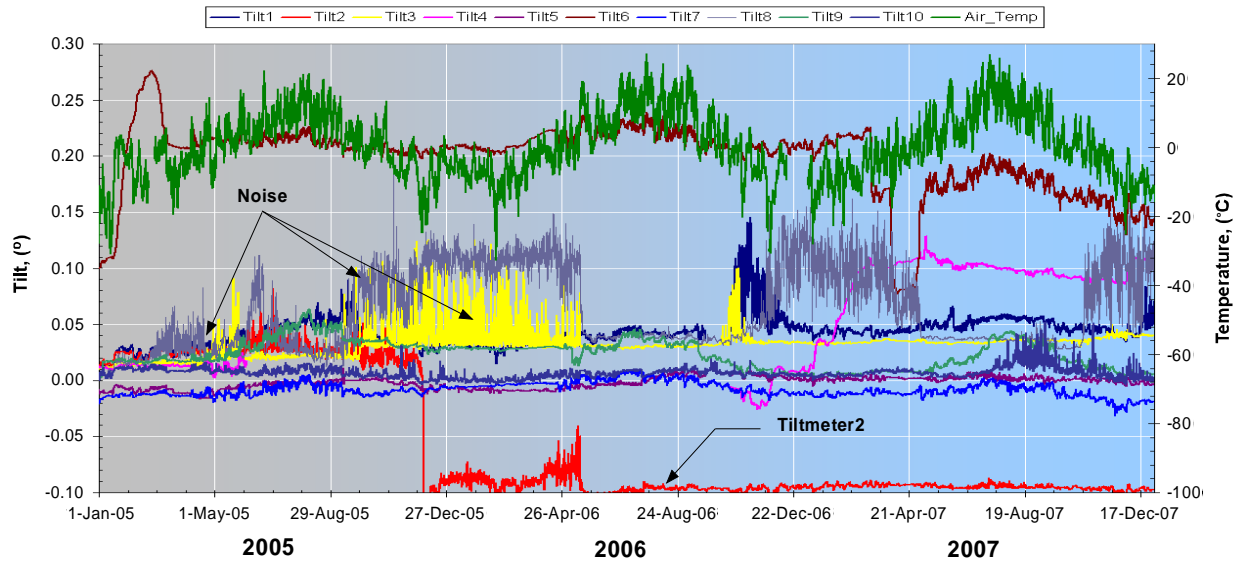
Figure 12. Plot of tilt versus time for tiltmeters, South Peak, Turtle Mountain.

In general, all sensors display an increase in tilt at the start of the summer period and a return to the previous state at the end of it (Figure 12). A similar cyclic variation in tilt associated with diurnal temperature fluctuations is also present, but at a smaller scale ($\sim 0.01^\circ$). Noisy responses due to moisture in the sensors continue to affect the quality of tiltmeter data (T-1, T-8 and T-10), although the addition of desiccant packs during summer 2006 has remarkably improved data quality (T-2 and T-3).

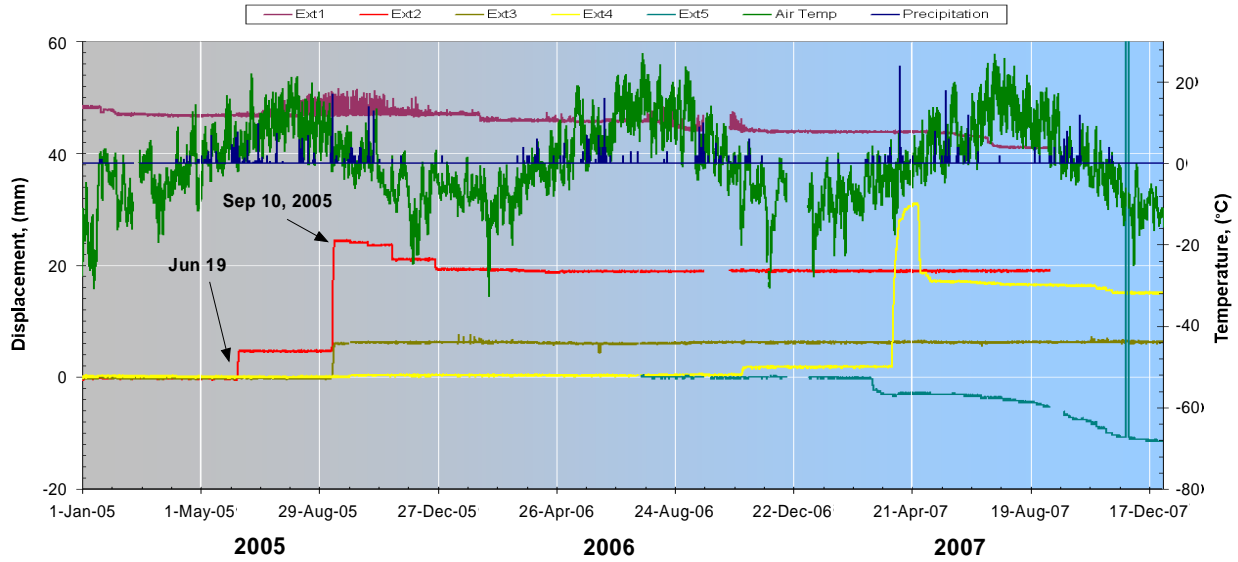
Figure 13. Plot of displacement versus time for extensometers, South Peak, Turtle Mountain.

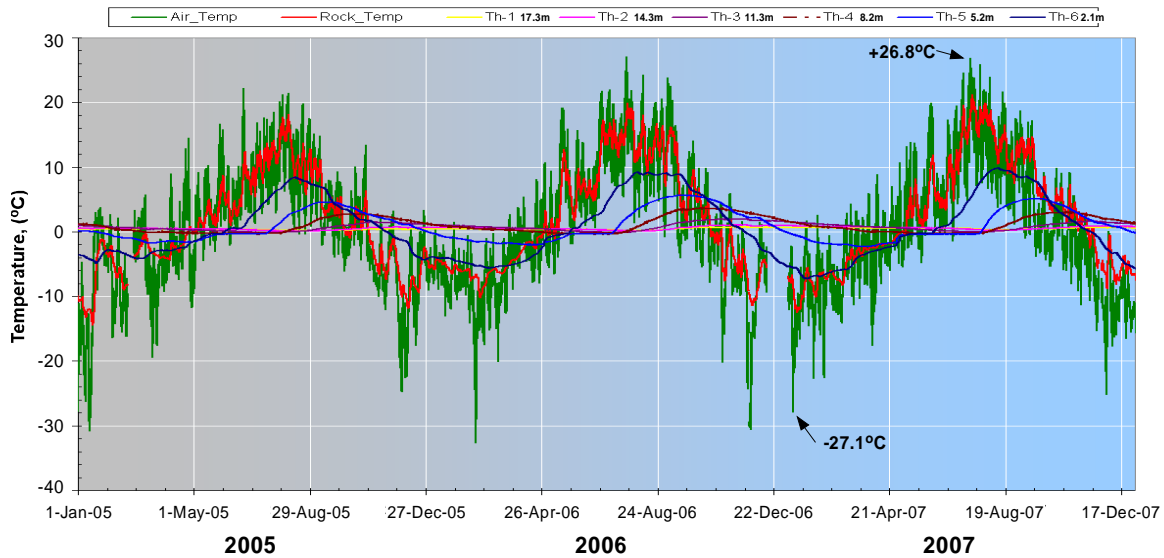
Figure 14. Air temperature and variation of rock temperature with depth in the borehole at the top of South Peak, Turtle Mountain, 2005-2007.

Average temperatures at the top of the South Peak of Turtle Mountain in 2007 were warmer than those recorded in previous years, ranging from -10.4°C in January to $+15.6^{\circ}\text{C}$ in July. In addition, lower extreme maximum ($+26.8^{\circ}\text{C}$) and minimum (-27.1°C) temperatures were registered (Figure 14) than in previous years. Significant daily temperature variations were also common. Rock temperature showed the same general trend as air temperature but was more subdued (lower maximum and minimum readings), with a time lag of about 12 hours relative to significant changes in air temperature. Seasonal temperature fluctuations penetrate only about 15 m into the slope (Th-2) and are negligible below that depth, with significant temperature variations measured down to a depth of 8.2 m (Th-4). On the other hand, daily temperature variations are measurable only about 4 m into the slope (Figure 14).

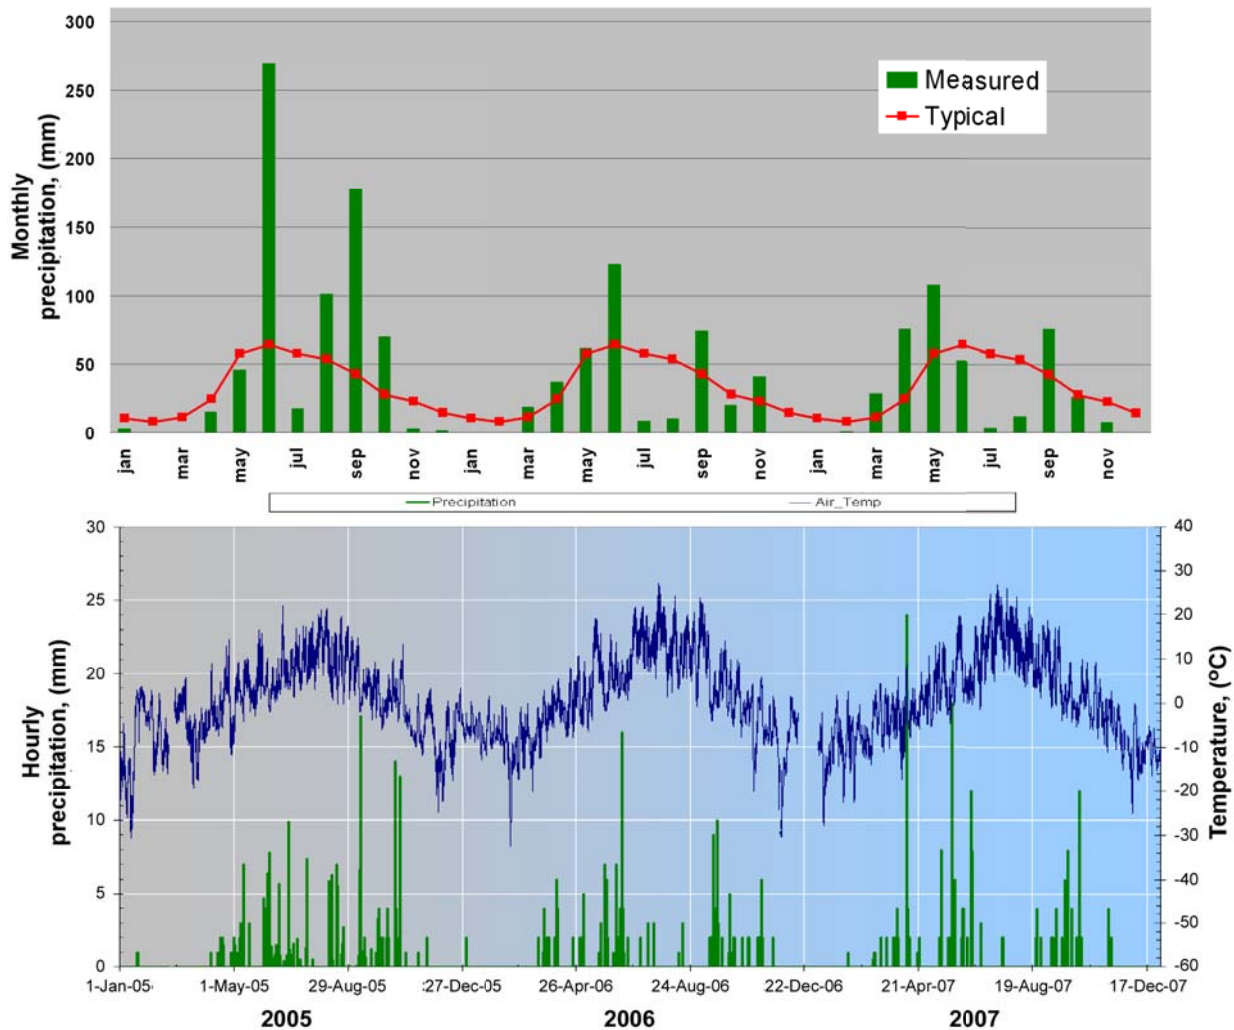
Figure 15. Measured and typical average monthly distribution of rainfall in the vicinity of Turtle Mountain, 2005–2007.

Total precipitation of 393 mm was measured during the reporting period on South Peak of Turtle Mountain, slightly below of the average precipitation of 397 mm measured at the nearby Coleman weather station of Environment Canada. Climate averages for this station are based on at least 15 years of data between 1971 and 2000. Below-normal winter precipitation was measured (Figure 15) and above-normal precipitation was recorded during the spring, with two major precipitation events recorded in early April and late May. Preliminary data indicate that the total volume measured during this event was among the second to tenth highest in the 3 years for which records exist. The summer of 2007 was a dry season, but precipitation increased to above-normal levels during fall, except for November.

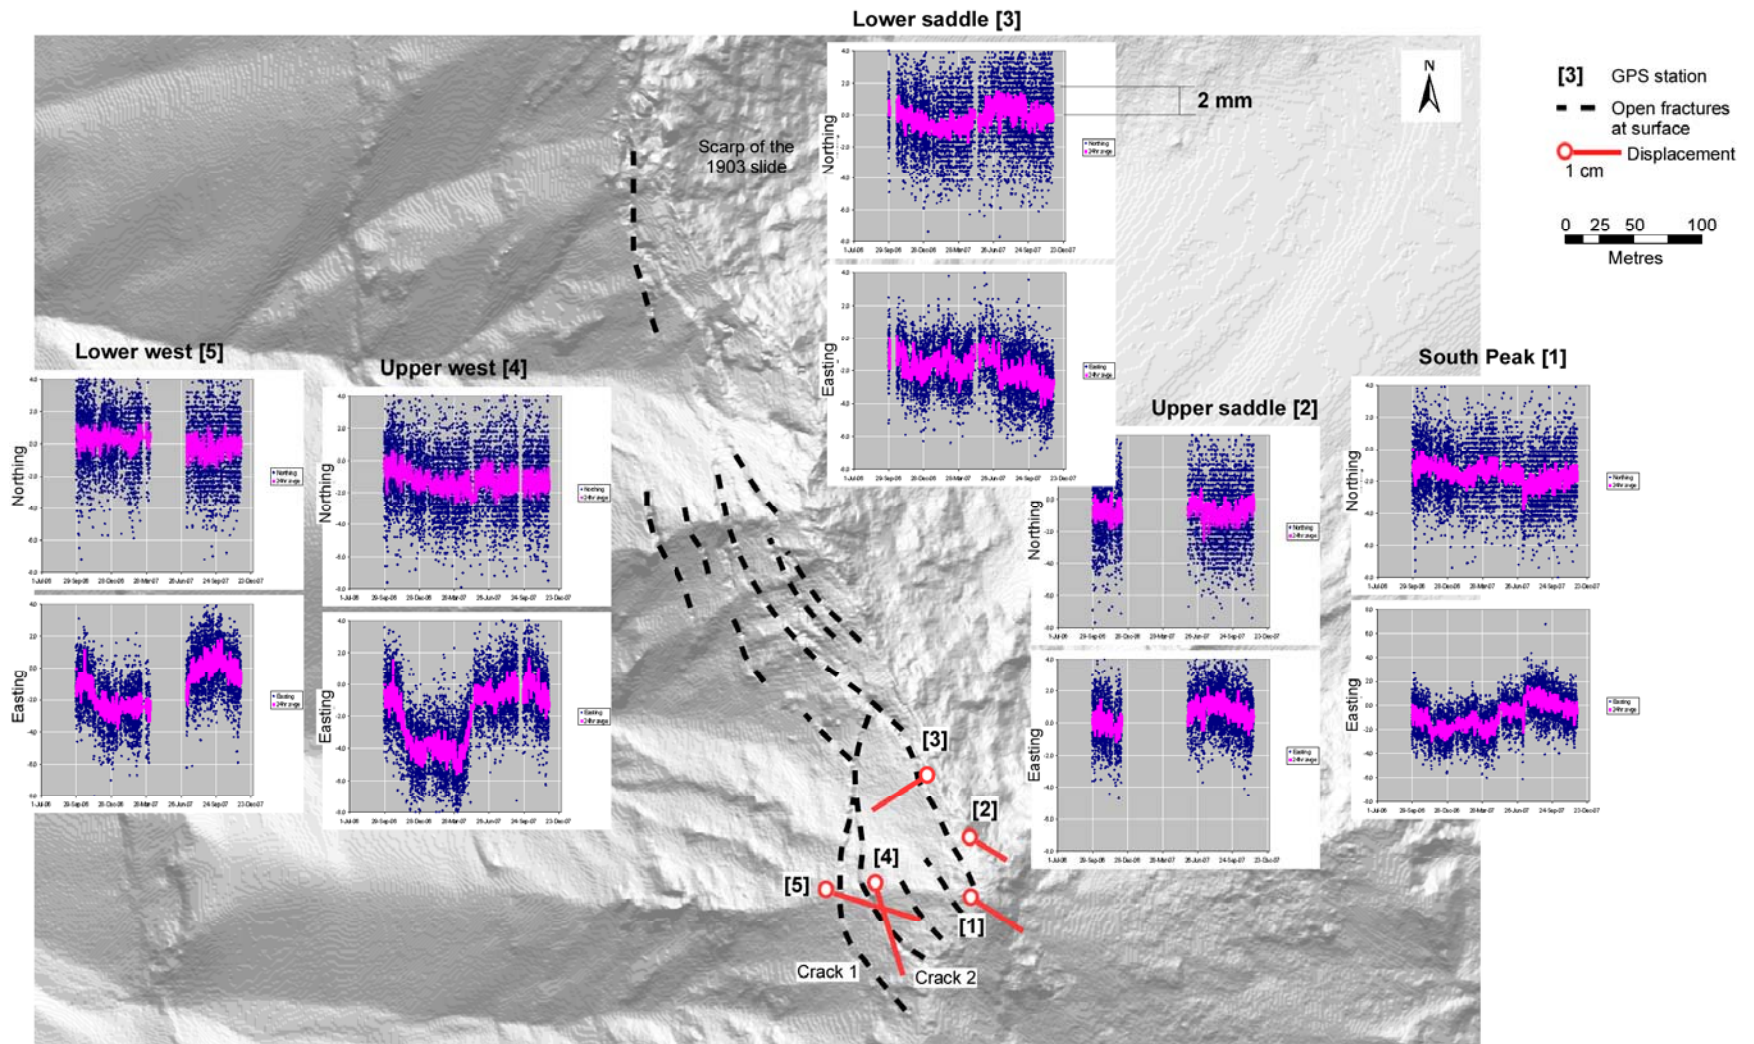
Figure 16. Surface displacements derived from dGPS stations during the period 2006–2007: horizontal component of the surface-displacement vectors plotted on a map of the South Peak of Turtle Mountain (red lines). The displacement vectors of the dGPS stations are absolute, since they are referenced to an external coordinate system.

As discussed in Section 2.1.2, six dGPS stations were installed during the summer and fall of 2006. These stations are located in two clusters: along the ridge just north of South Peak and on the west face of the mountain immediately downslope from the South Peak borehole (one on each side of Crack 1). Spatial coverage is therefore limited, with only one station situated within the stable part of the rock mass (Third Peak station). The results of monitoring between the summers of 2006 and 2007 are shown in Figure 16. The magnitudes of the displacement-rate vectors vary from 0.7 to 1.8 mm/year. Absolute displacement vectors are directed to the southeast for stations located at upper saddle, South Peak and upper and lower west, and to the southwest for the station located at the lower saddle, and are more or less congruent with the displacement directions observed at the photogrammetric targets (Moreno and Froese, 2007). However, the uncertainty in direction is large because their magnitude is small relative to the instrument resolution. Additional years of data are needed to confirm these results.

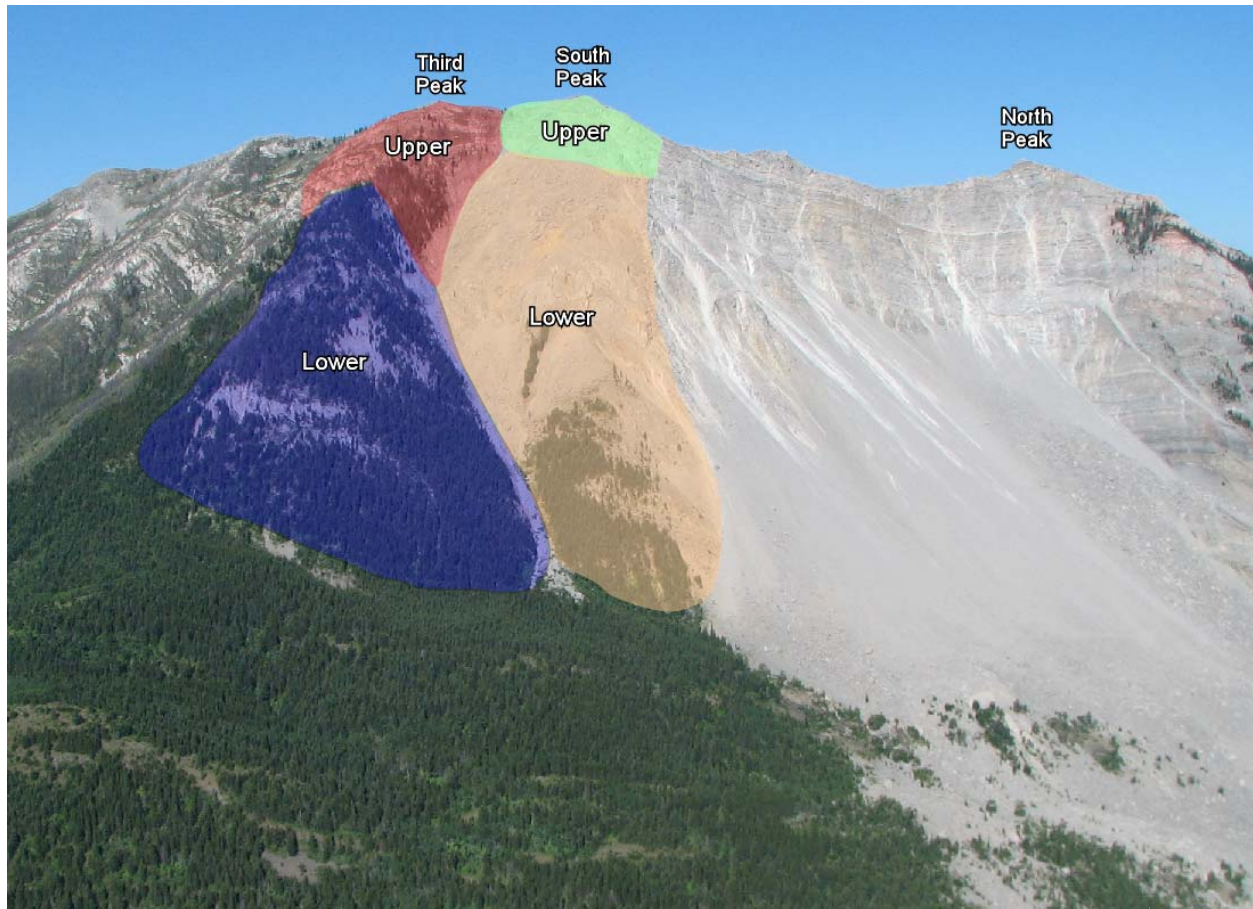
Figure 17. Eastern face of Turtle Mountain, showing the upper and lower zones of Third and South peaks. These areas were the focus of detailed structural mapping and kinematic analysis.

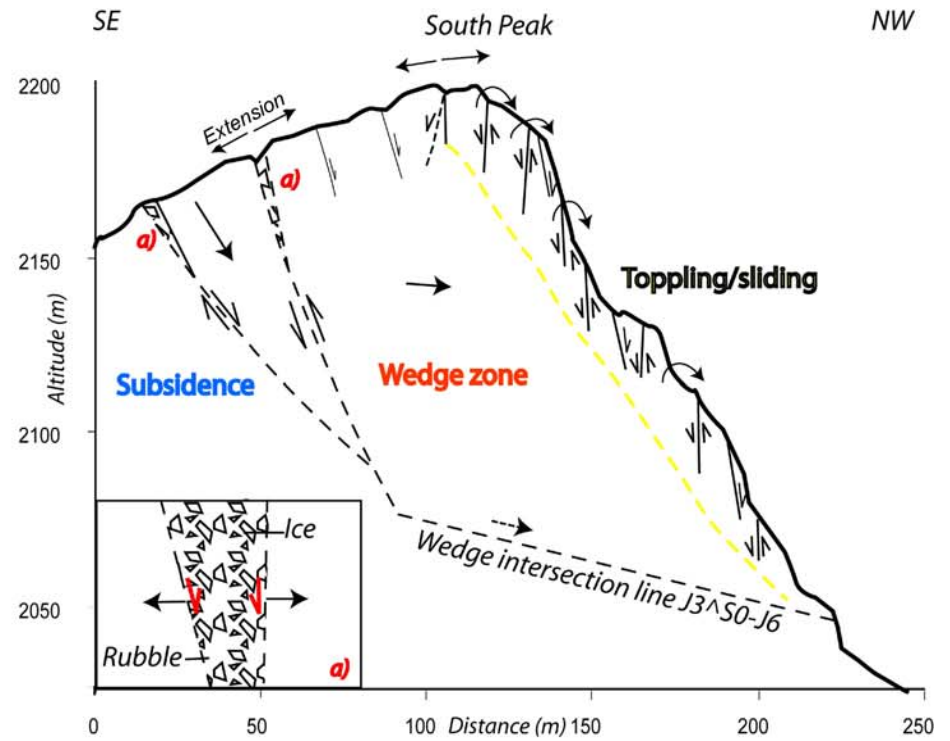
Figure 19. (Left) 3-D model of the South Peak of Turtle Mountain with the three main potential sliding joint sets (J2, J3, J6). (Right) Simplified schematic diagram of the postulated kinematic modes of failure on upper South Peak, Turtle Mountain.

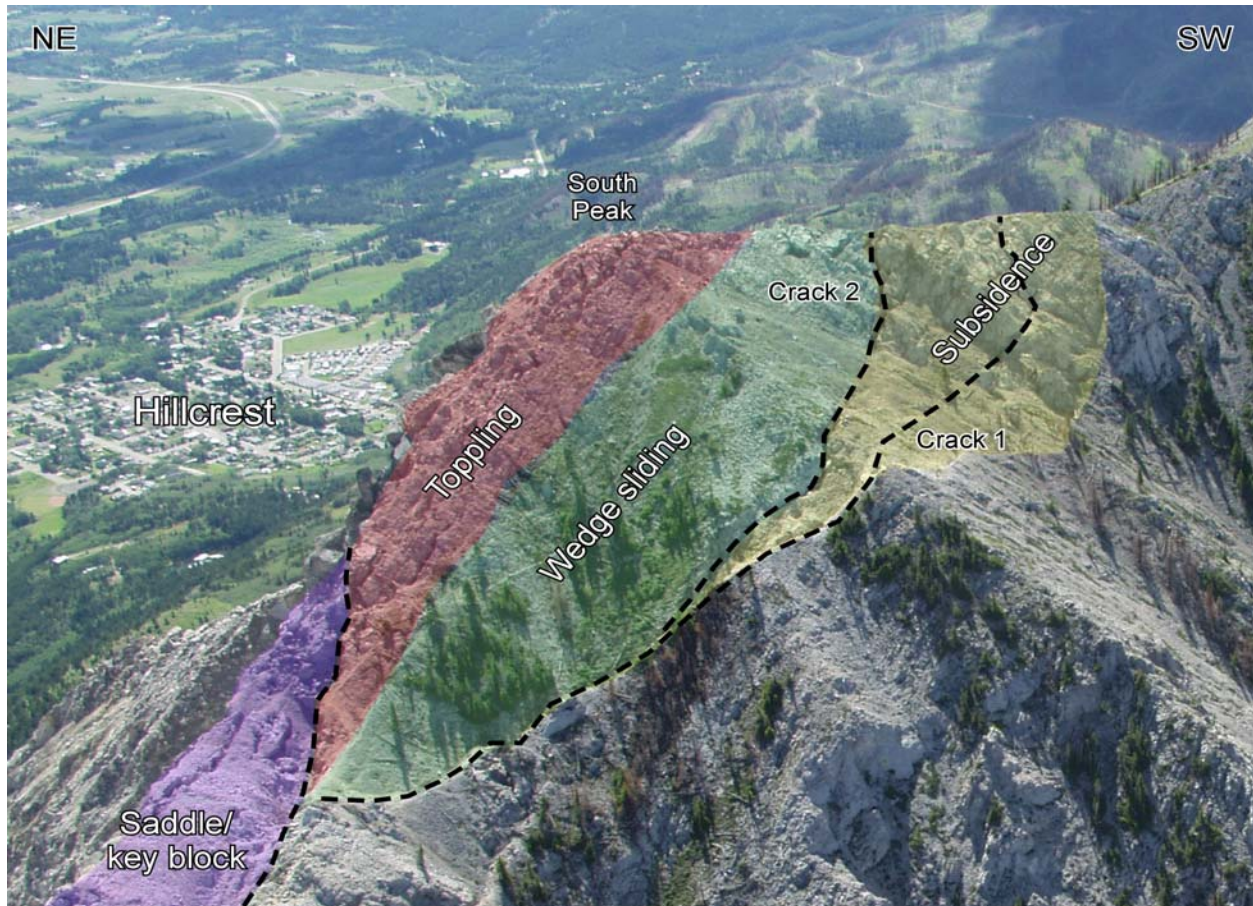
Figure 20. Oblique view toward the south of the South Peak of Turtle Mountain, showing the three main zones of deformation observed.

When comparing the structural measurements from the DEM with recent oblique aerial photography, the main wedge and toppling zones can be observed on the South Peak area (Figure 20). On this photo, three distinct zones of deformation can be observed on the South Peak wedge: toppling to the east, wedge sliding to the northeast, and formation of a graben to the south and west of the wedge. The features

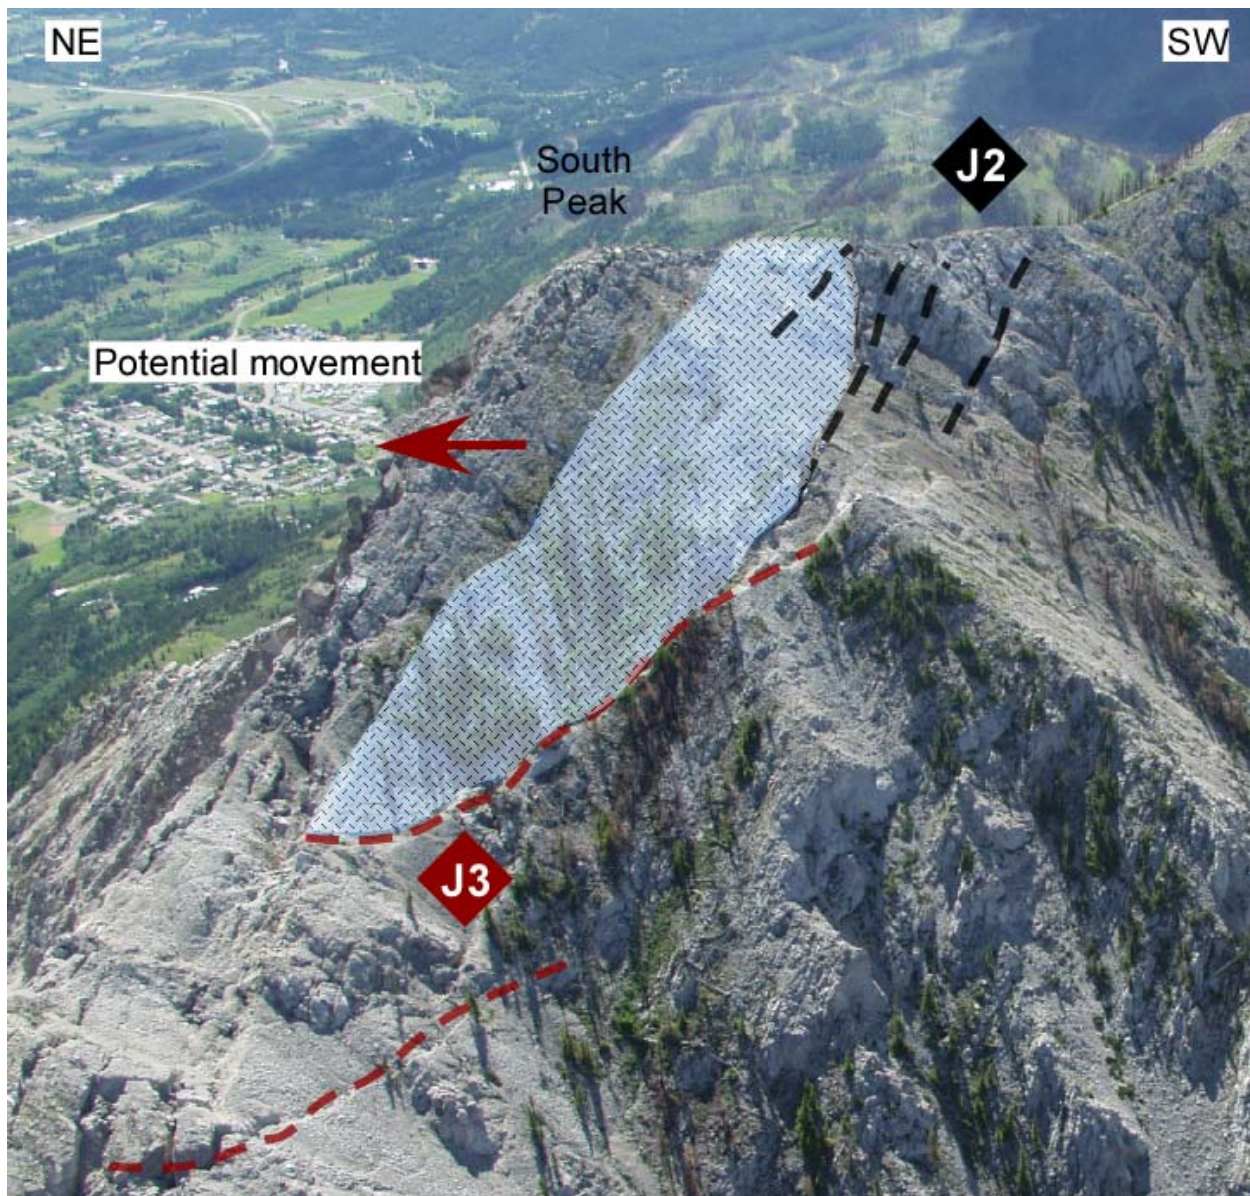
Figure 24. Lateral view of the postulated wedge failure zone (Zone 2). This zone is bounded by joint sets J2 (black) and J3 (red) and, at its base, by the bedding on the western limb of the Turtle Mountain anticline.

For Zone 2, the displacements are structurally controlled by joint sets J2 and J3, and either joint set J6 or the bedding (S0) along the western limb of the Turtle Mountain anticline, as shown in Figure 24. The only target from the 1980's monitoring program located in this zone is P20. The overall displacement of target P-20 between 1982 and 2005 is 17 mm toward 357°. As shown in Table 2, the vertical component of this target's deformation is negligible, indicating that the deformation is predominantly translational, most likely on a bedding-controlled rupture surface. Joint set J2 and joint set J6–bedding S0 (J2/S0-J6) intersect at 344°/33°, reasonably close to the results obtained for the displacement of photogrammetric target P20. Therefore, these likely represent the structural controls on the rupture surfaces, with joint set J3 helping to delineate the volume of the wedge mass. With this orientation for the potential rupture surface, the dip angle of 33° is likely too shallow for the wedge to start sliding as the result of its own weight, so an external force would have to be applied. This could be provided by seasonal ice damming and water accumulation in the cracks behind the mass or the force exerted by the heavily broken, subsiding mass in Zone 3 (*see below*).

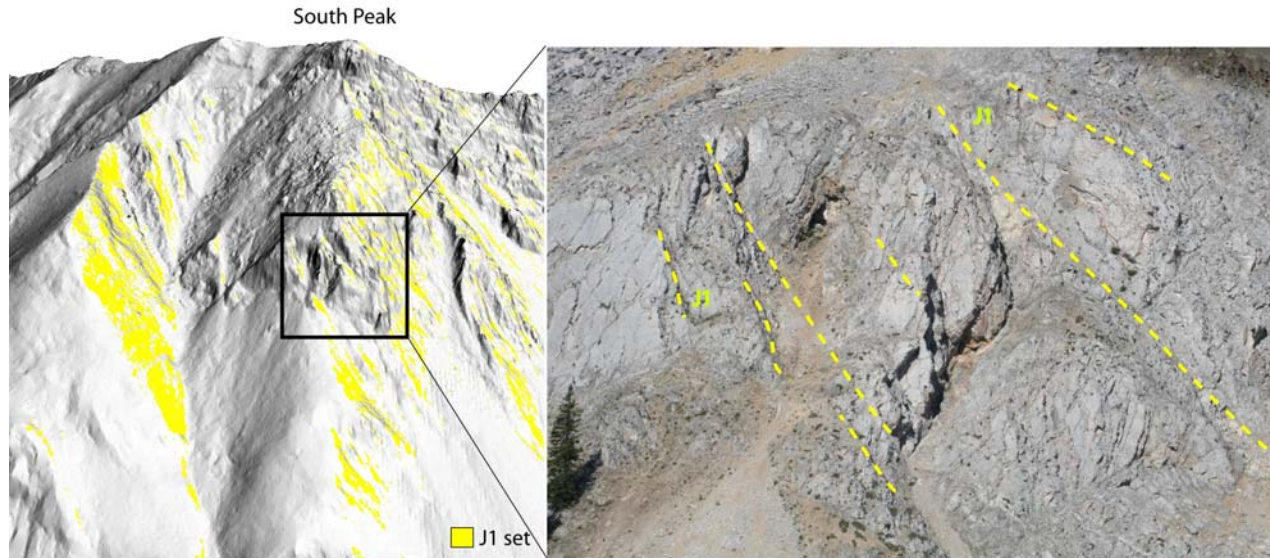
Figure 26. Influence on morphology of the joint set J1: (Left) 3-D DEM view showing extraction of joint set J1 from the COLTOP 3-D analysis. (Right) Close-up of outcrop conditions in the lower South Peak area; rock fracturing along J1 joint set indicates possible activity.

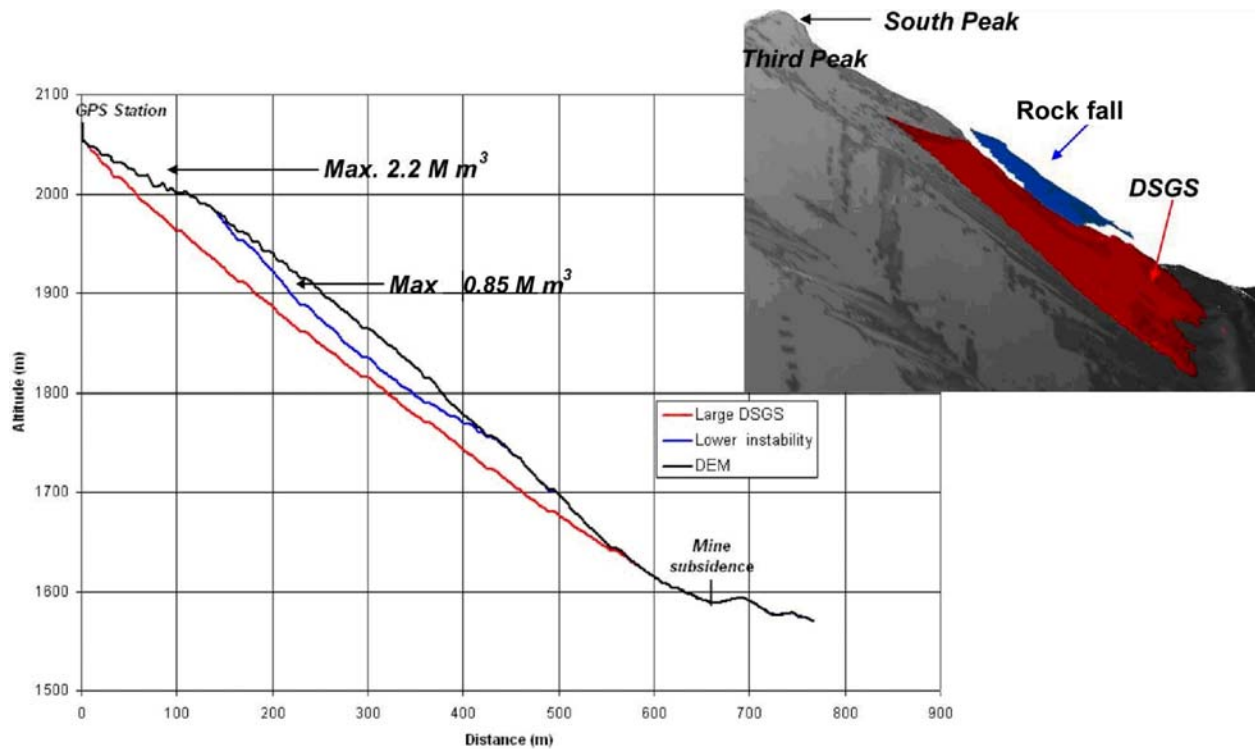
Figure 30. Cross-section of the two main unstable volumes identified on the lower Third Peak (from Pedrazzini and Jaboyedoff, 2008). Abbreviations: DEM, digital elevation model; DSGS, deep-seated gravitational surface; M, million.
