Turtle Mountain Field Laboratory: 2007 Data and Activity Summary

F. Moreno and C.R. Froese

Energy Resources Conservation Board
Alberta Geological Survey

Moreno, F. and Froese, C.R. (2008): Turtle Mountain field laboratory: 2007 data and activity summary; Energy Resources Conservation Board, ERCB/AGS Open File Report 2008-07, 40 p.

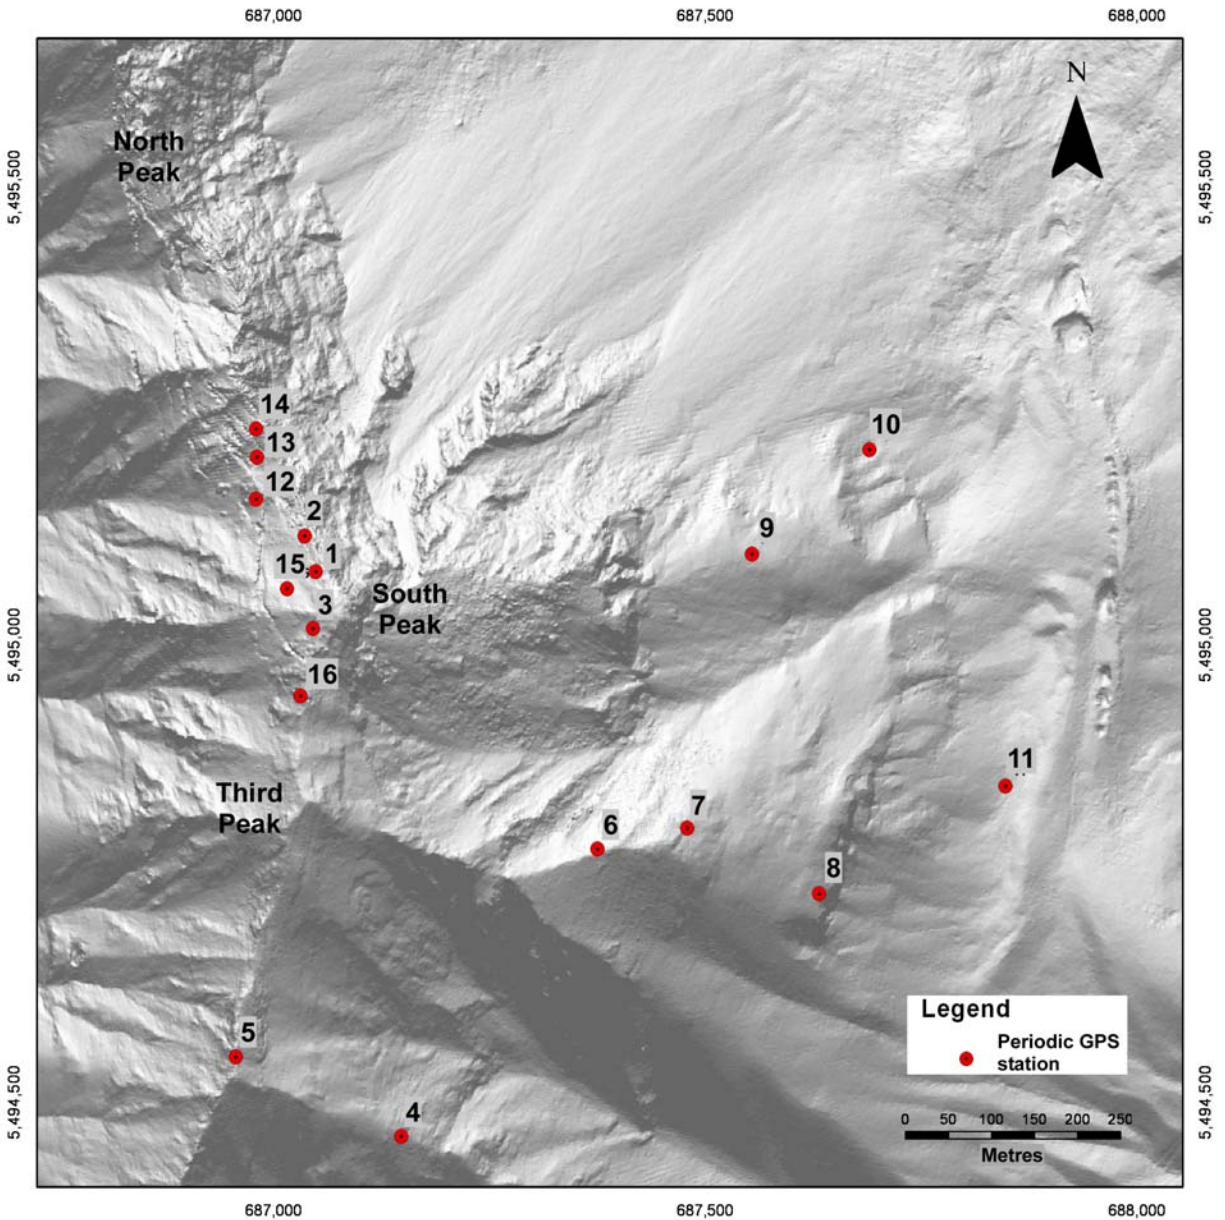
Figure 34. Locations of the 15 periodic dGPS monitoring points installed in the summer of 2007 by the University of Calgary Geomatics Engineering Group.

As expected, no significant movements were observed during the June to October 2007 time frame. Possible movements were observed on targets 6 and 13, but further readings in the summer and fall of 2008 will be required to confirm these trends. It is expected that, for most of the movements on the east face, many years of observation will be required to gain confidence in movement rates and patterns. It is expected that trends will become clear in a shorter time frame in the Saddle zone, due the high relative activity in this area.

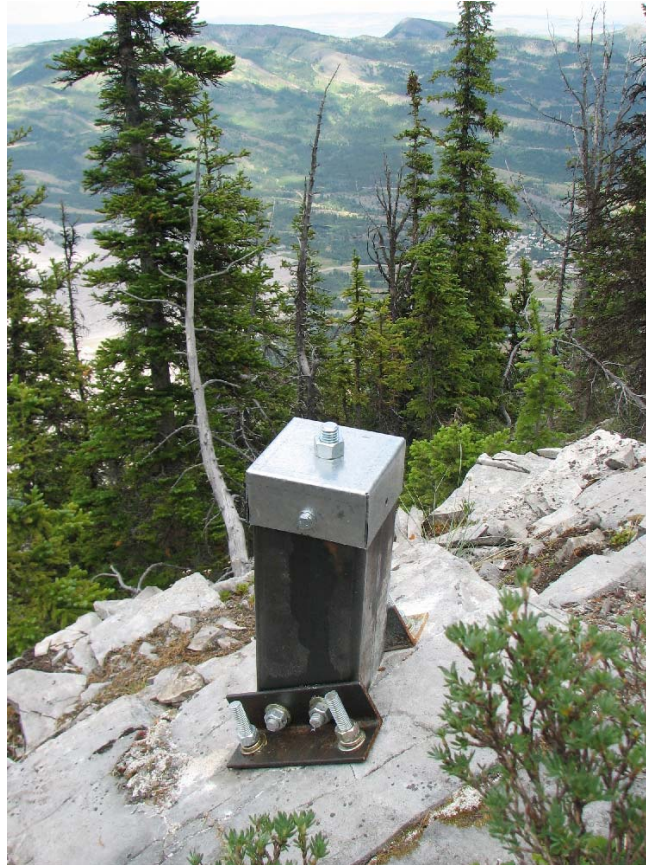
Figure 35. Typical periodic GPS point installation on Turtle Mountain.
