Turtle Mountain Field Laboratory, Alberta (NTS 82G): 2015 Data and Activity Summary

AER/AGS Open File Report 2017-03

D.E. Wood, D.K. Chao and T.C. Shipman

October 2017

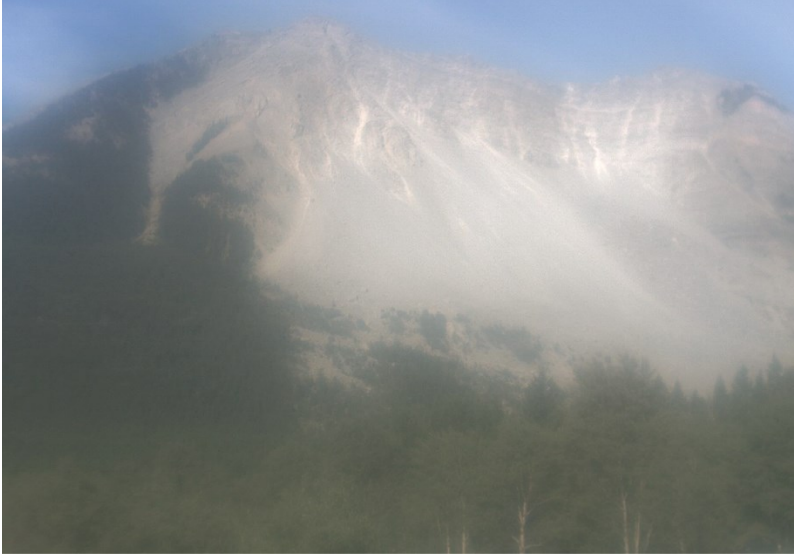
Figure 3. (a) Bellevue web camera image before lens change showing distorted image from condensation; (b) Bellevue web camera image after the lens was replaced.

The images taken by web cameras located on South Peak and at the Bellevue pump house became progressively distorted during the spring. It was presumed that the seal on the camera lens had become brittle over the years and had failed. Upon examination of the camera lens it was determined that condensation build-up was the cause of the poor-quality images (Figure 3a). Lenses were replaced on the Bellevue (Figure 3b) and South Peak web cameras.

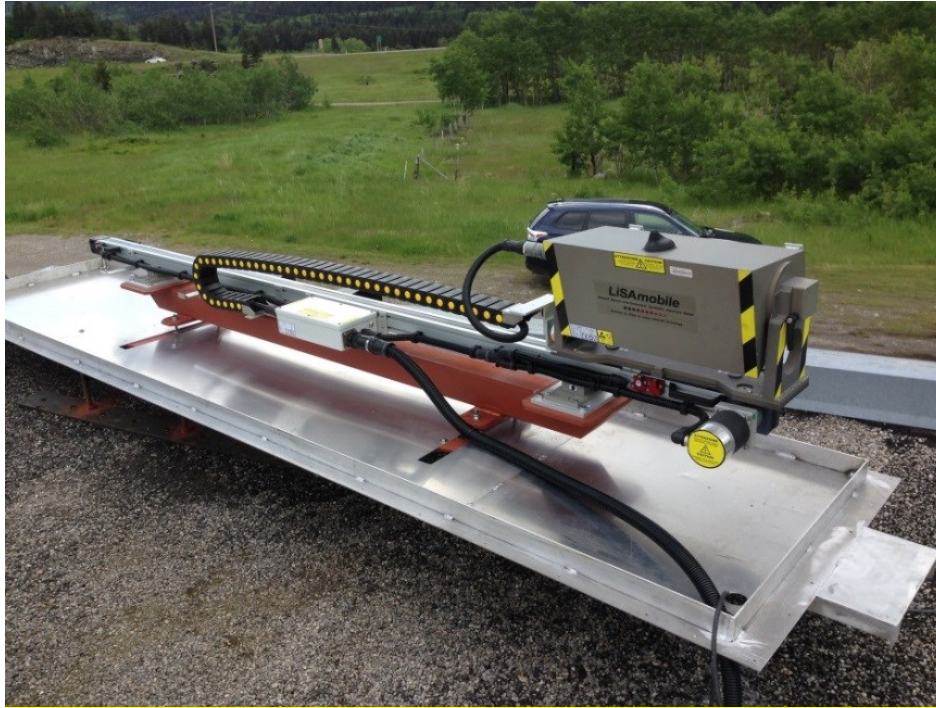
Figure 4. (a) LiSAmobile system without radome and temperature regulation unit; (b) LiSAmobile system completely assembled (Photos courtesy of Ellegi).

The newly installed LiSAmobile system (Figure 4a) was leased to the AGS and installed in June 2014. Additional documentation on the feasibility study, service contract, fabrication of supporting materials, LiSAmobile installation, and initial system calibration is included in Wood et al. (2016).

LiSAmobile consists of two main parts: the radar head and mechanical components. The radar head is an active radar sensor that transmits microwave pulses towards an object and receives in return a backscattered signal. The radar head, which consists of two antennas (transmit and receive), is attached to a linear positioner (cradle) mounted on a horizontal track. The travel distance of the radar head along the track can be adjusted to allow for optimal scanning coverage of the mountain face. The radar head travels back and forth along the 2.5 metre track once every ~8.5 minutes.

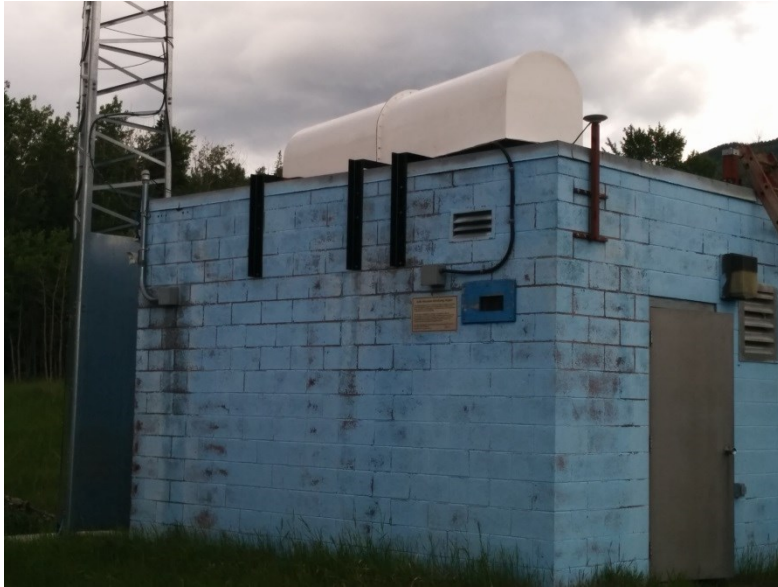
Figure 5. LiSAmobile system at the Bellevue pump house station.

In June 2014, a ground-based radar device was installed at the Bellevue pump house (Figure 5) for monitoring small displacement on the east face of Turtle Mountain. The LiSAmobile GB-InSAR uses the interferometric synthetic aperture radar technique to measure small displacements at each point on the surface of the mountain.

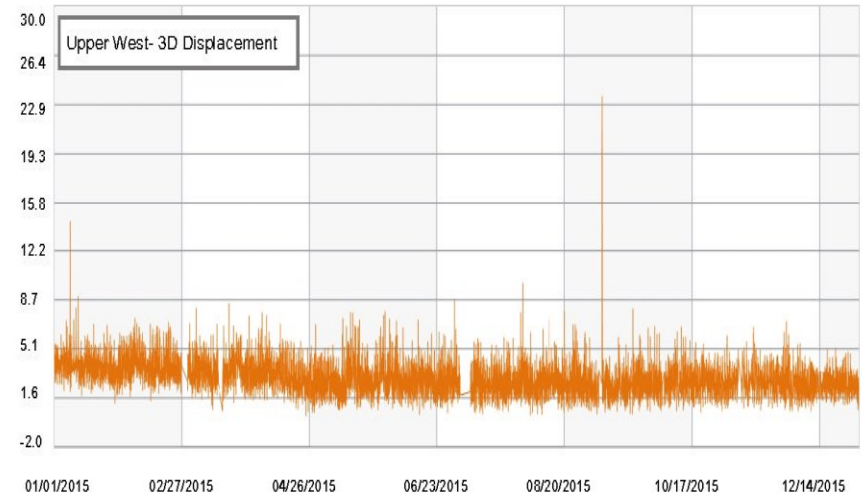
Four dGPS stations experienced data transmission problems in 2015 (Figure 6 and 7): Lower Saddle station data became sporadic in late April, Ridge station went offline in early December, Upper Saddle station stopped transmitting data in late June, and South Peak station started sending sporadic data in mid-October.

Figure 7. Surface displacements derived from dGPS stations during 2015.

AGS decided not to interpret the 2015 dGPS data because of the questionable data quality. We expect that deformations will continue to be in the millimetre range, as Turtle Mountain's rock masses are moving very slowly. At the end of 2015, the AGS will complete an internal review of the dGPS network data. These internal reviews help the AGS continue to test and develop new monitoring technologies and equipment for the mountain.
