**Turtle Mountain Field
Laboratory, Alberta (NTS 82G):
2020 Data and Activity
Summary**

AER/AGS Open File Report 2022-01

D.K. Chao

Alberta Energy Regulator
Alberta Geological Survey

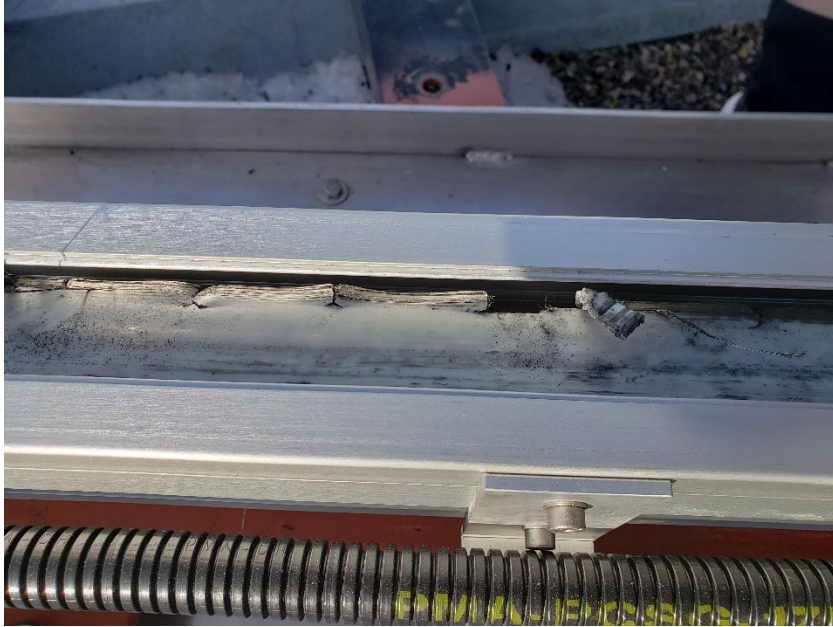
Ellegi notified the AGS on April 1, 2020, that they lost data transmission from LiSAmobile to Italy. An inspection by a local contractor ruled out electrical and communication failures. The AGS staff were dispatched shortly after to the Crowsnest Pass to conduct a detailed diagnostic of LiSAmobile. With guidance from Ellegi, it was determined that the linear positioner (drive belt) connected to the radar unit was misaligned and damaged, preventing the radar unit from moving (Figure 3). Fortunately, this mechanical failure did not affect the radar unit and its signal transmission/receiving functions.

Figure 3. Linear positioner (drive belt) connected to the radar unit was misaligned and damaged, preventing the radar unit from moving along the track of the LiSAmobile unit at Turtle Mountain, Alberta.

Components from LiSAmobile, including the linear positioner, motor, and track, were shipped back to Ellegi in Milan, Italy, for repair, service, and testing. The radar unit was placed in local storage during the repair. On May 7, the AGS staff arrived on site to reinstall LiSAmobile and began testing with Ellegi. After testing the alignment and movement of the radar unit along the track, and several hours collecting and sending measurement data to Ellegi for analysis, LiSAmobile was officially returned to fully operational status on May 8.

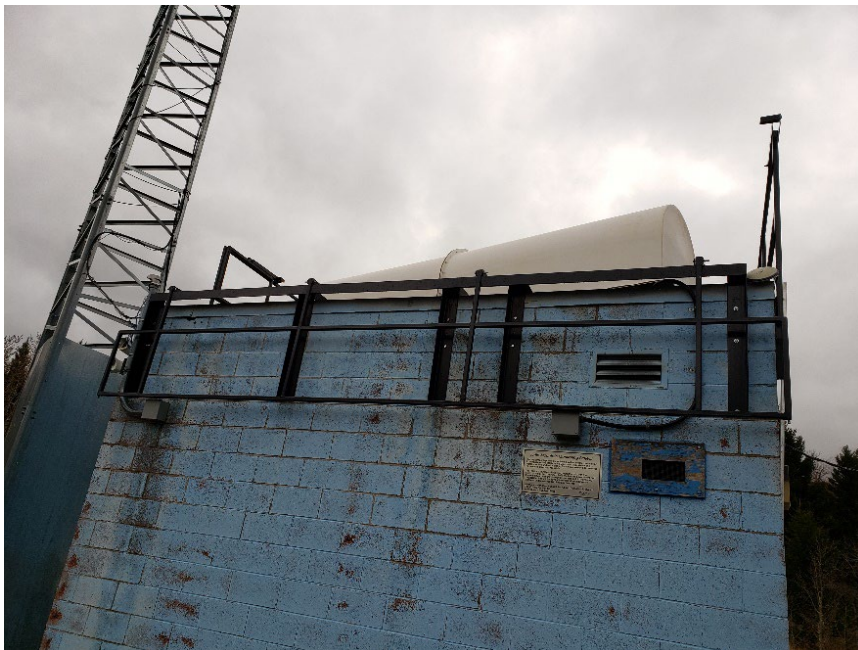
Figure 5. Front hand railing in the open position at the Bellevue pump house (Turtle Mountain, Alberta) so the railing does not interfere with LiSAMobile readings.

In March 2020, the AGS had metal hand railings installed around the roof of the pump house to ensure the safety of its staff and other workers. The railings on both sides and the back of the building are fixed in place, with an opening designed for access to the roof. The railing at the front can be folded down against the front wall while LiSAMobile is in operation to avoid interfering with its radar signals (Figure 5). The railing is folded up and locked to the side railings during the repairs and maintenance of LiSAMobile.

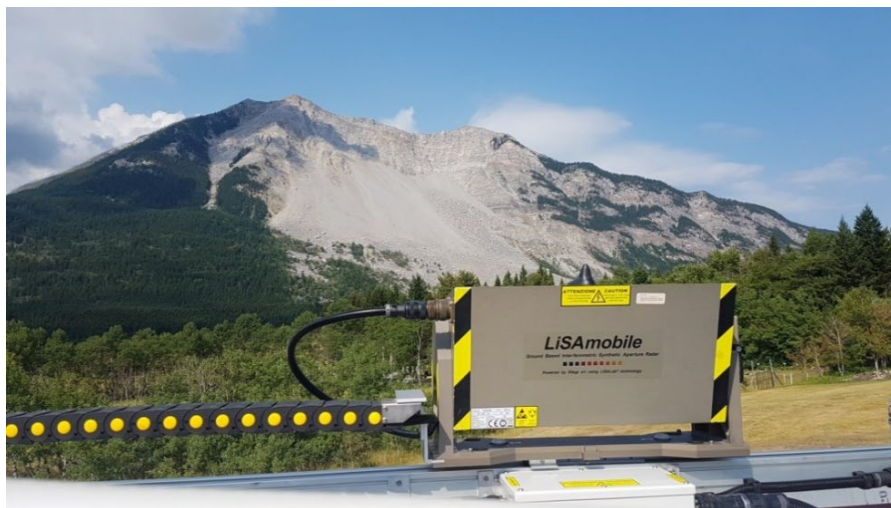
Figure 6. LiSAmobile system without radome (housing structure), Turtle Mountain, Alberta.

LiSAmobile was installed at the Bellevue pump house in June 2014 to monitor small displacements on the eastern face of Turtle Mountain. The LiSAmobile GB-InSAR (Figure 6) uses the InSAR technique to measure small displacements at each point on the surface of the mountain. For additional information, refer to Wood et al. (2016).
