**Turtle Mountain Field  
Laboratory, Alberta (NTS 82G):  
2017 Data and Activity  
Summary**

**AER/AGS Open File Report 2018-12**

D.E. Wood, D.K. Chao, J.A. Yusifbayov and T.C. Shipman

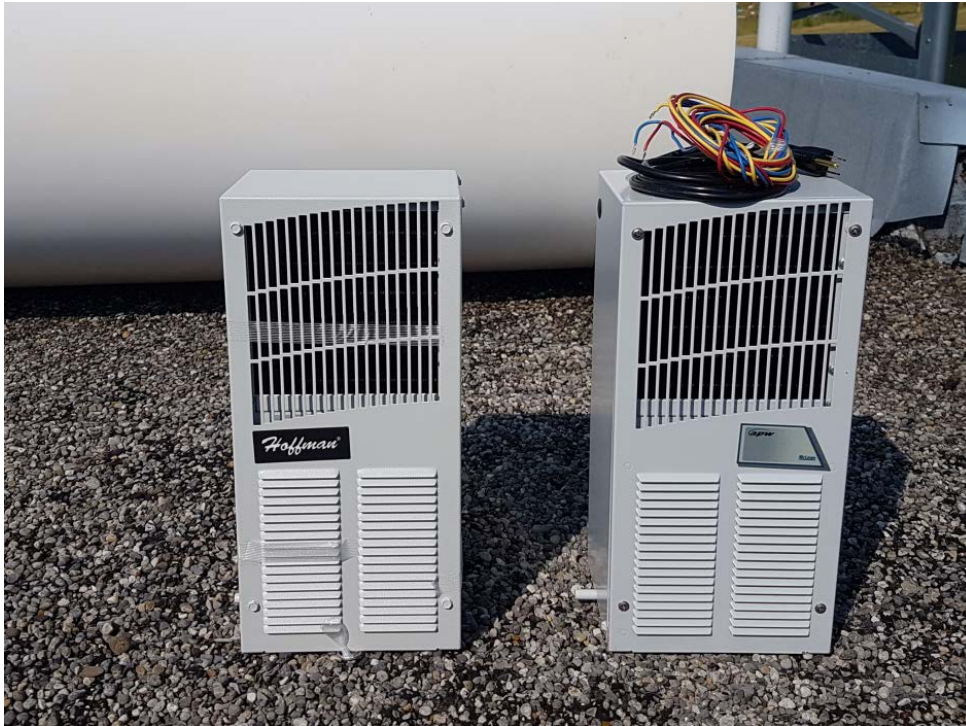
**Figure 2. Replacement of temperature control unit during annual LiSAmobile maintenance conducted by an Ellegi engineer.**

In 2017, an annual maintenance campaign was conducted in mid-July that included a joint-team from Ellegi and the AGS. The field maintenance objectives included

- inspection of the radome for any structural or waterproofing issues,
- examination of all power and communication cables,
- replacement of a temperature control unit,
- mechanical maintenance on the radar head with lubrication of moving parts,
- internal radome cover and gasket checks,
- power box inspection,
- dust and lubrication of drive belt and instrument components,
- replacement of various filters,
- radio frequency evaluation, and
- mechanical shut-down and restart testing.

During the site maintenance, the LiSAmobile radome was inspected for signs of physical damage, structural deterioration, and water leak exposure. The radome protects LiSAmobile from significant fluctuations in precipitation and temperatures that are typical throughout the year in the Crowsnest Pass, Alberta. These exposures include high and low temperatures during summer and winter, high wind gusts, and heavy precipitation events. The inspection revealed the radome had continued to withstand all the environmental factors and protected the LiSAmobile system efficiently as designed.

The belt and motor that drives LiSAmobile were cleaned, lubricated, and inspected for signs of deterioration, as it has been in continuous motion since 2014. Inspection of the belt system showed little sign of wear, and the motor was in good operating condition. The temperature controller was replaced during the site visit with an updated model for preventative maintenance (Figure 2). Since its replacement, the unit has been performing optimally with no issues. The annual field maintenance for LiSAmobile found no problems with the system and only preventative maintenance was completed.

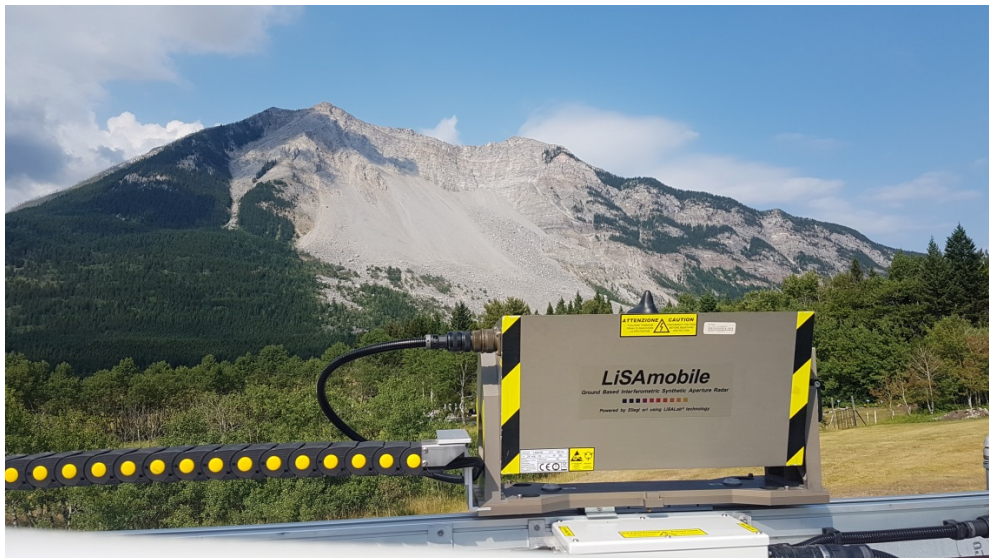
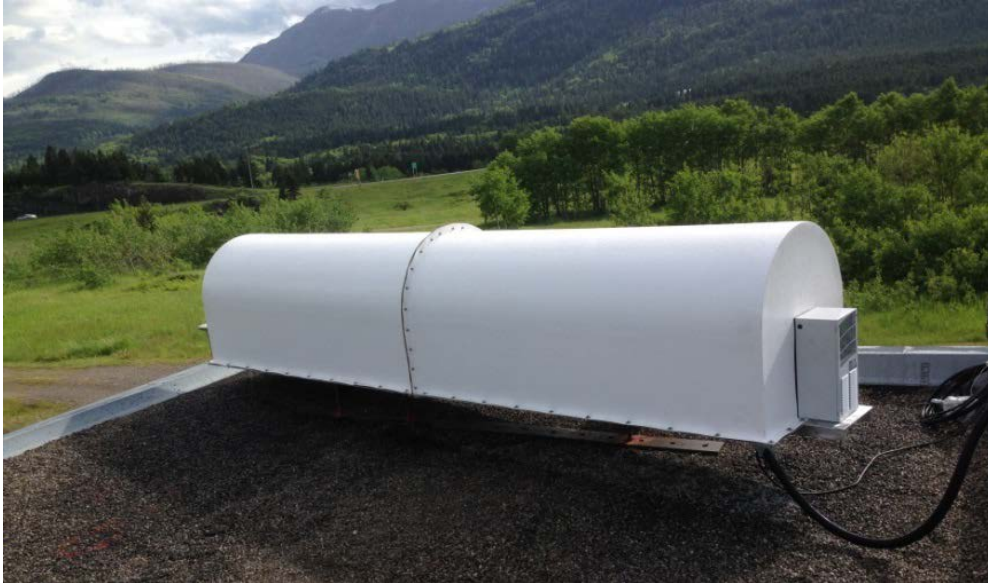
Figure 3. (a) LiSAMobile system without radome and temperature regulation unit; (b) LiSAMobile system completely assembled (Photo courtesy of Ellegi).

The LiSAmobile system was leased to AGS and installed in June 2014 (Figure 3). Additional documentation on the feasibility study, service contract, fabrication of supporting materials, LiSAmobile installation, and initial system calibration is included in Wood et al. (2016).

LiSAmobile continued to provide high-quality data throughout 2017 with little to no interruption. The innovative radome structure (Figure 3) continued to perform as expected and protected the equipment from harsh environmental factors. The internet service provider lost the connection between LiSAmobile and its network communication a couple of times during the year. Data collected during these disruptions was temporarily stored on local storage and transmitted once the internet connection was re-established; therefore, no displacement data were lost. The internet service plan was updated in 2017.

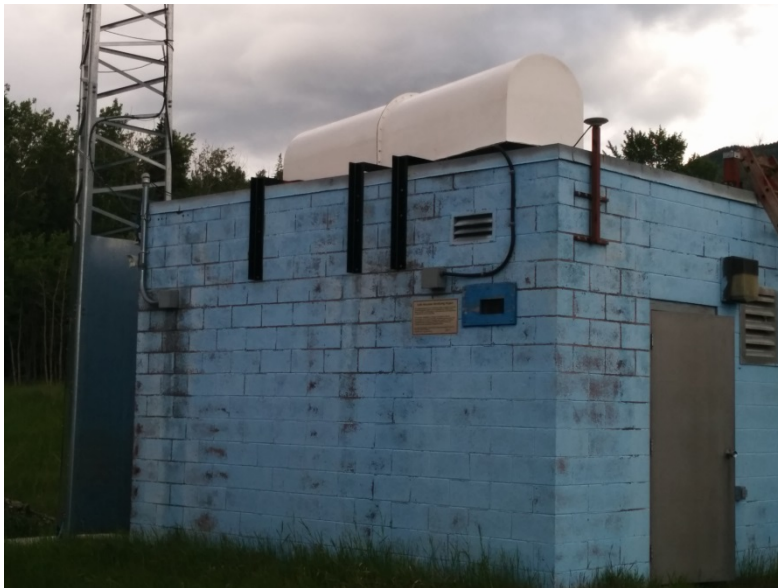
Figure 4. LiSAMobile system at the Bellevue pump house station.

LiSAMobile was installed at the Bellevue pump house (Figure 4) in June 2014 to monitor small displacements on the eastern face of Turtle Mountain. The LiSAMobile uses the interferometric synthetic aperture radar technique to measure small displacements at each point on the surface of the mountain (Figure 5).
