Turtle Mountain Field Laboratory, Alberta (NTS 82G): 2014 Data and Activity Summary

AER/AGS Open File Report 2015-10

D.E.Wood, D.K. Chao and T.C. Shipman

February 2016

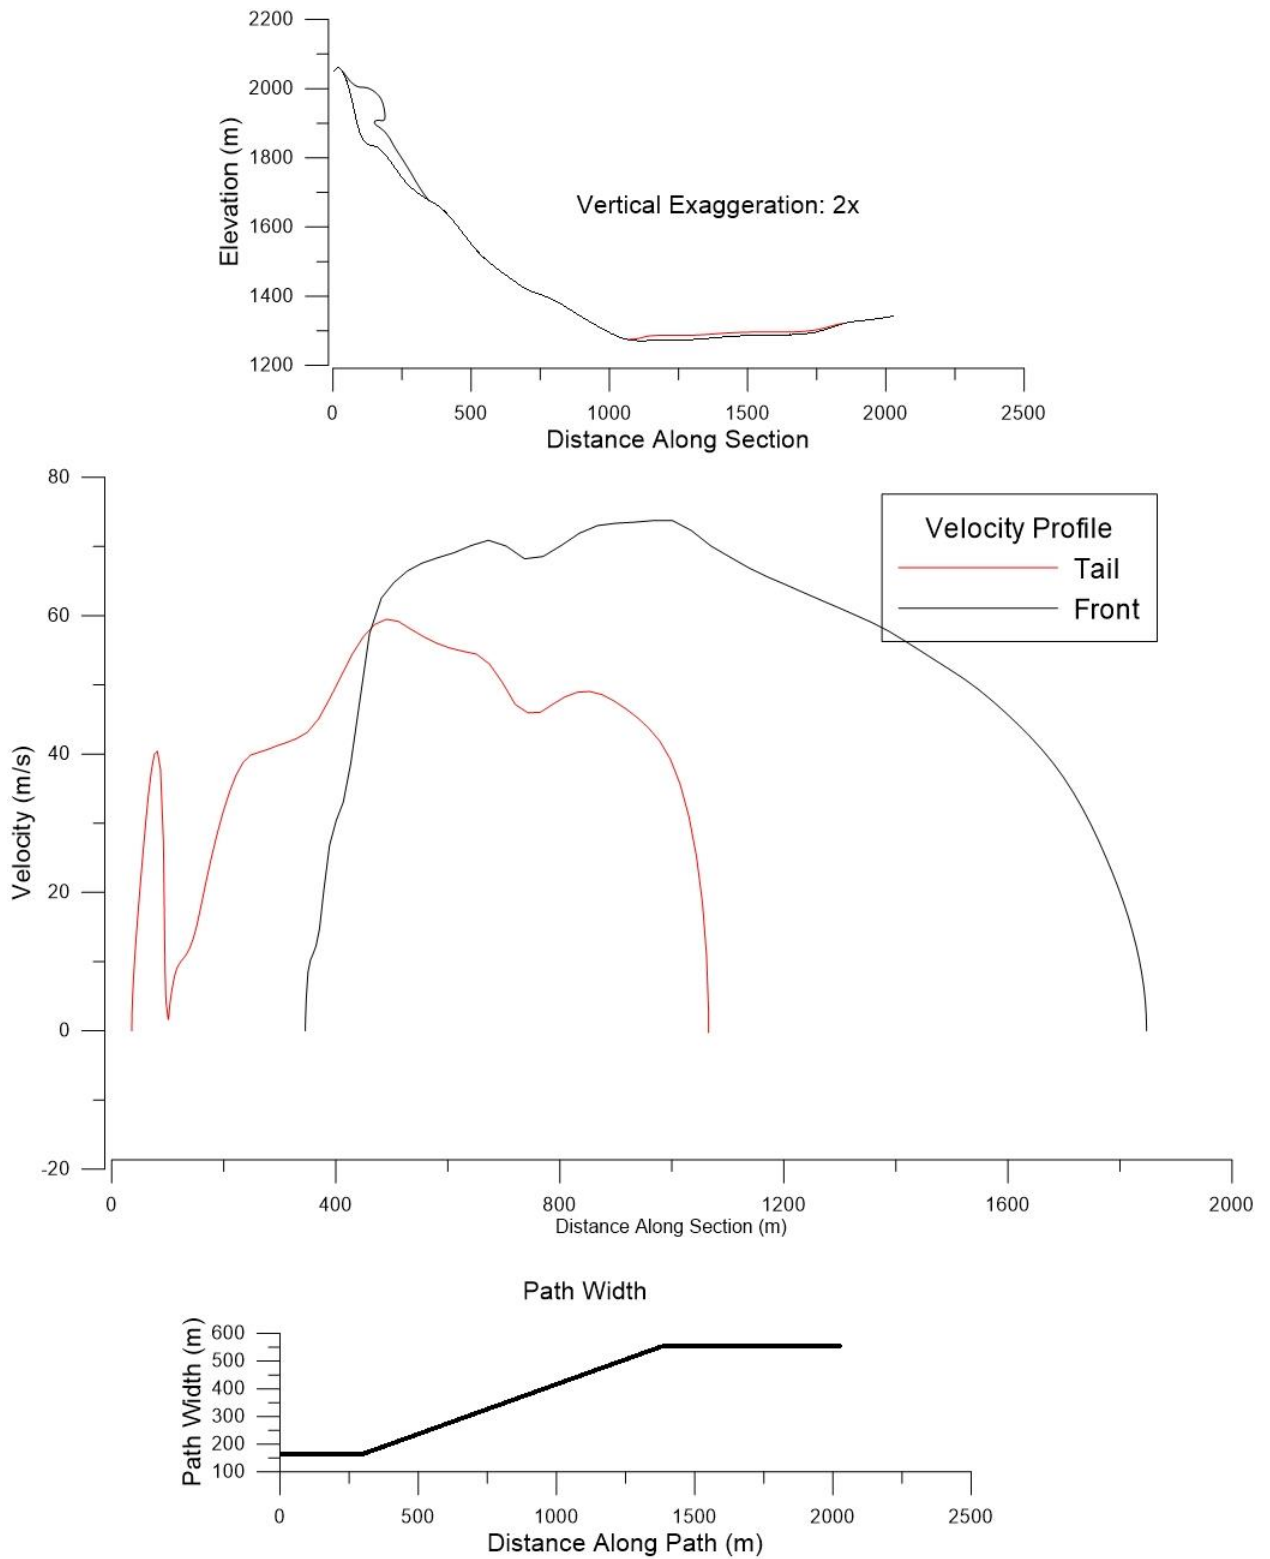
Figure 12
 Dan-W prediction for the frictional rheology with a friction angle of 20° .

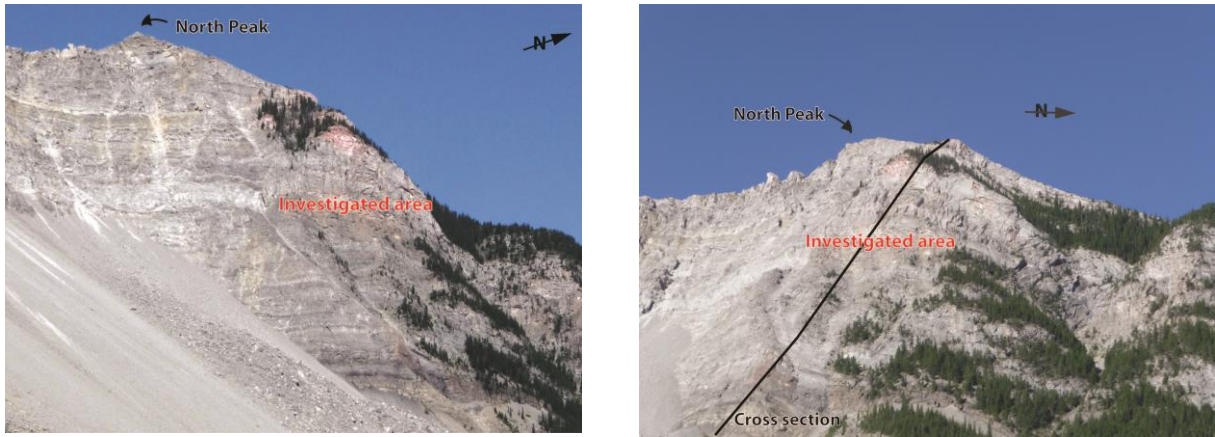
The later provides a slope stability analysis of the rocky spur located at the NE of North Peak, in Turtle Mountain (Figs. 1 and 2). In particular it aims at 1) understanding the rock mass structure and the kinematic behaviours and 2) to highlight the volume of a potential rock failure event and its failure mechanism.

This sector un-monitored by in-situ devices has been noticed as potentially unstable and investigated more in details during summer 2011 field survey (Florian Humair, Michel Jaboyedoff and Andrea Pedrazzini). Recent Ground-Based InSAR acquisition performed by the AGS demonstrated signs of activity at the base of this zone (Jamie Warren and Jill Pearse from the AGS).

Figure 2: Views of the investigated zone and Section 1.

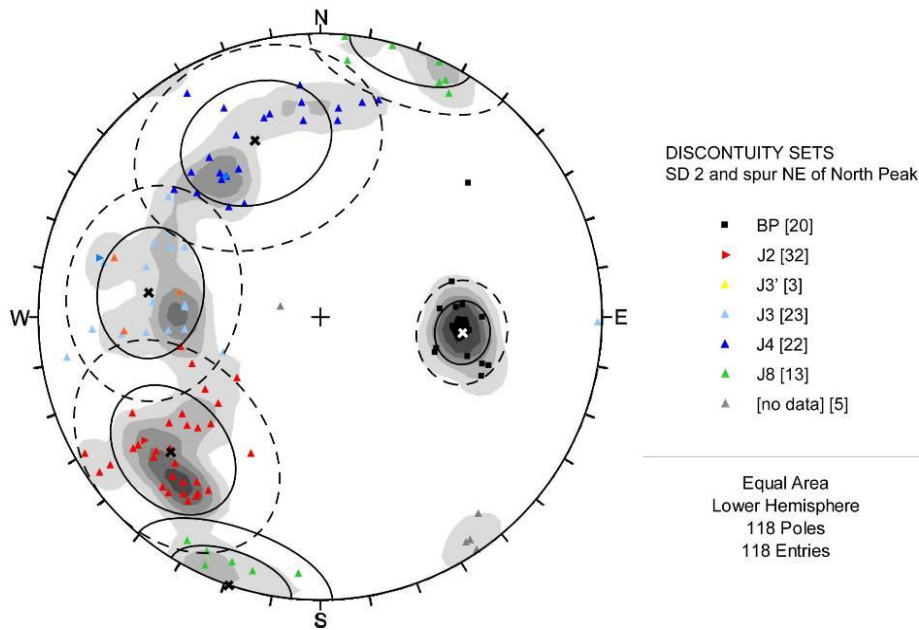
Figure 3: Pole representation of the discontinuities in North Peak area in equal area, lower hemisphere. The variability one sigma (full black ellipses) and two sigma (dashed black ellipses) are displayed.

Five main sets of discontinuity are revealed in North Peak area (Fig. 3 and Table 1): Bedding (BP), J2, J3/J3', J4 and J8 (Pedrazzini et al., 2011; Humair et al., 2013).

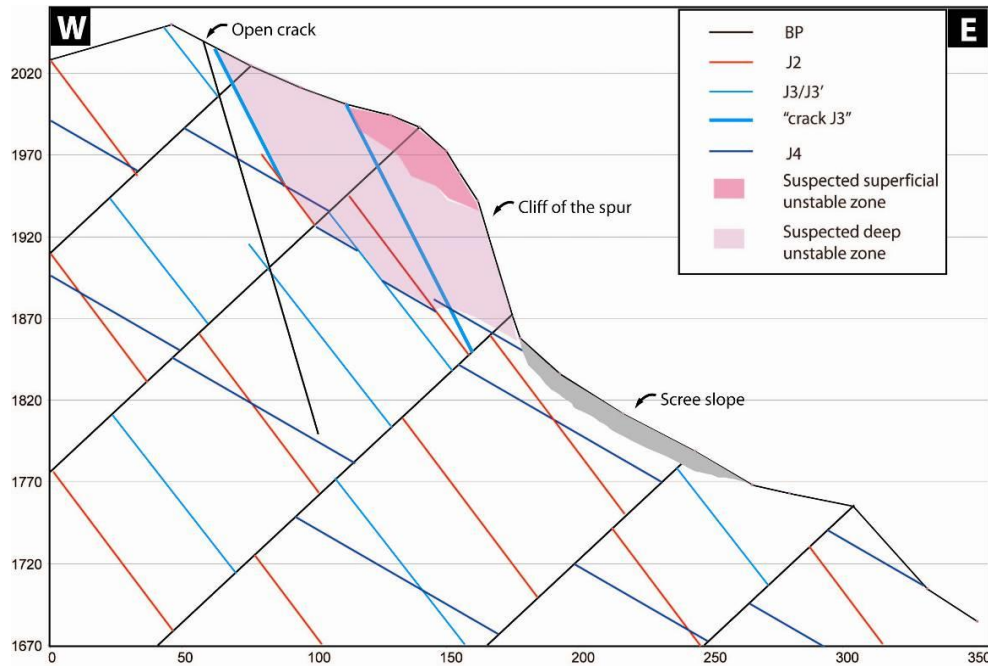
Figure 5: Conceptual model of the profile used for UDEC modelling (un-scaled). The traces of the discontinuities are shown as well as the suspected unstable areas (deduced from field observations). As J8 is parallel to the profile, it is not represented in the profile. This set has no kinematic relevance in 2D and is considered as lateral release surface.

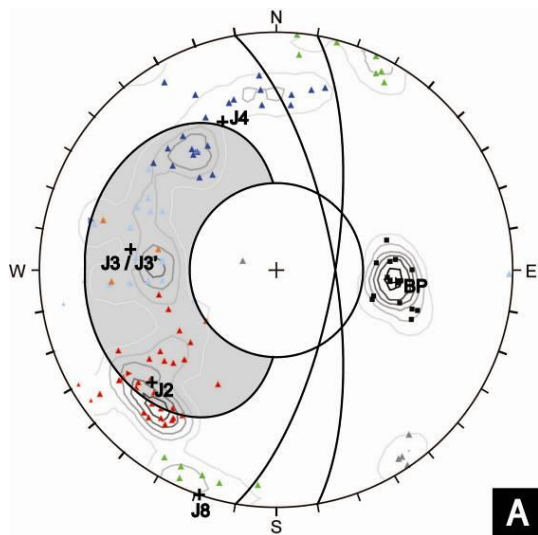
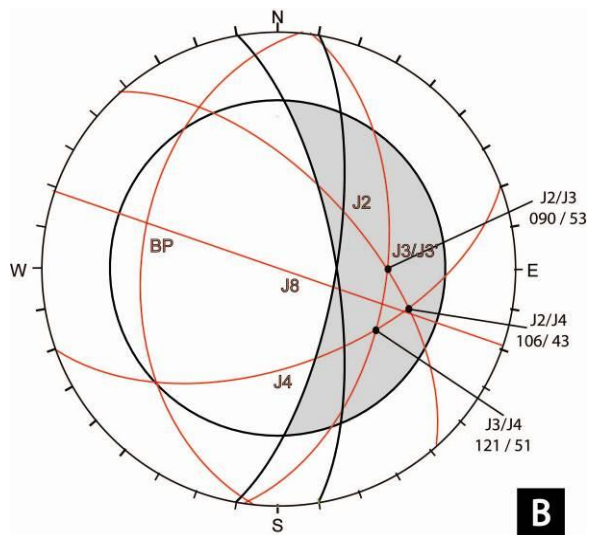
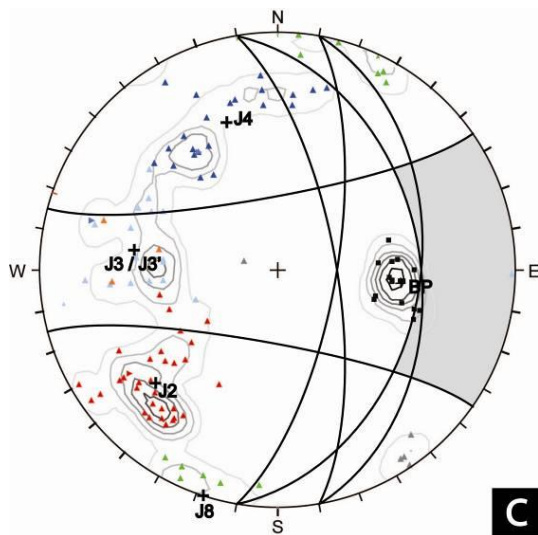
- Planar sliding along J2, J3/J3' and J4 are possible (Fig. 6A).
- Wedge sliding is possible along intersection lines J2^J3, J2^J4 and J3^J4 (Fig. 6B). Theoretically, wedge sliding can also occur between J2^J8, J3^J8 and J4^J8. However, due to the steepness of J8, the failure would more likely correspond to a planar sliding on either J2, J3/J3' or J4, laterally constrained by J8. J8 is thus considered as a lateral limit that allows the lateral delimitation of the sliding blocks.
- Block toppling across BP cannot be excluded especially when regarding the high persistence and close spacing of this discontinuity set.
- Overhanging failure mechanism along BP is also likely to mobilize small volumes (not demonstrated using stereographic technique).

Figure 6: Kinematic analysis in equal area, lower hemisphere. Two topographies (080/70 and 100/70) are taken into account (black traces). A) Potential planar sliding on J2, J3 and J4. B) Potential wedge sliding on $J2^J3$, $J2^J4$ and $J3^J4$. C) Toppling mechanism seems unlikely.

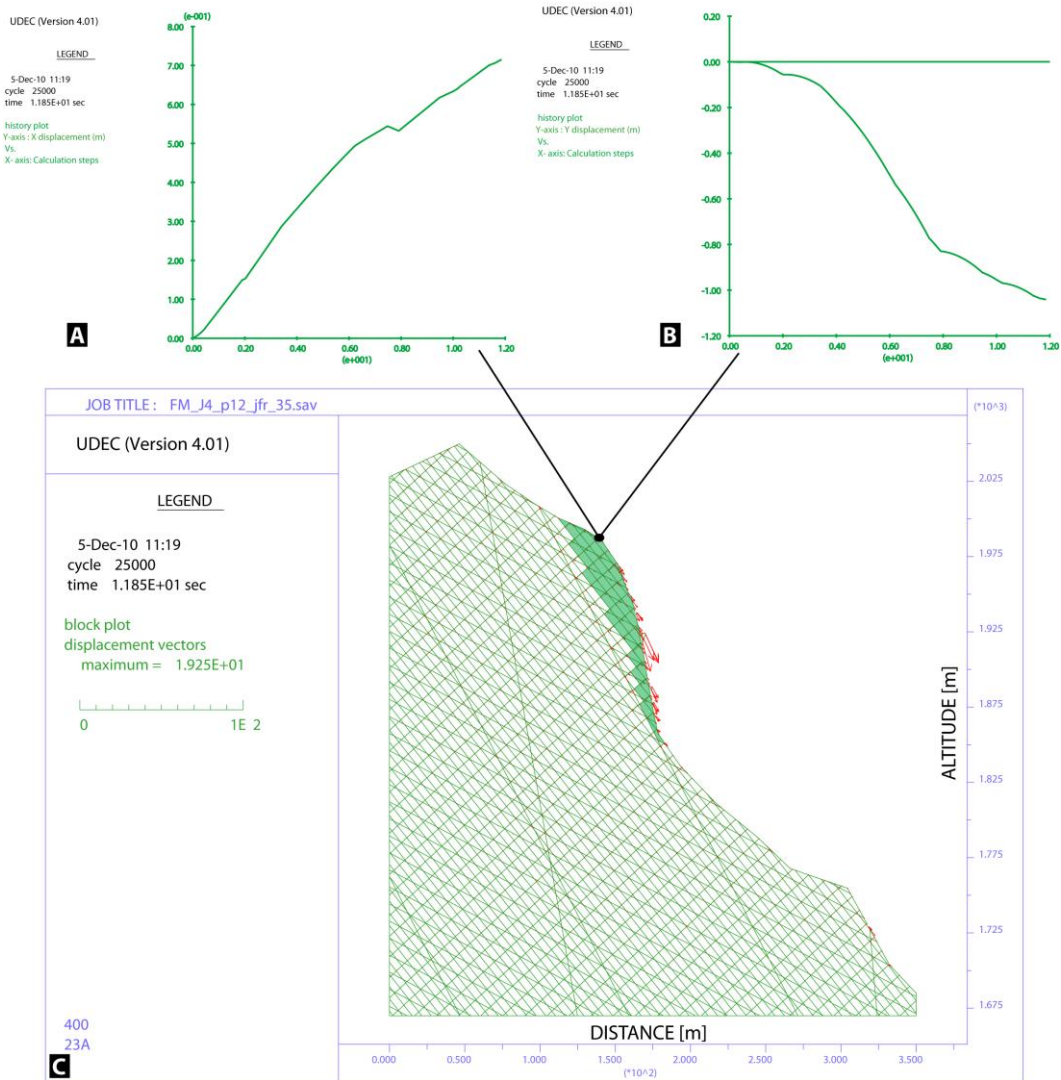
The potential failure surface and displacement deduced from respectively the most optimistic and the most conservative models are shown in figures 7 and 8 (i.e. *FM2_J4_p12_jfr_35.sav* and *FM5_J4_p50_jfr_30.sav*).

Figure 7: UDEC window for model FM2_J4_p12_jfr_35.sav. A) and B) displacements along X and Y axis at 140m/1985m on the profile. C) Calculated displacements (red arrows) and expected failure surface (green). Step-path sliding along J2, J3/J3' is highlighted by the displacement vectors as well as toppling failure mechanism across BP (Section 3).

Toppling failure mechanism across BP has also been highlighted by models (Figure 7). According to the models, this mechanism appears to be limited to some blocks only and does not involve the whole unstable zone. Hence, this failure mechanism cannot be totally excluded.

Overhanging failure mechanism is also pointed out, but it is likely to involve only rockfalls of the rockface (Figures 7 and 12).

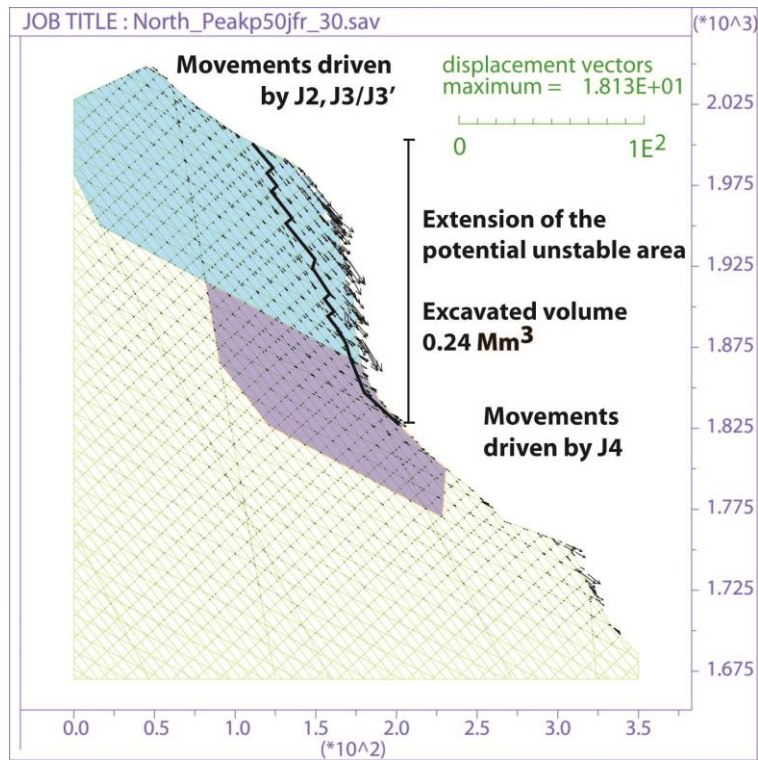
Figure 8: UDEC window for model FM5_J4_p50_jfr_30.sav showing the calculated displacements (black arrows), the expected failure surface (black line) and the control on movements. Movements driven by step-path sliding - subsidence along joint sets J2 and J3/J3' at the top of the cliff and by set J4 at the base of the cliff. Modified after Froese et al. 2012.

The failure mechanism deduced from kinematic analysis (Chapter 3) is in good agreement with the numerical analysis. Indeed, when all discontinuity sets are included in the model, the potential **failure mechanism** can be described as a **bi-planar sliding** (Figure 8, 10 and 11) (Brideau and Stead, 2012; Fisher, 2009; Fisher and Eberhardt, 2012; Hoek, 2000):

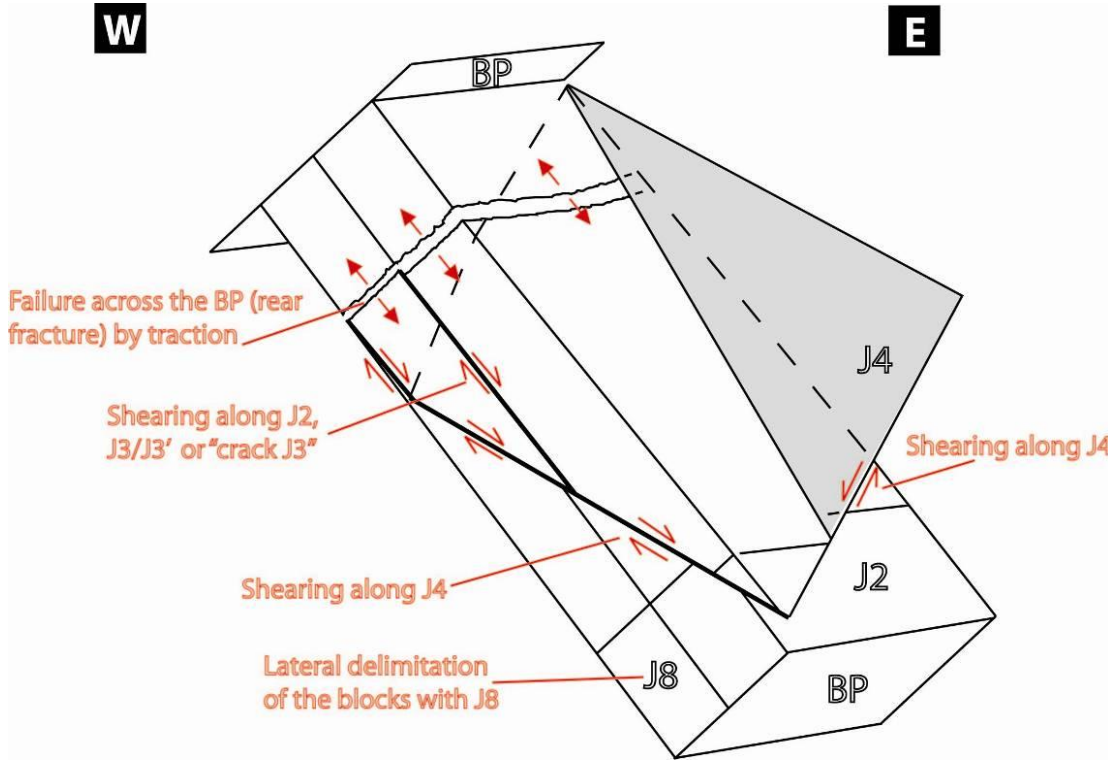
As a consequence, the bi-planar sliding seems to be the most appropriate mechanism contributing to the destabilization of the spur along with potential toppling in a minor extent.

Figure 10: Schematic representation of the suspected failure mechanism with bi planar failure on J2 (or J3/J3' or "crack J3") and J4. The rear release is permit by opening across the BP and the blocks are laterally delimited by J8.

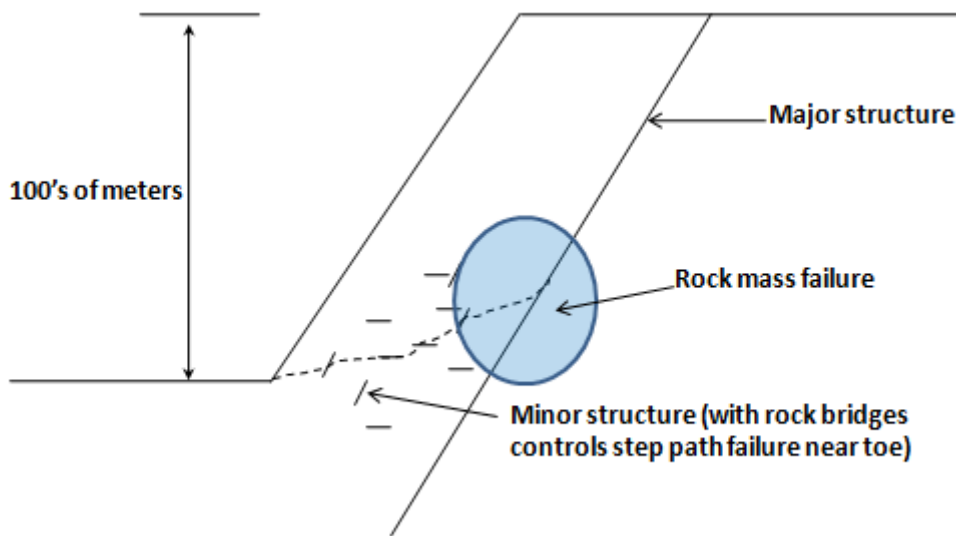
Figure 11: Illustration of a complex slope failure described as a bi-planar failure (After Hoek, 2000 in Fisher, 2009). The active portion of the slide (bounded by a major structure) moves down leading to a rock mass damage zone. The presence of minor non persistent structure allow step-path failure at the toe of the slide.

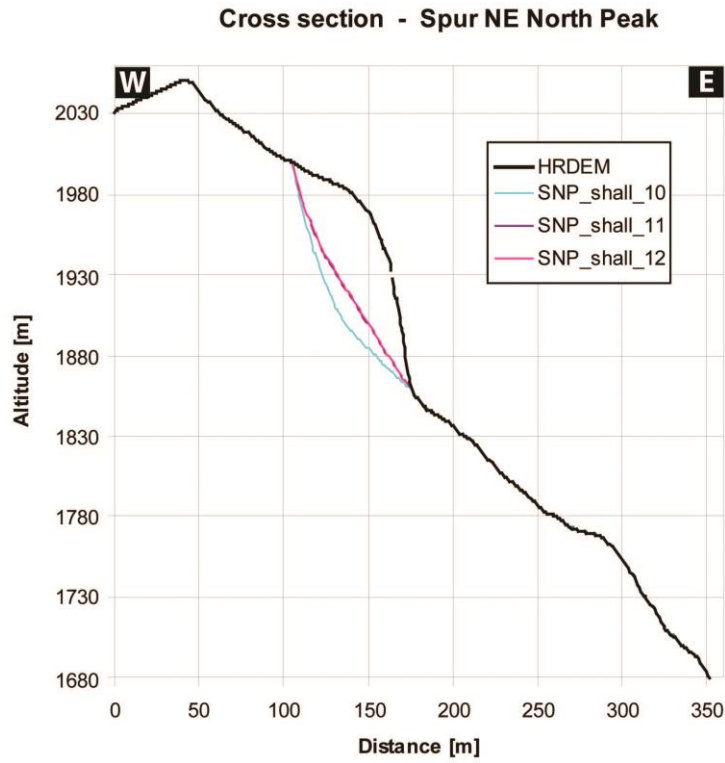
The results give volumes comprised in a range **between 0.183 and 0.249 Mm³** and the maximal vertical depth of the failure surface reached 70 to 88.1 m (Table 6). The three selected models display a steep concave surface failure in the rear of the spur, with a progressive flattening when approaching the basal boundary of the mobile zone.

Figures 13 and 14 respectively display cross section (of all three models) and visualisation of the SLBL calculation with a post-failure morphology (*model SNP_shall_11*).

Figure 13: Cross section of the spur showing the shape in 2D of the failure surfaces for the shallow instability calculated using the SLBL method.

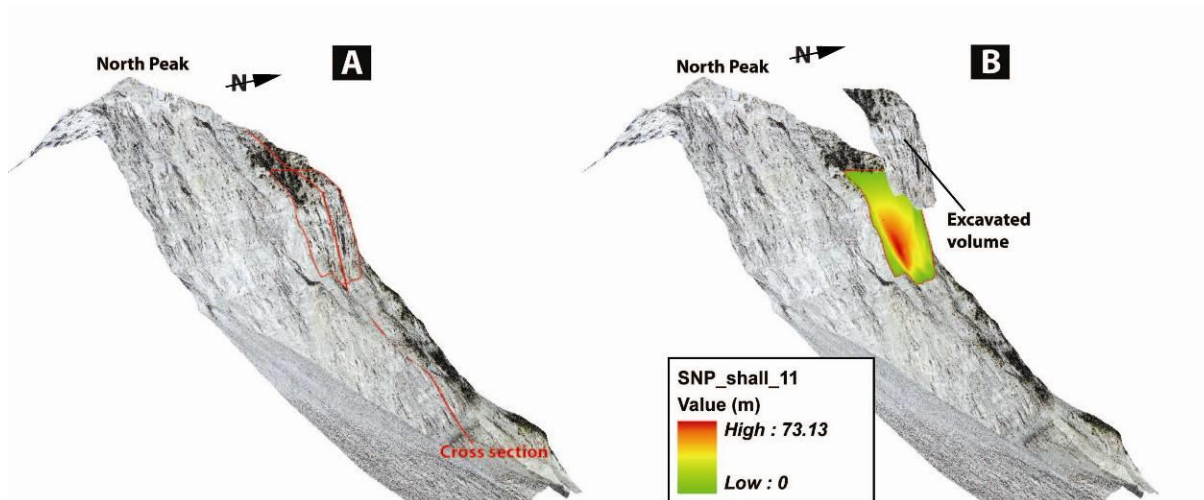
Figure 14: A) View looking the investigated area where the cross section and the extent of the unstable zone are shown in red. B) Representation of the result of the SLBL calculation for the model SNP_shall_11 outlining the depth of the failure surface.

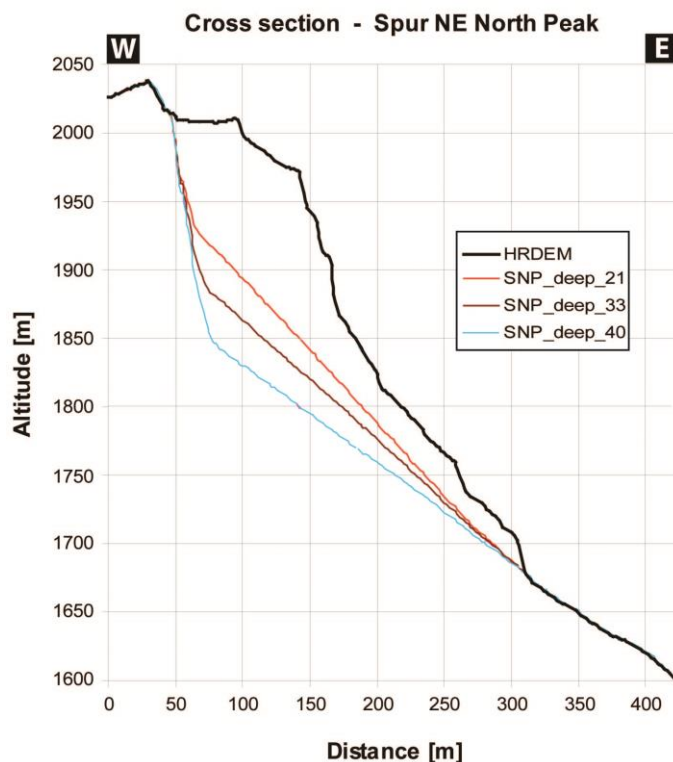
Figure 15: Cross section of the spur showing the shape in 2D of the failure surfaces for the deep instability calculated using the SLBL method.

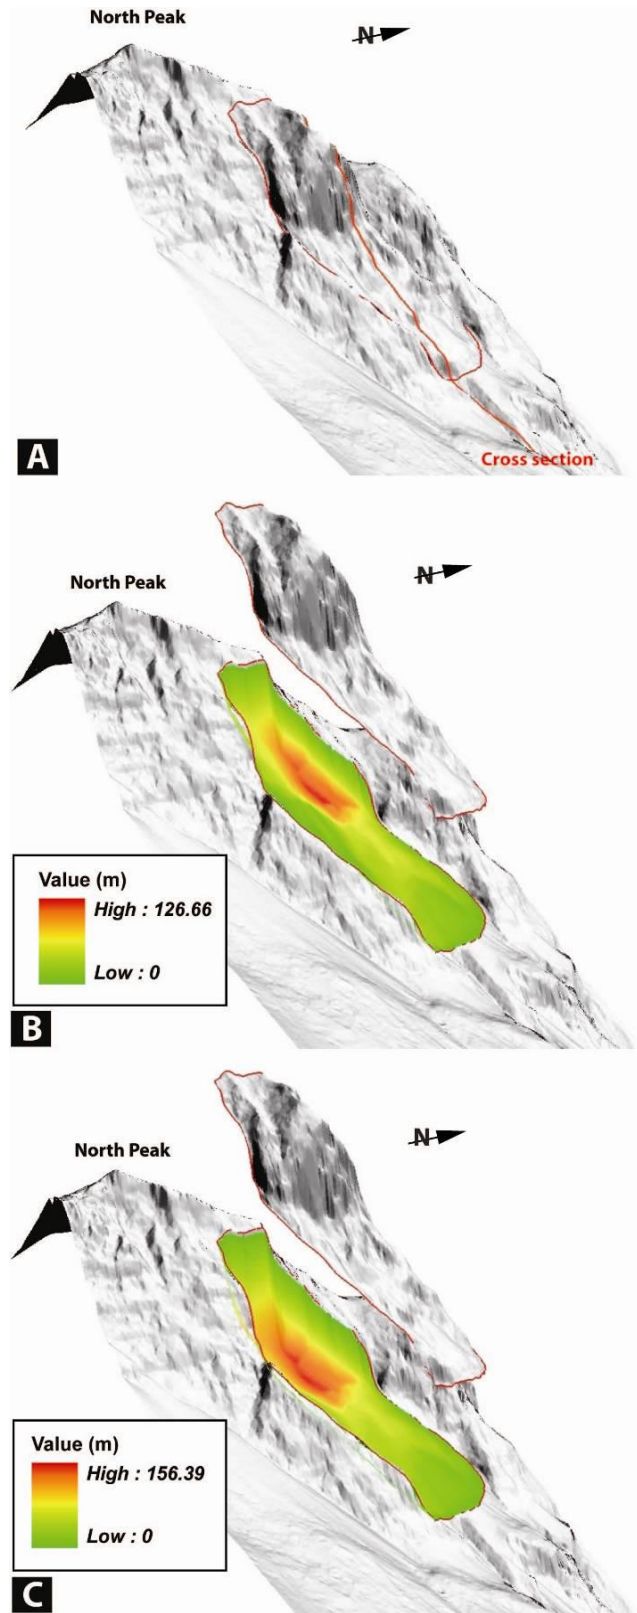
Figure 16 presents the visualisation of the SLBL calculation for models SNP_deep_21 and 33 and display a post-failure morphology which is quite satisfying, when compared with the topography of the saddle area cliff (between North Peak and South Peak).

Figure 16: A) View looking the investigated area where the cross section and the extent of the unstable zone are shown in red. B) and C) Representation of the result of the SLBL calculation for the model SNP_deep_21 (B) and SNP_deep_33 (C) outlining the depth of the failure surface.

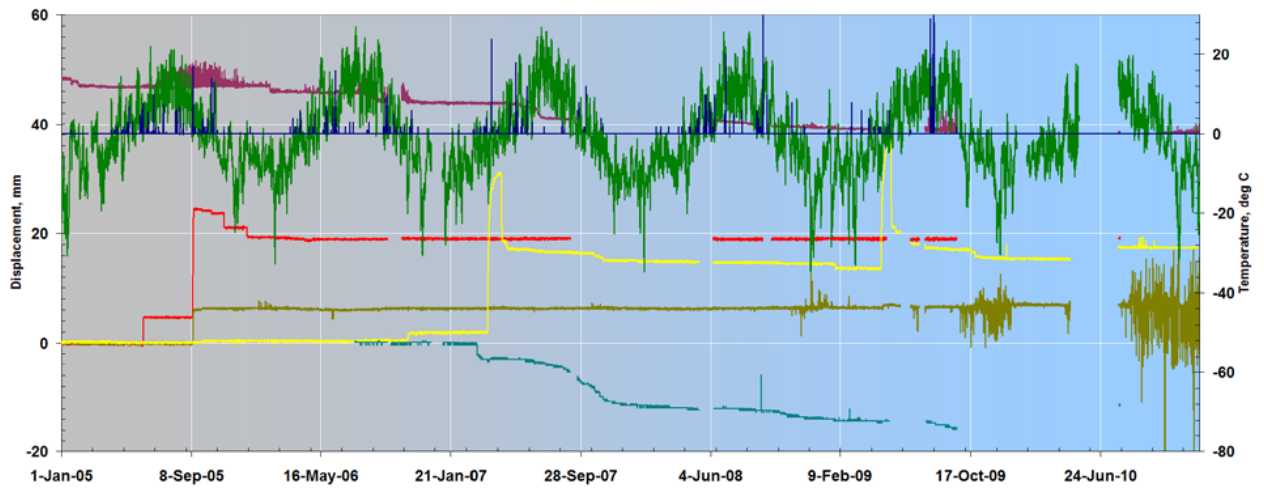
Since 1903, various types of measurement devices have been used at the Frank Slide to measure the displacement of rock masses with the most significant effort taking place since 2003 (Froese et al. 2009). Movements have been analyzed in detail by Froese et al. (2009). The longest set of measurements is provided by a series of control points positioned and identified on large scale aerial photographs for displacement computation ranging from 1985 to 2005. These analyses give a displacement rate ranging from 0.9 to 3.2 mm/year. Local crackmeters have indicated movement of order at 1 mm per year (Figure 2).

Figure 2. (Figure 10 of AGS OFR 2010 (2012-03)).

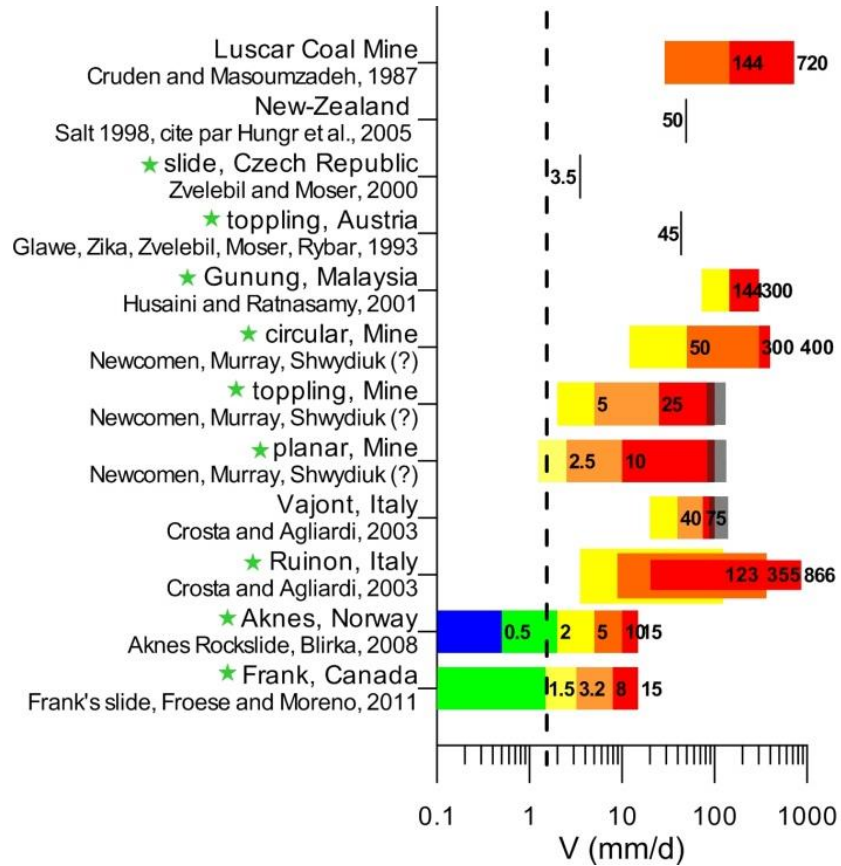
It is known that increasing acceleration of movements can be observed several weeks and months before an actual event. A compilation of known rate of movements for various slides around the World is shown in Figure 3 and 4, together with the threshold values proposed for the Åknes rockslide in Norway and Turtle Mountain. The rate of movement indicative of a 'yellow' alert is in the two proposals suggested to be of 1.5 mm/day, i.e. c. 450 mm/year.

Figure 3. Different values of velocity criteria threshold for warning system found in literature. Colors have been adapted for this figure (some authors did not associate values with colors; from Locat et al. 2013).

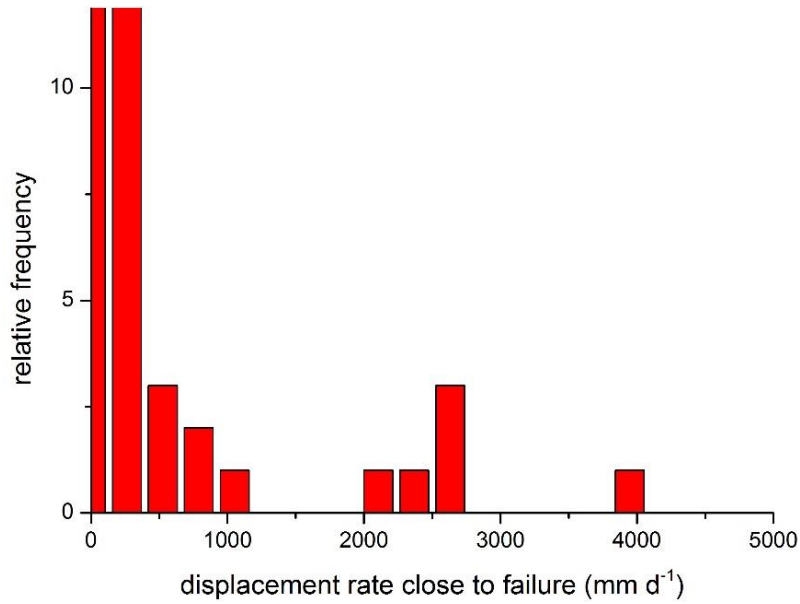
Figure 4. Histogram of relative frequency of displacement rate values close to the catastrophic collapse for a sample of 53 historical events (Crosta et al., 2013).
