Hydrogeological Field Notes by Dr. József Tóth 1964–1969 Central and Southern Alberta

J. Tóth¹

Tóth, J. (2014): Hydrogeological field notes by Dr. József Tóth 1964–1969 central and southern Alberta; S.A. Stewart (comp.), Alberta Energy Regulator, AER/AGS Information Series 143, 140 p.

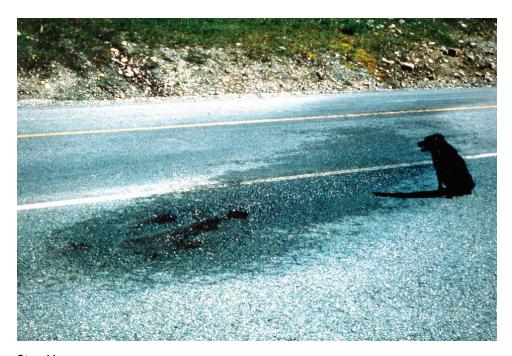
Stop 14

Water flows perceptibly through black top pavement over an area of approx. 5×4 ft. Top $\frac{1}{2} - 1$ inch portion of pavement broken off and removed. Cracks in pavement within 5-6 m from spring are kept moist. Road bank on north side of road displays very strong seeps, with moss, and actively discharging water.

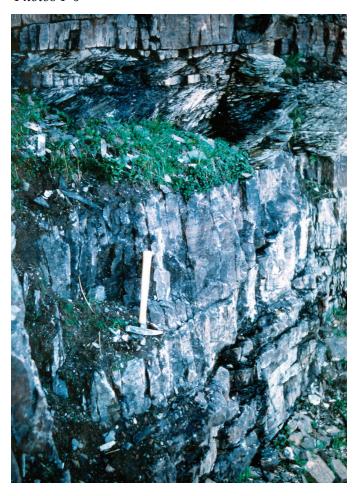
Stop 19-1

<u>Photo 1</u>: Seepages (at visible rates) through (a) vertical fractures of thick sandstone bed; (b) bedding planes, of sandstone beds and thin shale beds, and (c) cleavage in the thin bedded shales. On sandstone ledge (with hammer) vegetation starting due to continuous moisture supply.

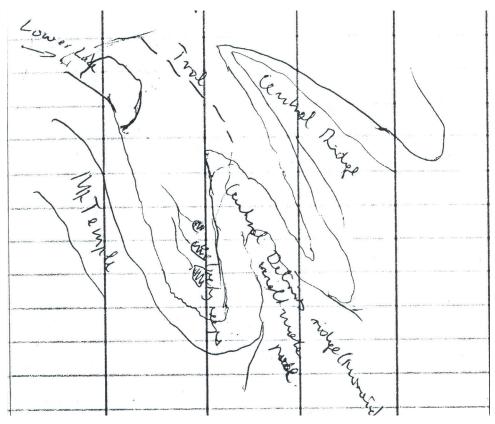
Sketch - stop 19

(Water Samples: rock wall seep, velvet seeps, melt water pool)

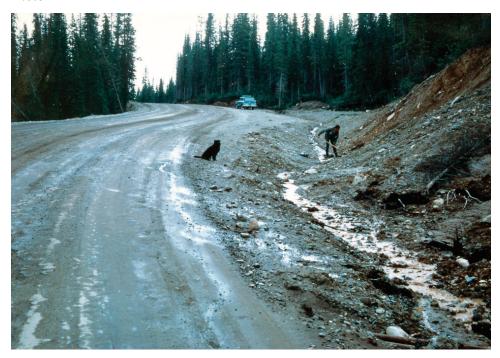
Stop 25-11

<u>Photo:</u> Caving till road bank, collecting seep water in ditch, groundwater bubbling up through road top forming rivulet in surface, drain pipes sticking out from under the road surface, bad road top due impossibility of black surface, steepness of the valley indicating mountain side position of seepage area. (Plant specimens collected)

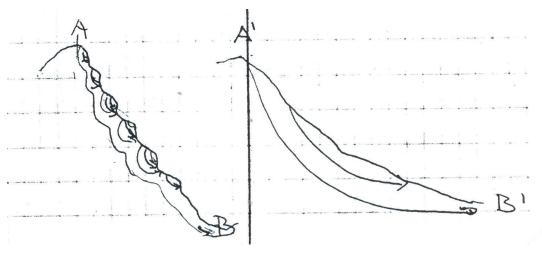
Sketch – stop 25

(1) One difference between the groundwater regimes in areas of highly accentuated topography and those with less pronounced one is that the flow systems are shorter in the former one and they may surface several times on one and the same slope (mountain side) while only one system would form in a corresponding, less steep area:

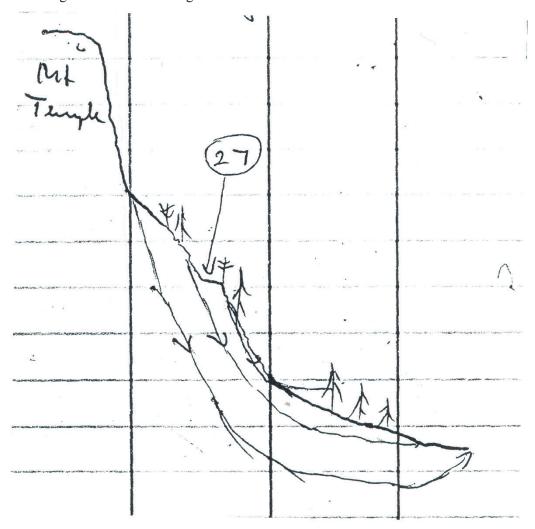
Sketch - stop 27, sk. 1

This phenomenon may <u>perhaps</u> be explained by the nearness of a protruding ridge of Mt. Temple, rendering this stretch a recharge or midline area:

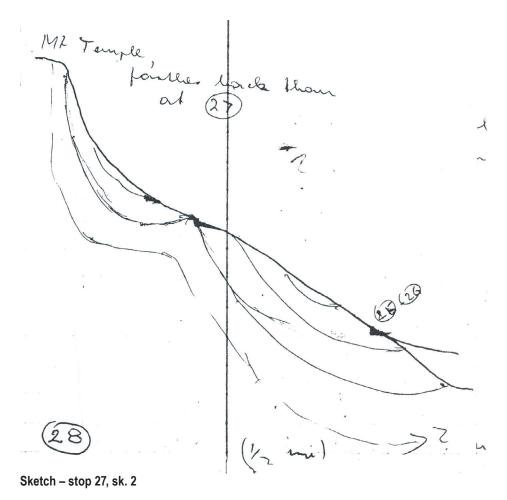
This possibility would contrast to the seepage areas of 25 and 26, where the following situation may be hypothesized:

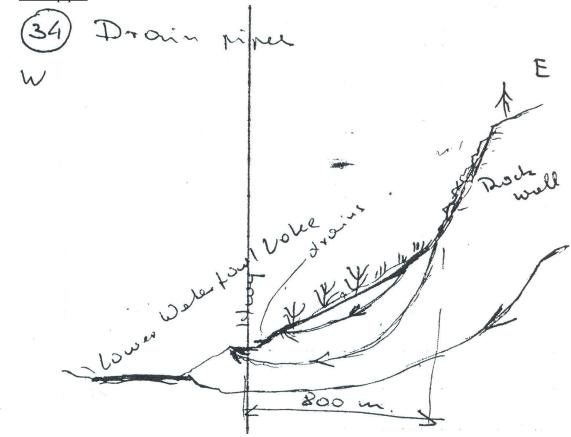
Sketch - stop 34

Drain pipes in high (8 m) gravel road bank. Steep scree slope behind it, which is flanked by steep rock wall farther east. Slumping in gravel bank.

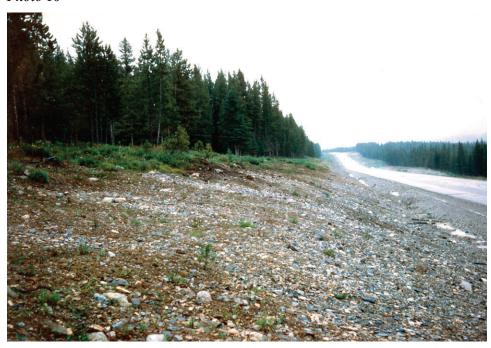
Stop 35-16

Photo: green discharge area; bank edge recharge; pipe discharge

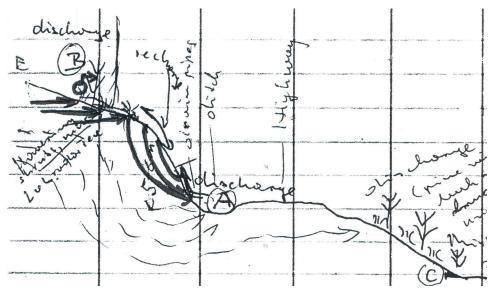
Sketch - stop 35

Total estimated discharge of 7 pipes: 12 gpm Individual discharges range 0.01 to 6 gpm.

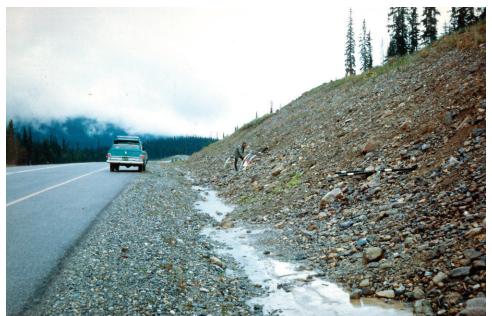
Stop 37-18

Photo: drain pipes in gravel bank discharge rate measurement.

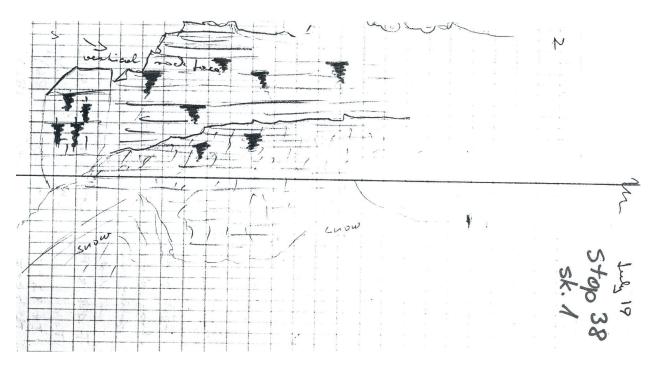
Sketch - stop 38, sk. 1

Photo: seepage out of vertical sheer rock face through bedding planes and fractures. (left-hand side portion of diagram)

This water may infiltrate just on the top of the rock cliff from snow melt and rain; may be regarded as the "first system" in the mountains.

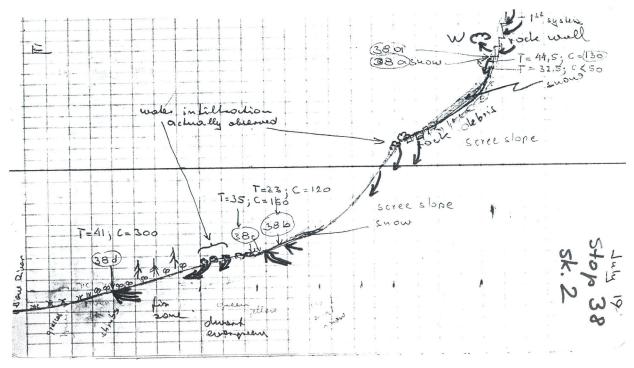
Sketch - stop 38, sk. 2

38c <u>Circular depression</u> in steep mountain side, with permanent looking seepage. Algae, velvety, moss, various broad leaf moisture loving flowers, dwarf evergreens.

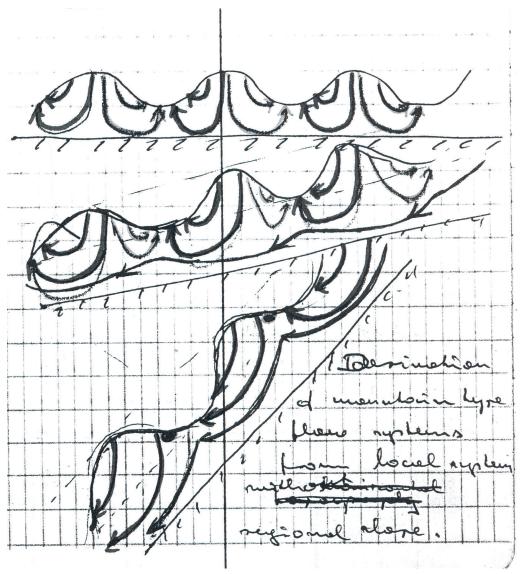
Sketch - stop 38, sk. 3

38d Seepage in circular depression out in the shrub zone but still approx 15 – 20 m above the valley floor. Mosses, "silver willow", Juncus indicate permanent discharge of water at this point. From the upslope end of the fir zone, towards the down slope end of it the dampness of the ground perceptibly increasing, which is seen by the increasing thickness of moss cover, the increasing density of phreatophytes, and the appearance of seeps or seep-depressions. Discharge (estimated from memory): at least 100 gpm.

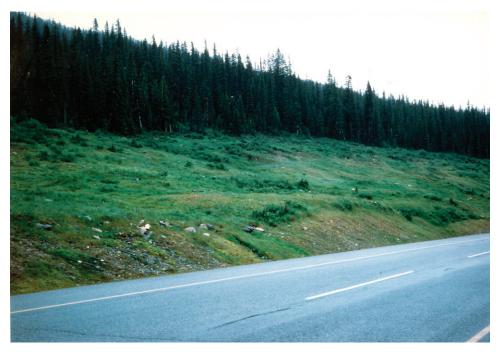
Stop 39-35

Photo: seepages, drain pipes, slumps along Highway 93, in road bank opposite to Bow Lake

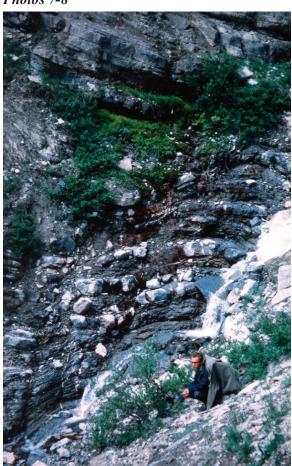
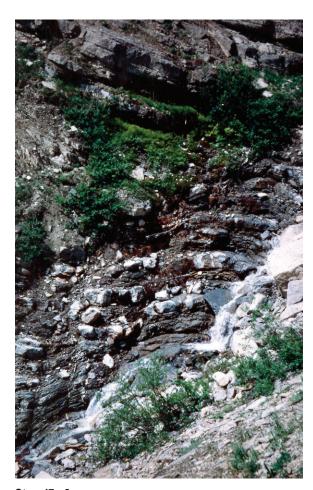
Stop 47c-7 Stop 47c-8

<u>Photo</u> (2) [one with, the other without Richard Stein squatting]: Water is issuing through fractures between two major fractures, and through bedding planes. Mosses, horse tail, shrubs indicate moisture. Calcite veins, iron oxide coating.

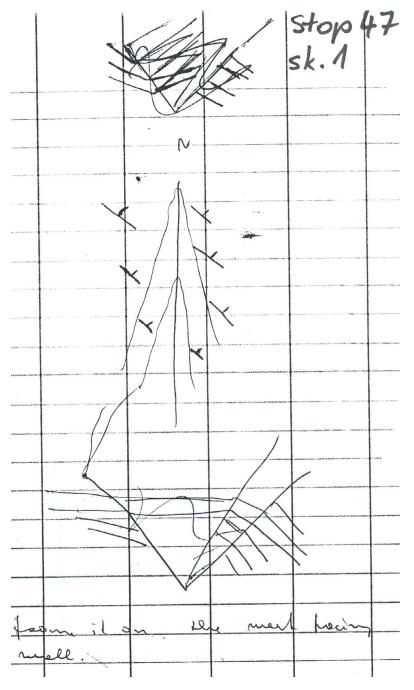
Sketch - stop 47, sk. 1

This is probably due to the fact that the beds are dipping toward the ravine on the east facing, and away from it on the west facing wall.

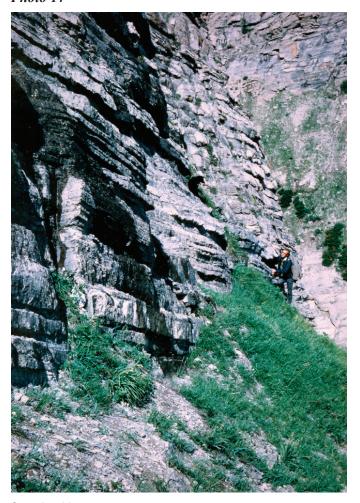
Stop 47e-14

<u>Photo</u>: Upper boundary of grassy slope; grass is very lush despite thin, almost nonexistent scree cover. Wet spot = groundwater discharge in one of various discharge points (seen on one of previous pictures – shiny fracture plates) starting slightly above grass fields. Point is: without major slope change or lithological or any other, groundwater discharge starts high on a sheer rock wall and will cause vegetation to start. This spot is approx. 500 ft. above first seepages.

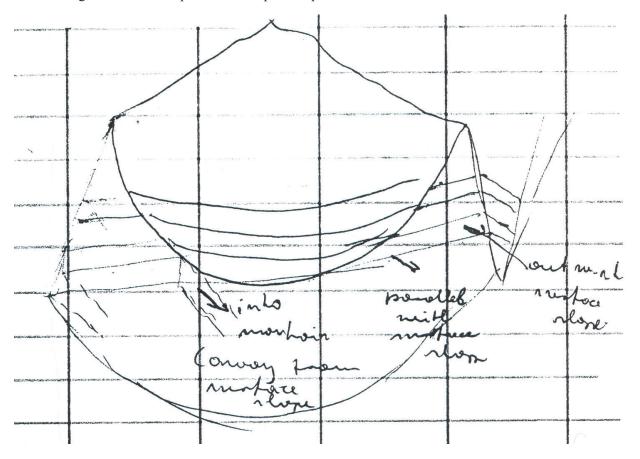
Sketch – stop 47, sk. 5

Ground moisture, as indicated by the vegetation is definitely increasing from (g) to (a). This must be due to the change of the relative positions of dip and top surface.

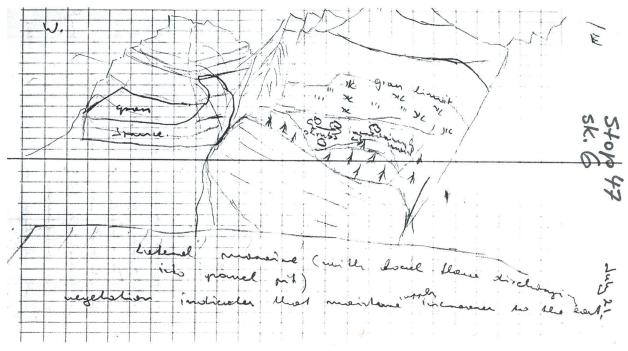
Sketch - stop 47, sk. 6

47h gravel pit with strong springs

The recharge area of this system must be the lateral moraine only 100 yards away.

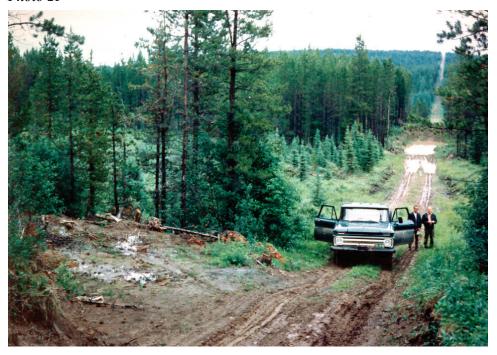
Stop 50-21

<u>Photo</u>: flowing shothole, with valley in background.

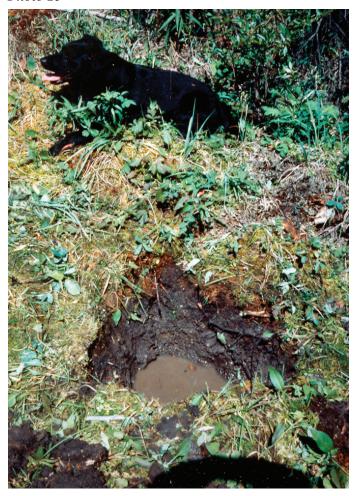
Stop 58-25

<u>Photo</u>: (2) Hole with upwelling water from under moss mat. (This is groundwater discharge, supplying the lush vegetation.)

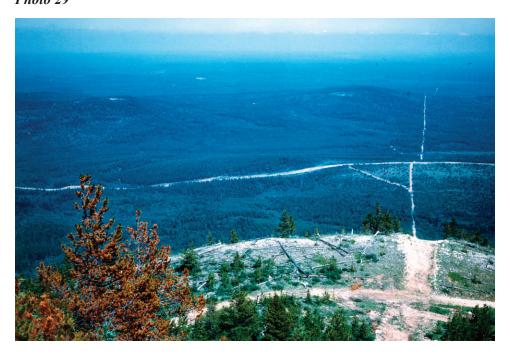
<u>Photos</u>: (2) Typical Foothills topography, taken from Marble Mt. to SSW. **Photo 29**

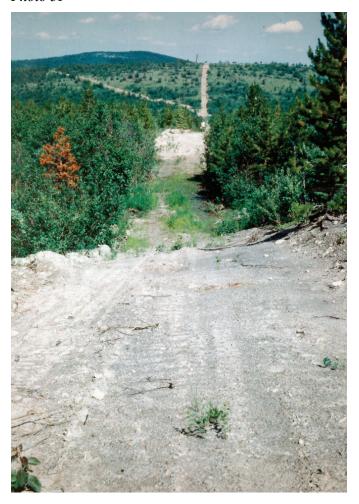
Stop 61-31

<u>Photo</u>: showing contrast between seepage area and other portions of cutline. Surface does slope to the left, thus water is <u>not</u> impounded in surface bowl.

There is a suggestion that this moist belt is coincident with the fault at the contact between Blairmore (ss, sh, congl) and Blackstone (sh, ss) Formations.

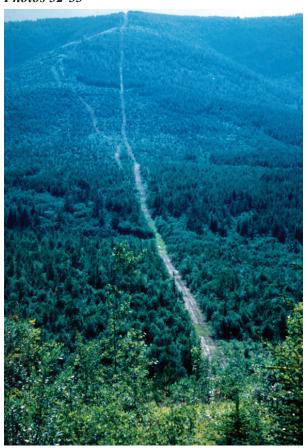
Stop 62-33

<u>Photos (2):</u> E. side of Marble Mountain, taken from the road showing fault associated seepages at kinks/knicks of the slope.

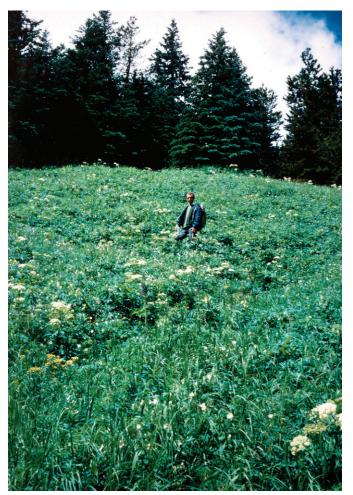
Stop 87

Photos: (1) General view of lush spring – diffuse discharge site

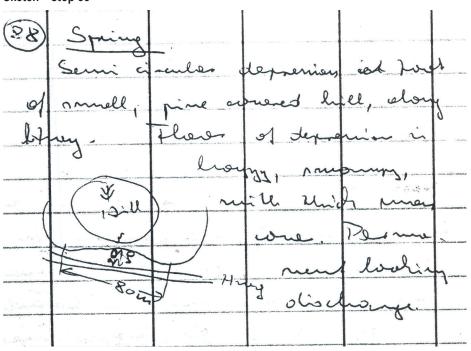
Sketch - stop 88

Semi-circular depressions at foot of small, pine covered hill, along Hwy. Floor of depression is boggy, swampy, with thick moss cover. Permanent looking discharge.

Water flows out of gravel at approx. 100 gpm (measured). (Water sample 88)

T=38°F C=70 μmohs/m Q=100 gpm

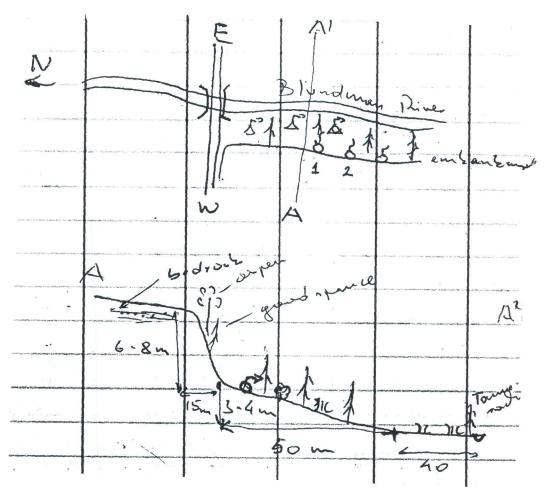
Sketch - stop 120

From the flat bottom of the valley, floor rises gently first, then abruptly, with an embankment it just approx. 6 - 8 m;

Approx. 400 m south of Hwy, first actual spring appears, 50 m farther, second.

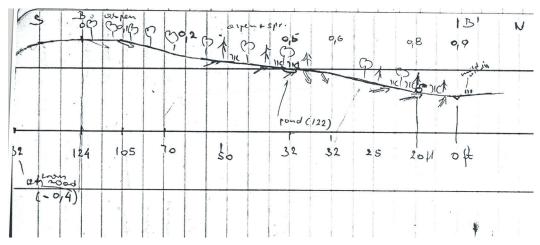
Sketch - stop 122

Between 0.5 and 0.6 mi. land becomes relatively dry, no spruce mixed with aspen. At 0.7 spruce appears (on east side of road where bush was not cut). With a gradual but very marked change vegetation becomes entirely phreatophytic by 0.9: aspen, spruce, tall alder, Labrador tea, horse tail, mosses, and broad leaf flowering plants in a rich, damp growth.

On the west side of the road, where the bush has been cleared, the corresponding change (?) in moisture conditions is reflected by a change from rich pasture grass to very lush and dense sedge and juncus growth. At the place these changes take place water starts to issue in roadside ditch from the ground forming a continuous flow in a well established, locally moss lined channel to creek at 0.9.

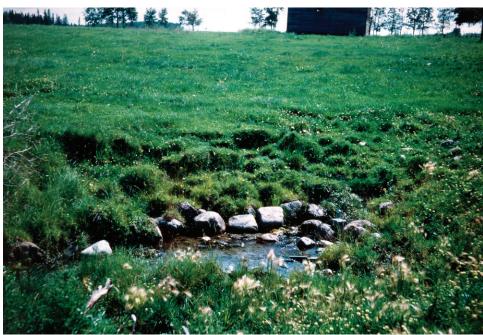
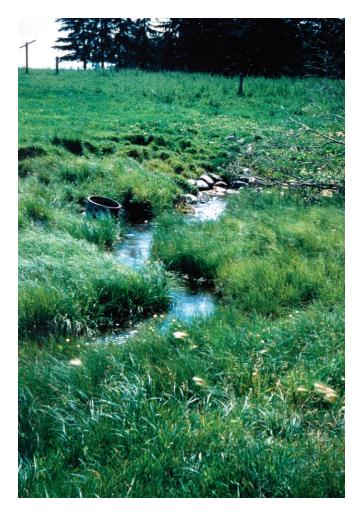
Photos (3): Spring and discharge channel.

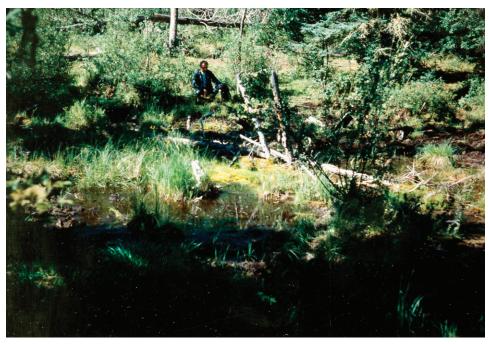
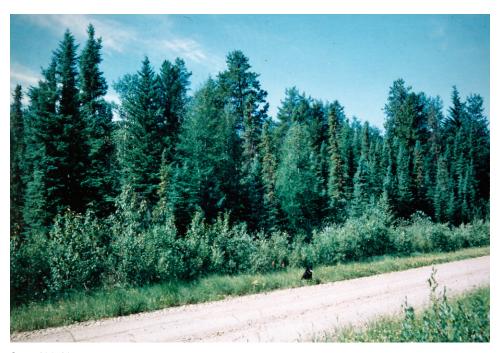
Photos: (1) spring

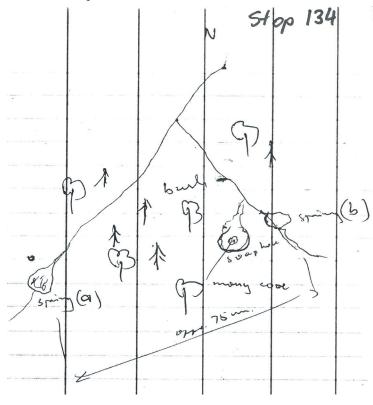
Sketch – stop 134

Two springs approx. 75 m apart with a soap hole in between them discharge water permanently into very well defined, permanent stream channel. Creek bed continues uphill but is dry.

Typical phreatophytic vegetation (see down slope 133), with thick moss & sedge cover at points of discharge. Top of soap hole is formed by a moss layer, which behaves as a membrane: quaky, bulging. Travertine chips found in discharge area of soap hole. Also, some slimy, yellowish, fibrous growth noticed at various points, reminiscent of yellow algae found in sulphur spring. A very faint sulphur odor is thought to have been smelt.

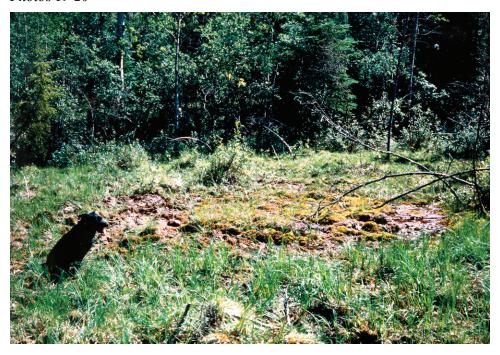
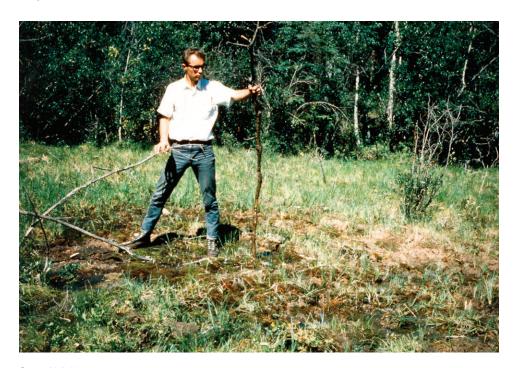
Photos: (1) soap hole – showing mossy core (2) soap hole, with soft depth indicated on pole by Richard's hand.

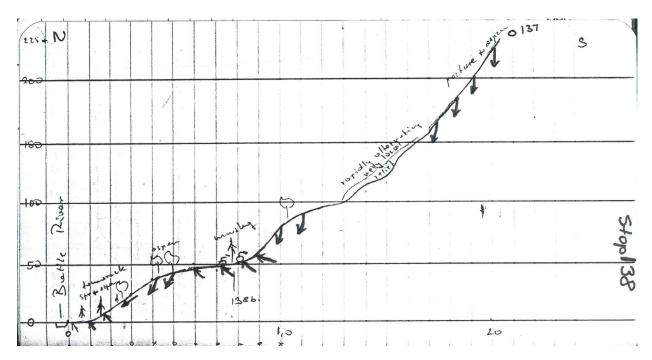
Sketch - stop 138

Nine springs lined up along bank. Water runs all year.

T=58°F C=650 μmohs/m Q~2-3 gpm

When it starts freezing, water level in springs rises approx. 1 ft. (Vegreville!) Sandstone is approx. 4 to 5 ft from the surface, under till.

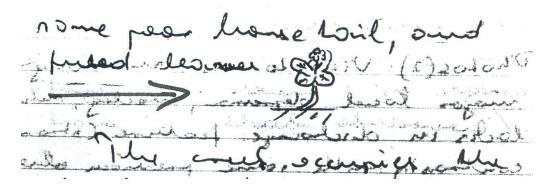
Sketch - stop 142

Ground and general environment moist, due to recent rains, heavy morning fog and dew. Stream bed is well defined, 10-15 ft. deep, 50 to 80 m across bank edges. Vegetation is mixed spruce, aspen, poplar, willow, flowering shrubs, some poor horse tail, and fused leaves:

The creek occupies the bottom of a major linear depression, of approx. 3/4 mi wide and 100 ft. deep. Apart from a rather well defined change in vegetation (from mediocre aspen to the mixed type specified at **141** and **142**), there is no obvious change in the moisture conditions from top to bottom. Ground is equally firm at both places; there is no indication of seeps or springs across this valley, and along a stream stretch of 200 m.

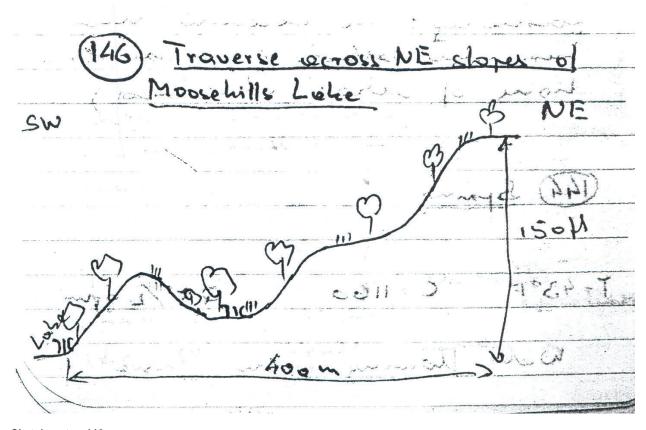
Sketch - stop 146

It is noted, however, that clump of spruce is located at the base of a long gravel-sand ridge. This material is probably the source of the other, few springs, reported in the area.

On top of hill crop grows. On the side of hill there is a coarse, very mixed, uniform vegetation of dwarf shrubs, grass, and broad leaf flowering plants. Before fire, hill was covered by poplar.

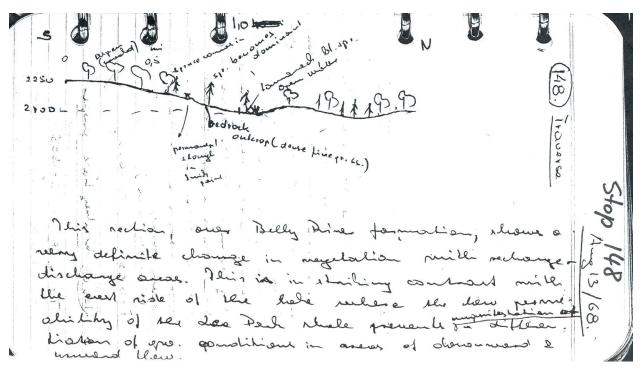
Sketch - stop 148

This section, over Belly River formation, shows a very definite change in vegetation with recharge-discharge area. This is in striking contrast with the east side of the lake where the low permeability of the Lea Park shale prevents manifestation of differentiation of groundwater conditions in areas of downward & upward flow.

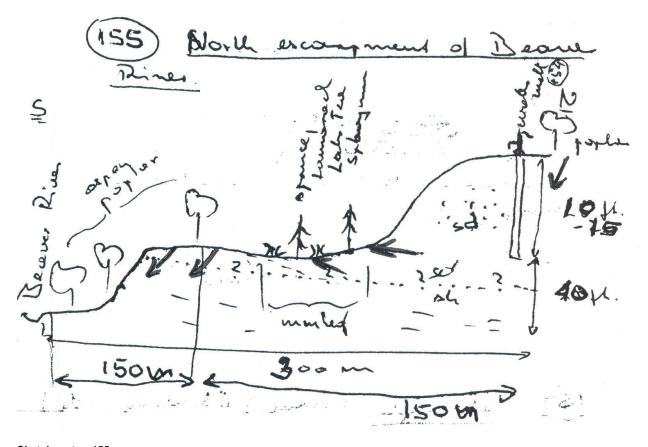
Sketch - stop 155

At knick point of first escarpment: "permanent seep", muskeg. No change in vegetation over second shoulder and second knick point, no indication of discharge. Sand may wedge out here, leaving the low permeability Lea Park shale near the surface, with very slow discharge.

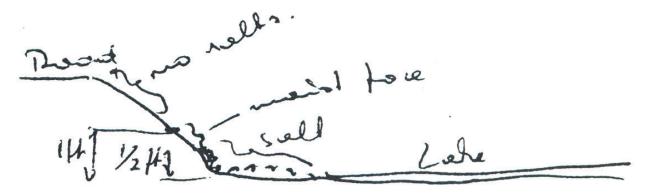
Sketch - stop 157

Salt incrustations start at the base of road filling, in association with visible seepage face.

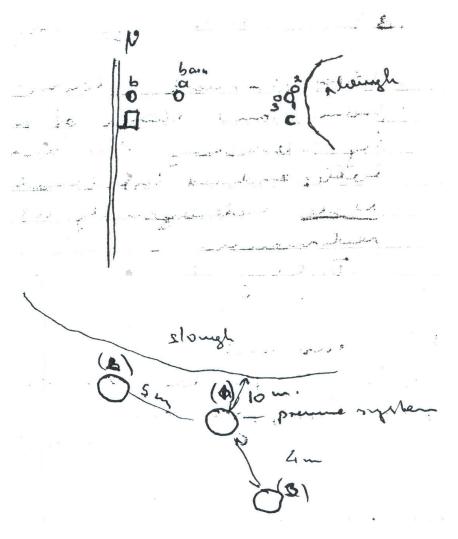
Sketch - stop 159, sk.1

Depth: 20 ft; quick sand at 5 ft from the top; Water level: 5ft from the surface. (Pleistocene sand)

Slough: approx. 16 ft – 20 ft deep Water of slough T=65°F C=165 μmohs/m Slough wells: Three holes dug to 20 ft.

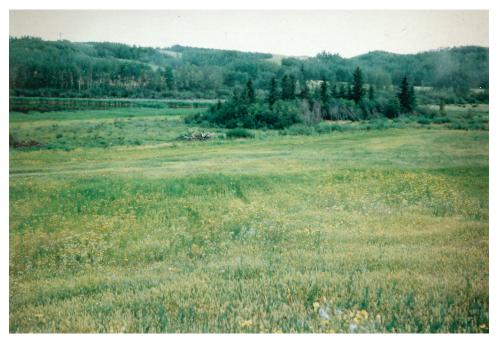
Stop 165-34

Photo: (1) spruce ring with hills and aspen growth on their top. (on south tip of Lake Eliza) (2) take from the hill side: dead wood pile is approx. 3 m above lake level: very soggy, seeping, cattails, no cultivation.

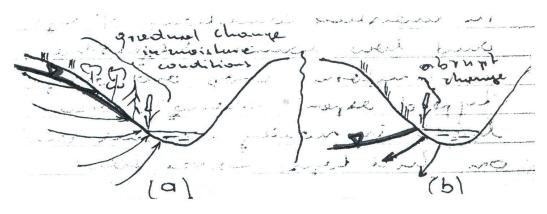
Sketch - stop 171

Possible explanation of different vegetation association at the edge of water bodies supplied by groundwater and surface sources:

- (a) <u>Groundwater fed:</u> depth to the water table increases gradually away from the open body of water, due to the shore line being an area of upward flow. This condition results in a gradual decrease in soil moisture, in turn resulting in a gradual change, and a wide spectrum, with mossy intermediate species, of plant types.
- (b) <u>Surface water fed:</u> depth to water table increases rapidly away from the body of surface water. Change in moisture conditions is abrupt: so is it in vegetation types; transitional species lacking.

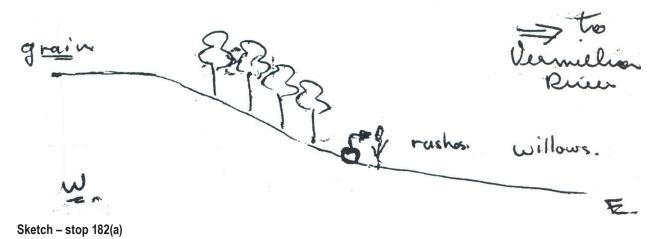
~150 to 200 yards north of **182**, situated at base of hill:

Tree growth as per **182**. Rushes are very pronounced in an oval area immediately below discharge point. Water has same rusty appearance as **182**.

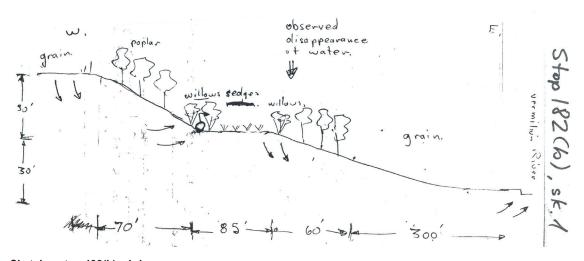
Sketch - stop 182(b), sk.1

Springs and seepages build terraces of iron rich ooze rather than depressions.

Springs and seepages reported for a distance of $\sim 1 \frac{1}{2}$ miles along river bank at same elevations. Also on opposite side of river as shown by photo.

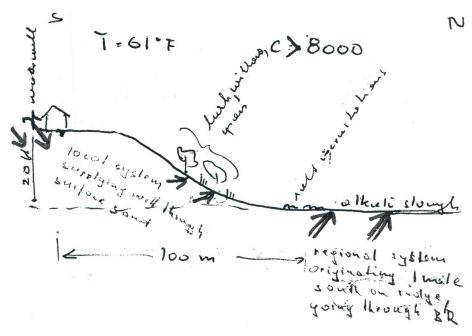
Sketch - stop 184

Gently rolling country. Well is near depression, but above alkali slough by approx. ____ft. Alkali slough

Very shallow (20-25 cm at center) sandy, bentonitic clay, flat, with water. Water is receding fast leaving heavy white salt incrustations around rim of lake.

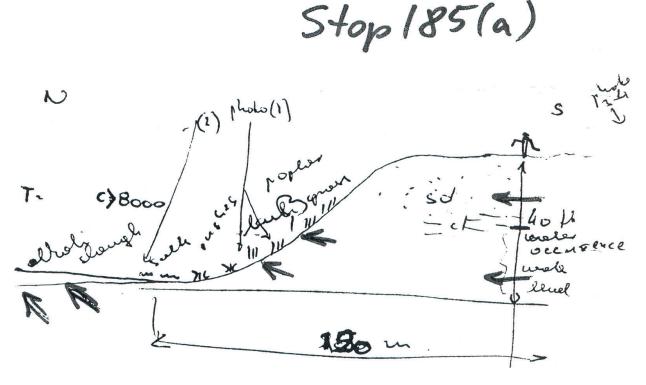
Sketch - stop 185(a)

Large slough with perennial water in it. Presently water level is slightly below normal. Heavy alkali incrustations surround lake like white rim. Lake level is approx. 40 ft. below well tested above. There is a drop between well and slough, with conspicuously lush grass, poplar, and willow vegetation. Situation is <u>identical</u> to that described at **184**.

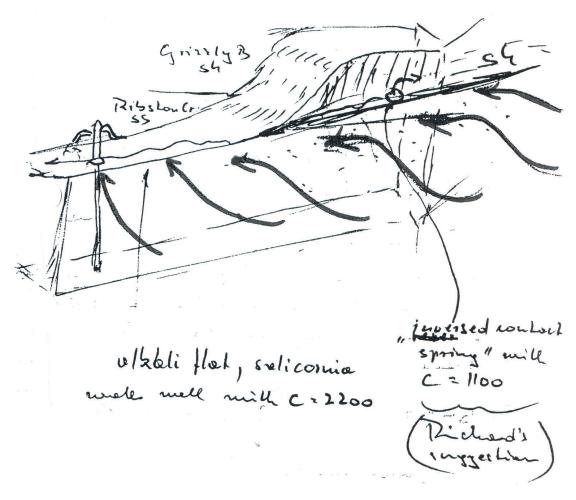
Sketch - stop 190, sk. 2

Note increase in conductivity between spring & house well; both waters may have the same origin.

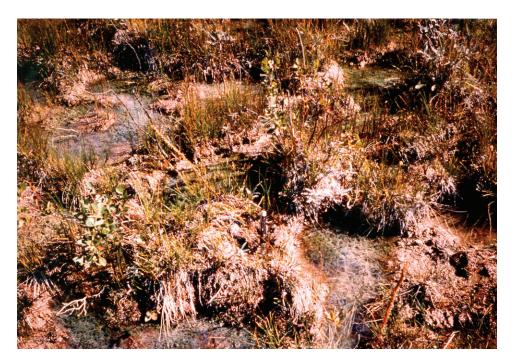
Stop 192

Starting at the base of a slight (2 m) embankment area of extensive (at least 200 x 100) active seep occurs on side hill. Area is boggy, marshy, with open water standing, and locally perceptibly moving in abrupt edged depressions between small (2 x 2 ft.) clumps of rushes.

Water bodies have whitish, creamy "sulphurous" muck layer sediment on sandy bottom. Large number of snails. Locally, pinkish sediment, suggestive of sulphur springs and seeps described in Northern Alberta. Area is characterized by lush <u>poplar</u> and aspen growth, alder, rushes and sedges. Seepage is developed <u>in or on</u> Ribstone Creek sandstone, found in outcrop in road cut just uphill of site.

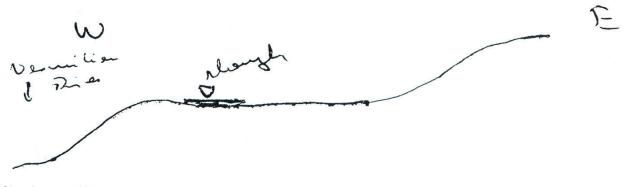
Sketch - stop 198

T=63°F C=300 μmohs/m

The slough itself is located on the edge of a flat portion of the valley; 4 ft. deep.

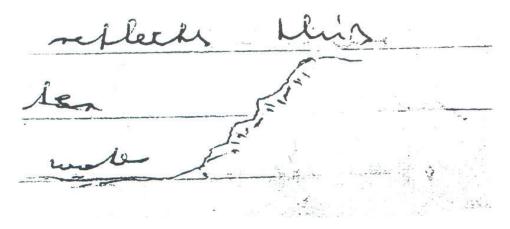
Sketch - stop 1, 1964.05.01

A dugout of approx. 50 x 40 m and 6 m deep. Bottom contains open water.

Top formation is highly oxidized till, to a depth of about 2 m. Below the till reworked bedrock. The bedrock is bentonitic evidenced by intensive sun (mud) cracking on the surfaces of the pit-walls. At places the surface is covered by very heavy salt precipitates. Below these areas the soil is moist to saturation. Parts of the relatively undisturbed bedrock are oxidized. Bedrock consists mostly of dark (wet) shale with sandy bands. At these bands salt precipitates are heavier. Erosional surface reflects this banded character.

Hole of about 5' x 2' was dug under the open water with the geological hammer. Whereas the sandstone looked relatively porous no water could seep into the hole because the pores are plugged by bentonite.

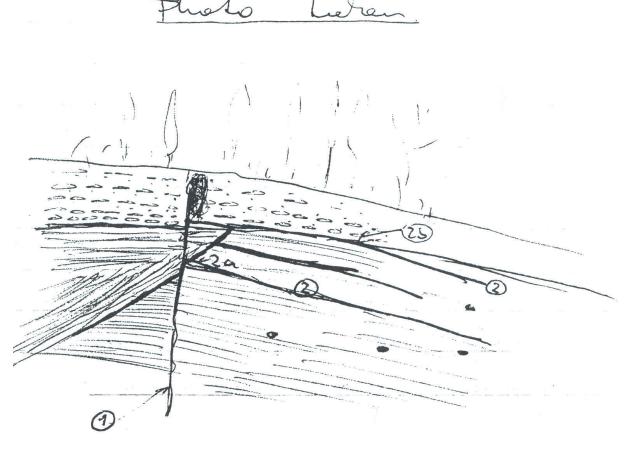
Sketch - stop 2, 1964.05.01

Photo legend:

- 1. Fractures might go (as in the sketch) through the gravels. The solutions give better induration to the unconsolidated gravels and they will stand as a slightly protruding column along the fracture.
- 2. These planes receive their water from other planes of discontinuity, such as fractures (2a) or contact between the sand and gravel (2b).
- 3. Also the cross-bedding planes water originates at other discontinuities.
- 4. White salts precipitate around roots forming tabular bodies of about 1/2" in diameter and hollow on inside (sample).

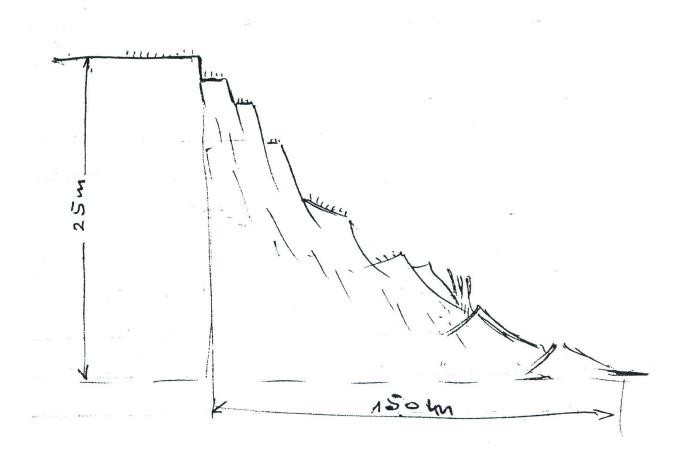
Sketch - stop 3, sk 2, 1964.05.01

At the bottom of the slide autochthon breccia of fine siltstone. At one place water is noticed to seep out of the ground.

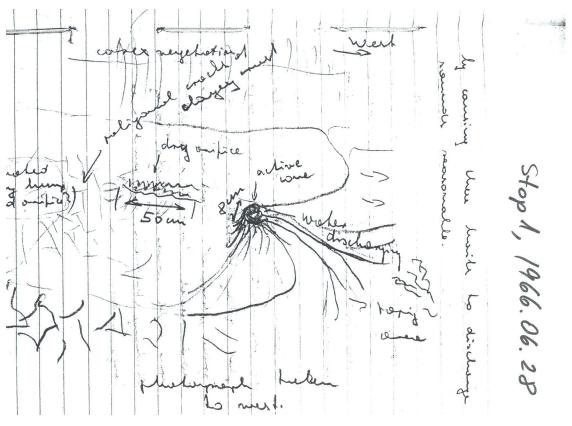
Sketch - stop 1, 1966.06.28

Surface of the second soap hole (or rather the area) is higher than the top of the road despite the fact that it is in the original ditch. Good indication of its "building" nature.

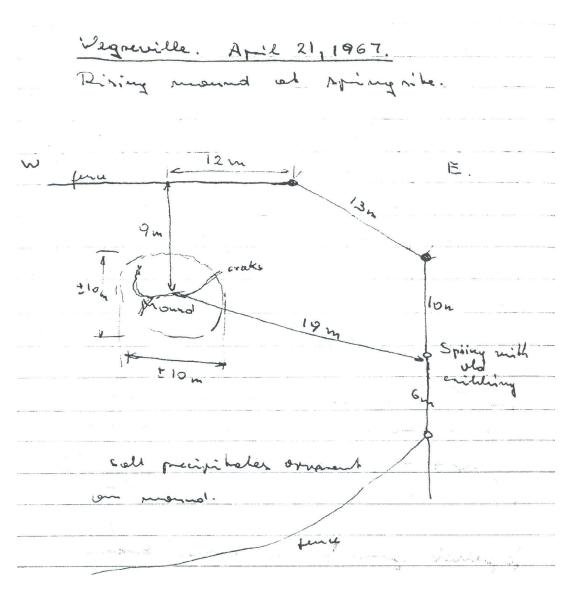
Sketch - 1967.04.21

Vegreville – <u>Rising mound at spring site</u>

Mound has apparently largely deflated since last visit. The semi-circular crack marked with branches has partly closed up, although still clearly visible. The winter apex of the mound (marked with a long stick on present photos) has been replaced by a depression, containing water presently. This water is thought to have been derived from ice or water underneath the mound. This conclusion is based on the following observations:

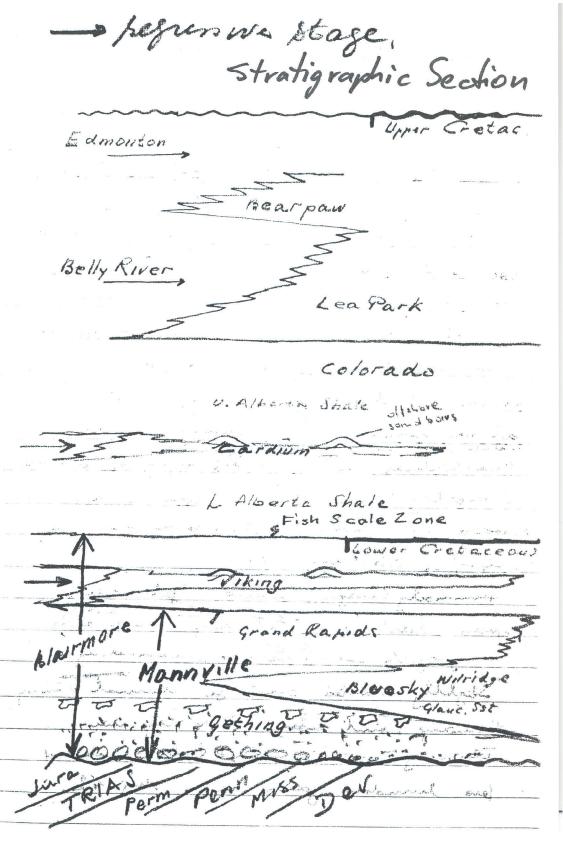
Sketch - stratigraphic section

<u>Photo</u>: showing slope with some "bulge" above whitish, bentonitic sandstone outcrop.

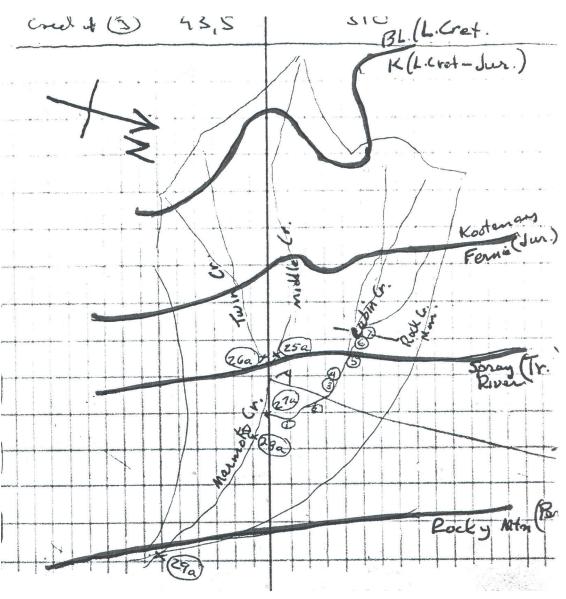
Sketch - sk. 1, 1968.06.24

T(°F)	Cond.(µmohs/m)
1	33	460	Spr. R. sltst
2	35.5	440 "	
3	35	390 "	
Creek at 1	40	345	
Creek at 2	41.5	315	
Creek at 3	43.5	310

On the basis of conductivity values it is suggested that springs discharging on north banks of Cabin Creek have water that has travelled along a larger flow system, probably more or less along the bedding planes that water discharging at 3). This water would go through a short system, across the bedding and along fractures. Bulk of creek water is from snowmelt.

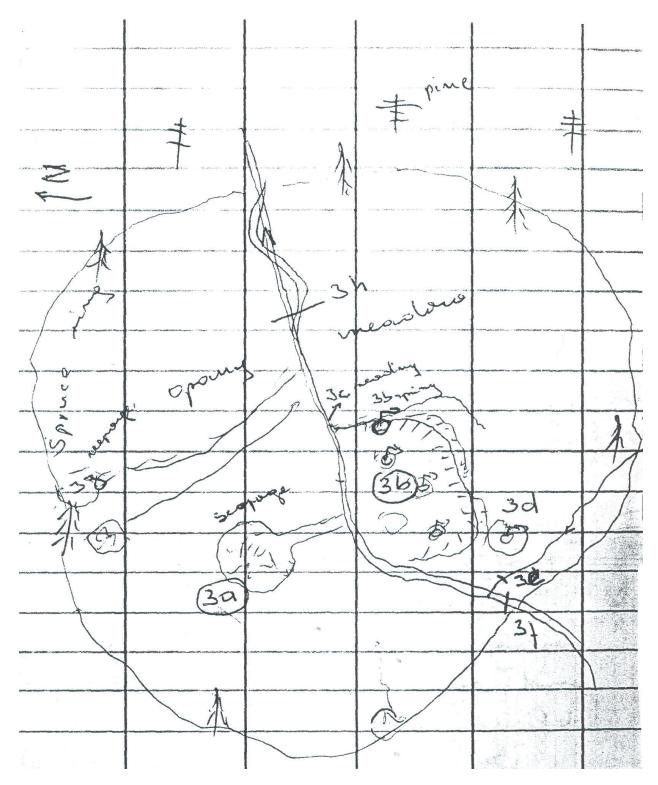
Sketch - 1968.06.26

Center part is slightly elevated and moss covered. Channel connecting seepage and creek is grassy but well defined.

On opposite side large (40 m) slumped, semi-circular washout discharging water at many spots. Obviously, this marked out depression, now fused with the creek is a further developed form of the first seepage.
